RISTKIHTPUIDUST MAJA RUUMTULEKAHJUKATSE – TULE LEVIK LÄBI LIIDETE JA LÄBIVIIKUDE

LARGE SCALE FIRE TEST OF CLT – FIRE SPREAD THROUGH THE JOINTS AND
PENETRATIONS

MAGISTRITÖÖ

Tallinn, 2018

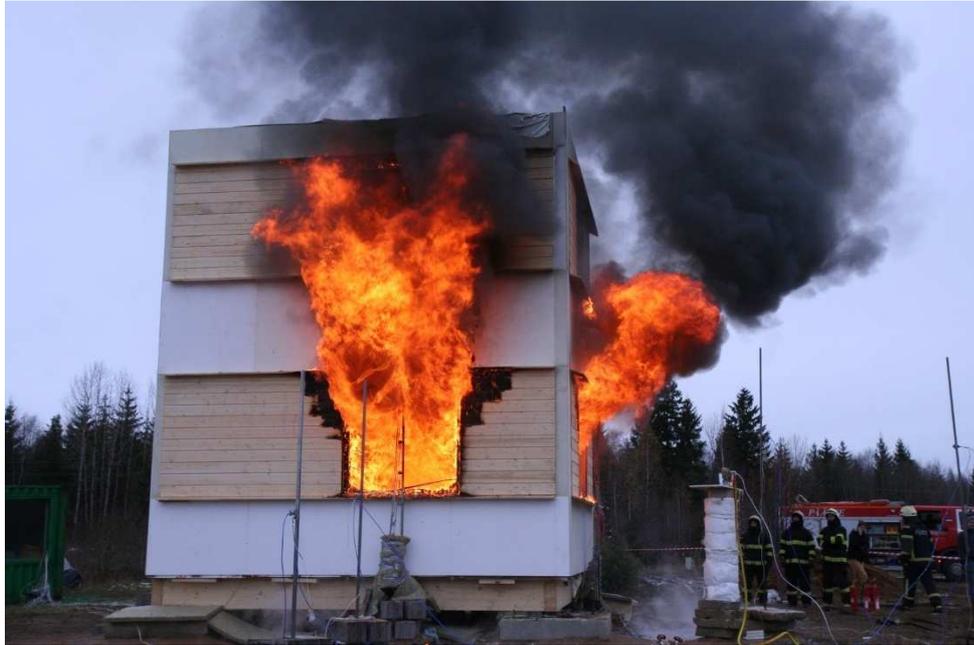
0:52:00 The cement board above the secondly broken window is starting to disintegrate.

Figure 2.15 Fire has spread to the facades

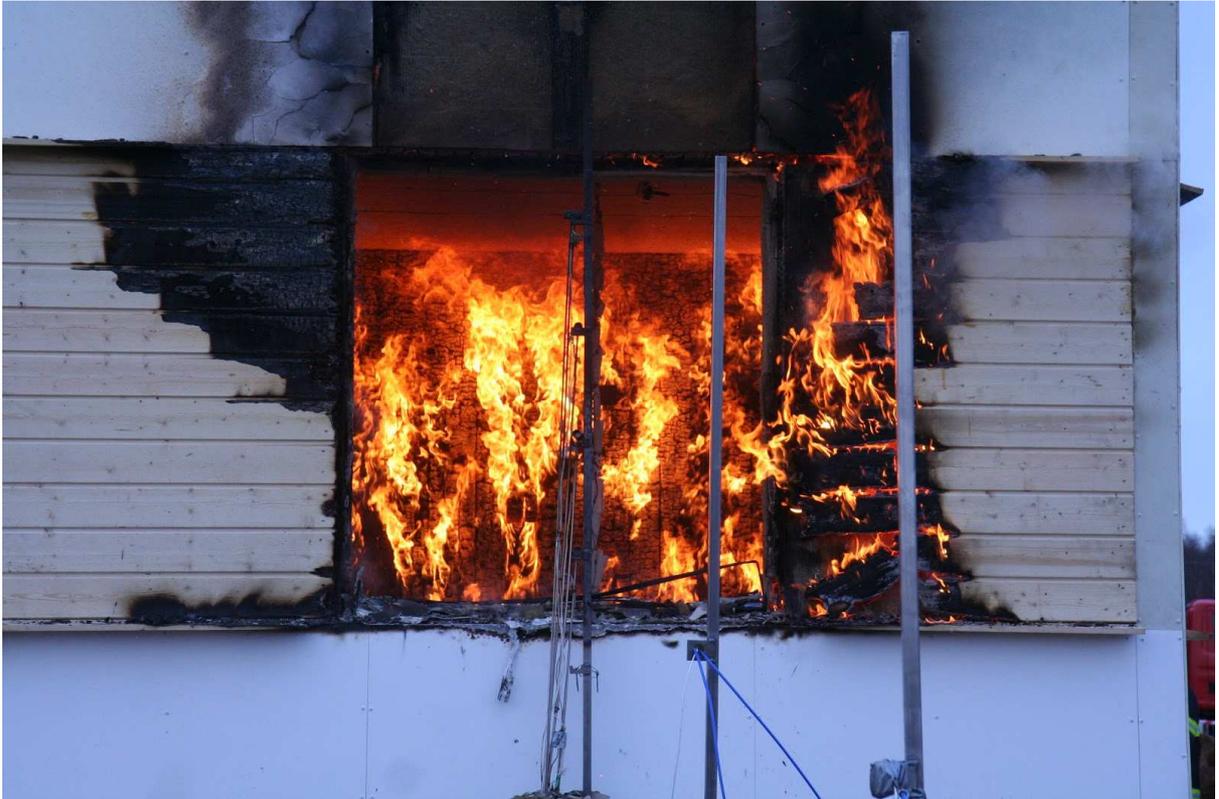
1:51:00 The charred layer of the CLT falls off and the second layer of CLT starts to burn with increased rate due to being preheated.

2:00:00 The second flashover occurs. The exposed second layer of CLT is now completely on fire, see Figure 2.18.

Figure 2.18 The second layer of CLT is burning

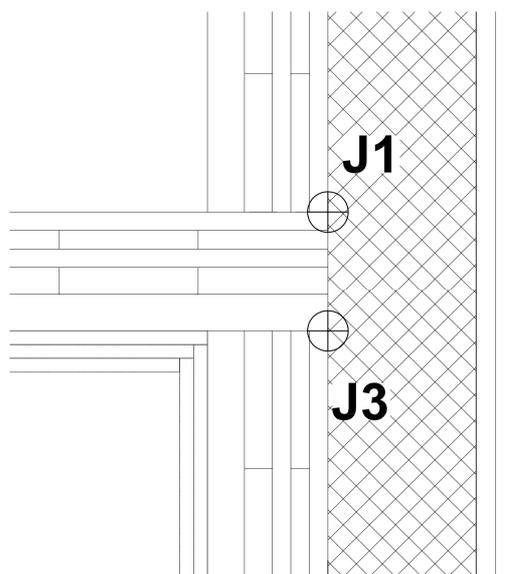
The sudden temperature rise is thought to be caused by heated gases penetrating the joint after the flashover occurred, which also set all the gases on fire. This means that the joint was not 100% airtight and the heat from the flashover pressed through between the gypsum edges and CLT. Another thing to be noted is that these wall corners did not have gypsum from two sides, but only from one.

Figure 3.5 Gypsum covering the joint from one corner

An overlapping joint as such could be able to entirely seal the connection and shield it from heat, if guaranteed to be built very accurately and tightly. An additional recommendation would be to add another strip of intumescent paper behind the gypsum, just to where the CLT + CLT joint starts. This would ensure the fire and heat never to spread through the joint.

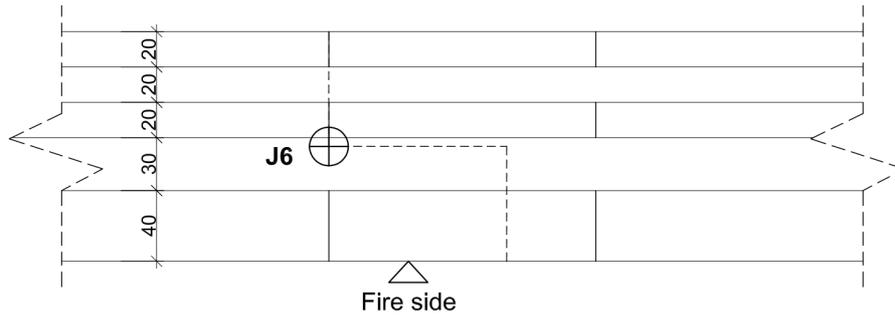
Figure 3.6 shows that right after 60 minutes, the thermocouple labelled as J6 also had a rise in temperature. As seen from Figure 3.1, J6 was placed into the joint on the uncovered CLT wall opposite to the room from the fire ignition point.

Figure 3.7 Thermocouple J6 was placed into the joint, behind the second layer of CLT

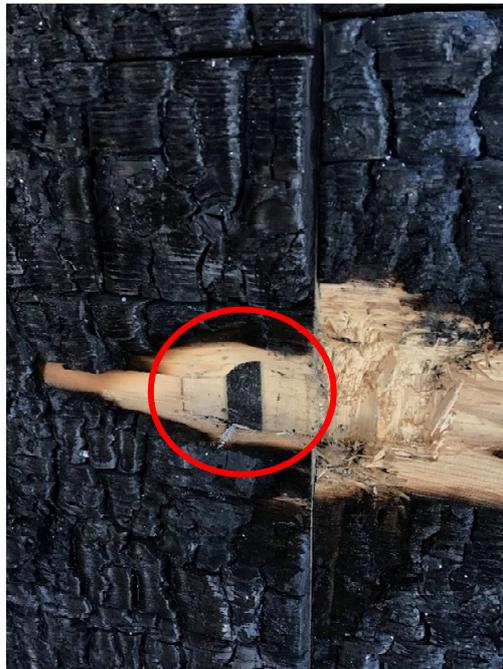
Since the flashover had occurred, igniting the unexposed CLT wall, it can be assumed that heat had started penetrating the joint. However, according to the figure above, the temperature stayed between 50 °C and 100 °C, which is not dangerous due to not being high enough for pyrolysis to happen. Therefore, the joint did not reach the temperature (200 °C according to the manufacturer) required for the intumescent sealing paper to trigger its expanding and sealing properties. This was also confirmed during a post-test site inspection. The joint was partially opened to see how the intumescent paper acted in the fire. As seen on Figure 3.8, the inside of the joint is completely unharmed by fire or heat and the Tenmat paper has not reacted to the heat, confirming that the recorded data is correct.

Figure 3.8 Partially deconstructed CLT + CLT overlap joint proving that the intumescent paper did not reach the required temperature for expansion

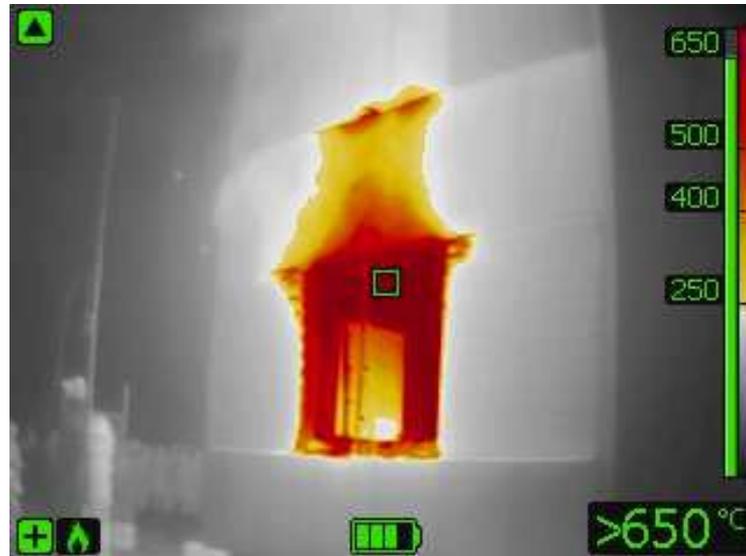
Since photos taken with a thermal imaging camera show the wall's temperature to be more than 650 °C, the low temperatures inside the joint are an indicator that the joint design and build quality were good (see Figure 3.9).

Figure 3.9 Thermal image showing wall temperature inside the compartment

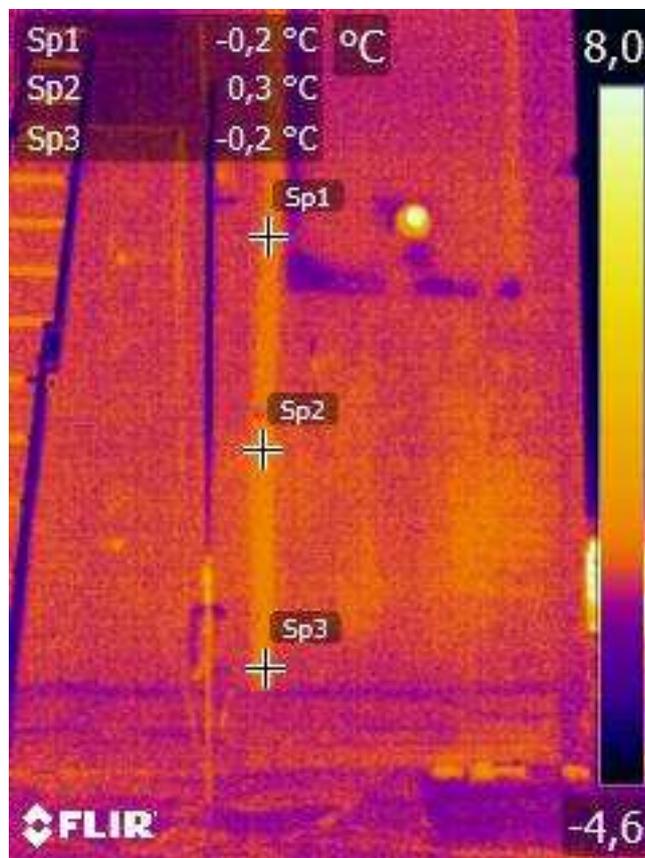
The effectiveness of the CLT + CLT overlap joint can also be shown with thermocouple J6 as an example. When comparing the recorded raw data to a photo taken with a thermal imaging camera from the outside, the differences in temperatures are drastic. The photo was taken with a timestamp of 13:05:18, which corresponds to 72 minutes into the test. The data shows that inside the compartment, temperatures were about 690 °C and only above 50 °C inside the joint. Figure 3.13 shows three different points along the lower floor span of the overlap joint. Each of these measurement points has a very low temperature of near 0 °C, therefore it is safe to say that the designed joint works extremely well in isolating a burning compartment from the outside.

Figure 3.13 Thermal camera image of the joint housing thermocouple J6

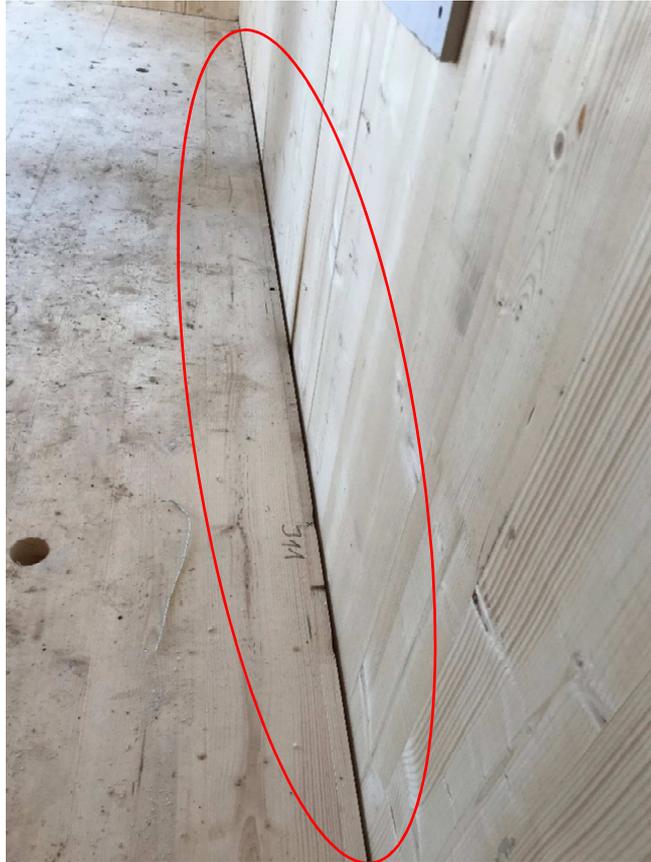
Figure 3.17 J11's location as seen from the upper floor. Visual inspection shows the joint to have worked perfectly due to no observable smoke or heat damage

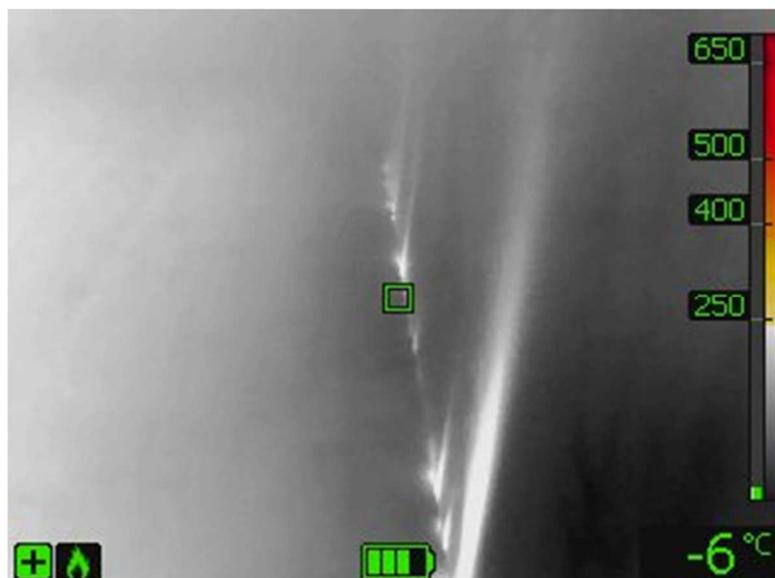
Figure 3.18 Thermal image taken by the fire brigade showing extremely low temperatures on the upper floor side of the joint

As seen on Figure 3.18, the temperature behind the joint on the upper floor was -6 °C. Meanwhile, the lower floors compartment had just had the first flashover and the temperatures inside the room, on the other side of the joint were over 1000 °C. The same can be seen on the image below, which shows the joint across the room.

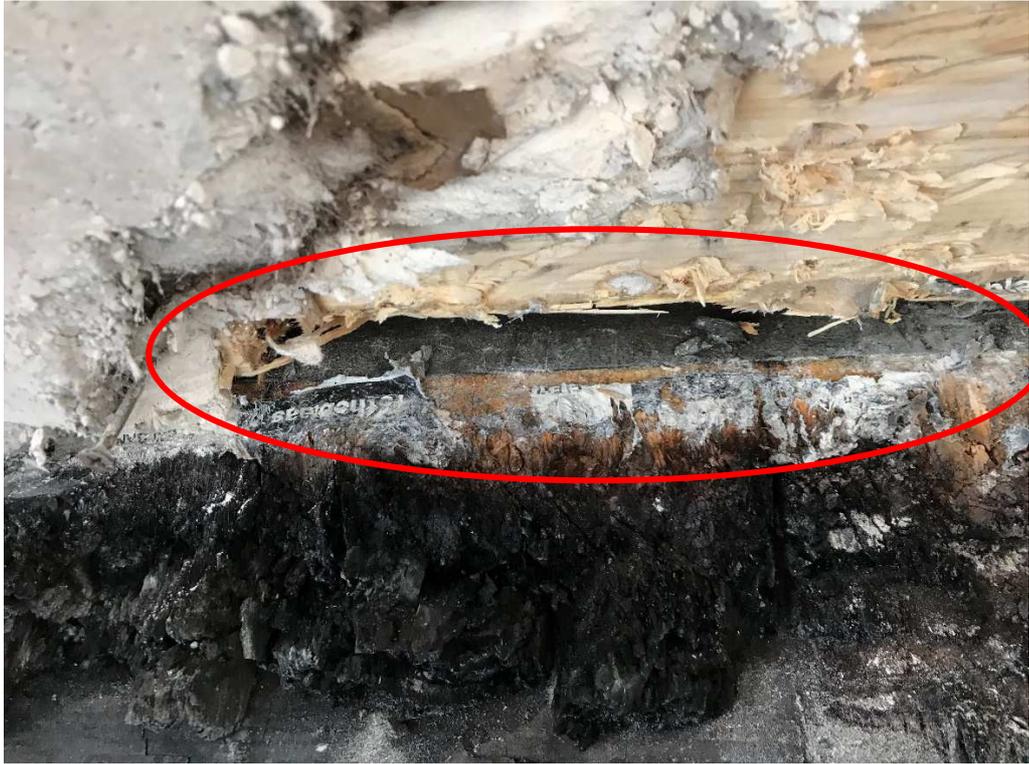
Figure 3.20 Deconstructed wall-floor joint meant for larger scale buildings. No expansion of intumescent tape has happened

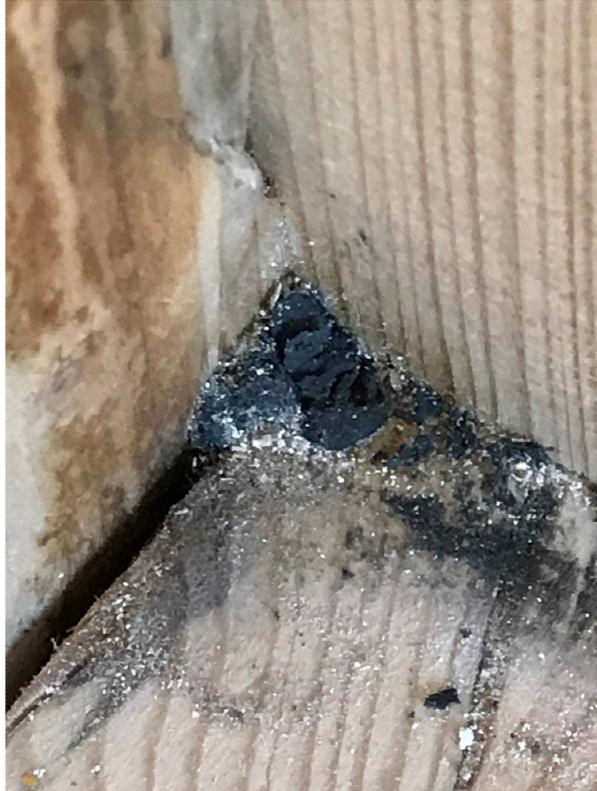
Due to the joints working ideally in a real fire scenario, the expanding properties of the intumescent tape were hard to demonstrate. However, during the post-test inspection and analysis, the expansion of the tape was observed inside each of the corners of the upper floor. This is shown on Figure 3.21.

Figure 3.21 Intumescent paper Tenmat FF104E after reacting to heat

One explanation why this happened would be that the heat and hot gases might have moved through a corridor which formed in between layers of gypsum. Another could be that the gypsum plates were not as tightly against the CLT in the corner as they were on the span of the ceiling. Whatever might have caused this, it still goes to prove that the intumescent tape provided by Tenmat has worked and isolated the second floor from hot gases and fire.

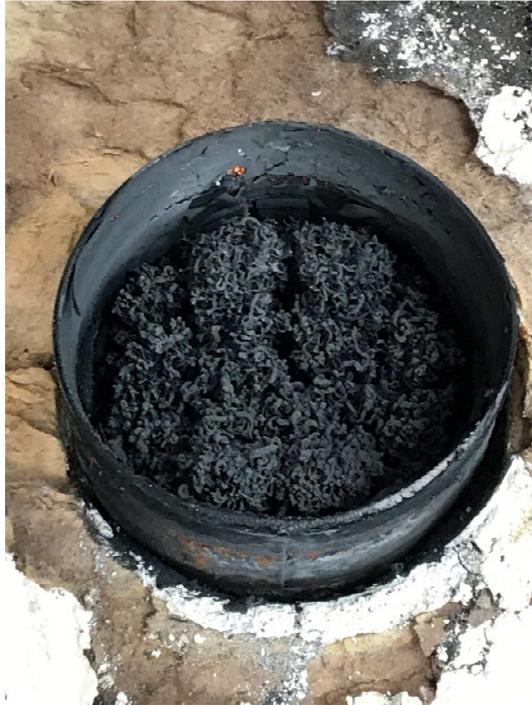
During a post-test inspection, the HVAC duct was also deconstructed to confirm if and how well the tested product had worked. After deconstructing the duct, it was observed that the graphite-based material used in the damper had expanded properly and sealed the entire span of the duct (see Figure 3.26).

Figure 3.26 The intumescent material used in the damper in its expanded form

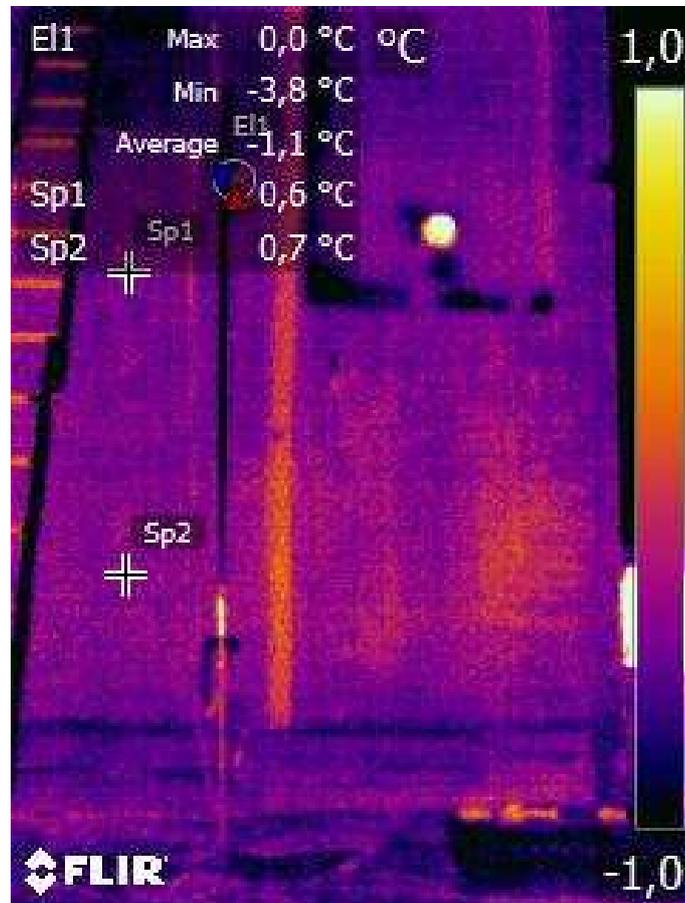
As with the HVAC, visual observations during the test showed no signs of failure from the small penetrations' sealing materials. Again, a thermal image of the outside wall showed extremely low temperatures, whereas the temperatures inside the compartment were very high as described

Figure 3.28 Thermal image of the smaller penetrations

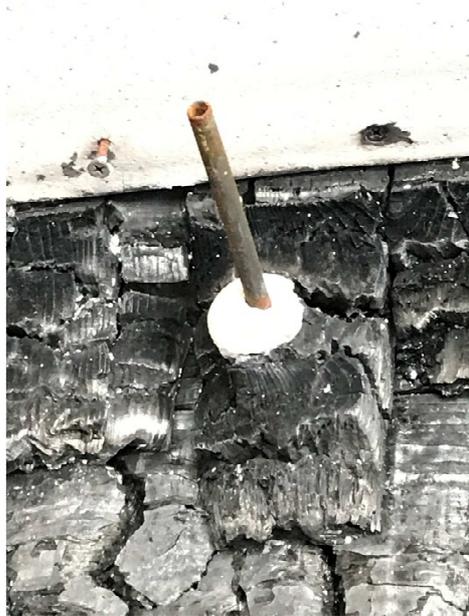
Figure 3.29 Expanded intumescent material around the tube

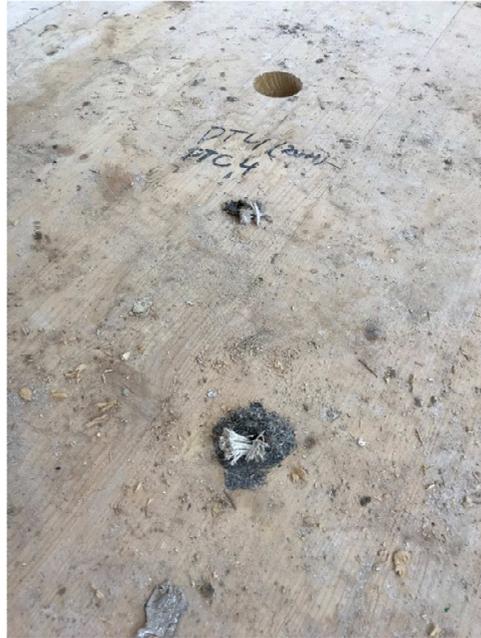
The plate thermometers and thermocouple trees that were attached to the ceiling had a penetration through to the upper floor. Those penetrations were sealed with a graphite-based sealant. No data was recorded with thermocouples for those penetrations, so the results are based on visual analysis. When the second floor was observed during the test and post-test inspection, no signs of failure were noted (see Figure 3.30). As the penetrations were under three layers of gypsum, it can be assumed that either the heat did not reach the sealant for it to react and expand, or that it expanded within the gypsum layers. However, since there was no visual fire or heat damage to the CLT panel on the upper floor, the penetration was successfully isolated from the bottom compartment.

Figure 3.30 Graphite-based material in the ceiling penetrations as seen from the upper floor

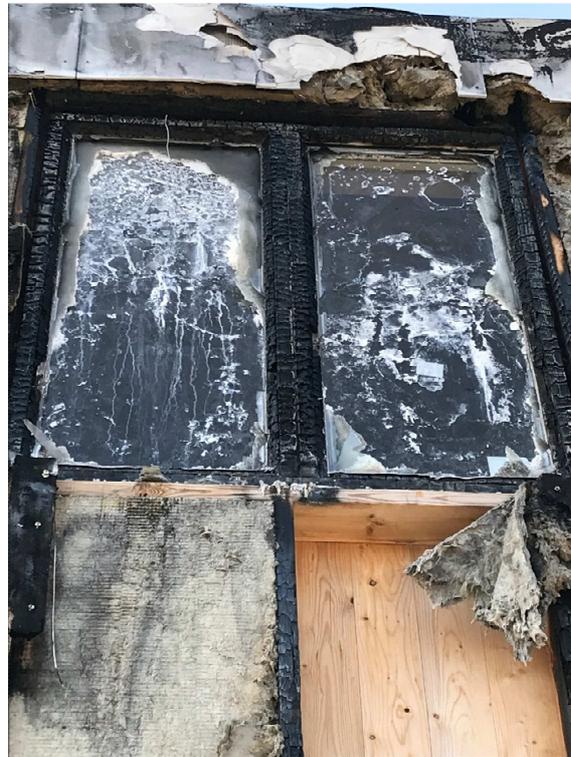
Figure 3.35 Fireproof window on facade 1-1 after the test

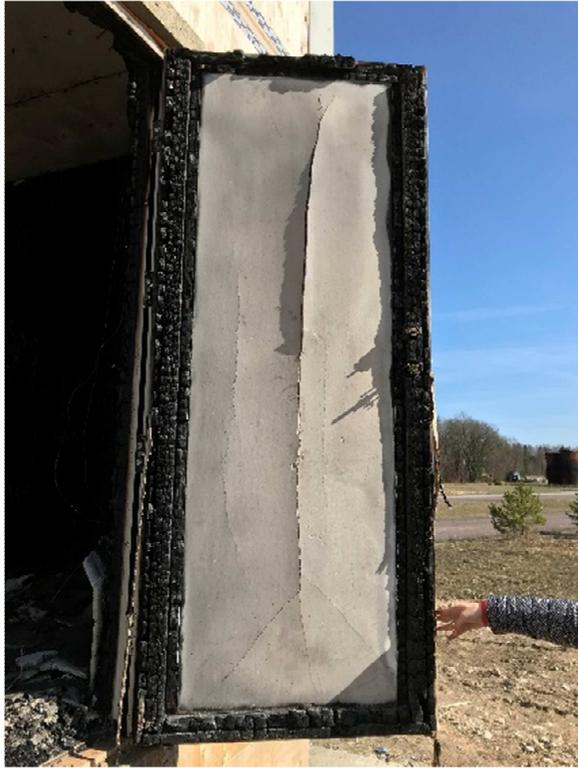
The fire did not access the door on the upper floor. On the lower floor though, the EI30 door held up surprisingly good. The inner board was charred, but no visible damage from fire was observed outside, so the fire did not reach the gypsum board that protected the door from the outside.

Figure 3.37 Inner face of the door after the test
