EENSALU & PIHEL

**Object:** Defence barracks, building monument reg.no. 8485

**Address of the object:** Kalaranna St 28, District of Põhja-Tallinn, City of Tallinn, Harju County

#### SPECIAL CONDITIONS FOR HERITAGE CONSERVATION

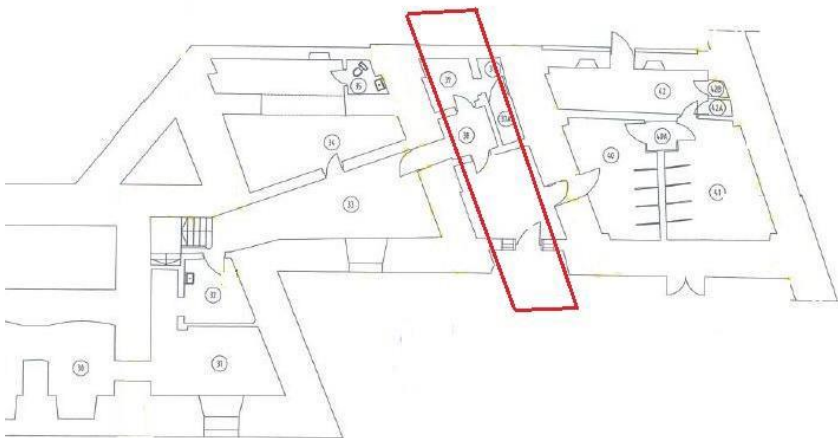
III. 59. The first floor plan of the eastern end of the lunette's southern wing: central under-arch passage, walls densely filled with gun ports, a niche with an arc aperture on the gorge courtyard façade. Project from 1838. eaa.79.2.170

2.14. The original limestone walls of the eastern end of the lunette's southern wing must be preserved and restored. Decayed wall parts to be repaired by sealing with the respective original material- bricks or slate. The original limestone walls in the casemates must be preserved and restored. It is recommended to open the original apertures: bricked-up windows, bricked-up inner doors, under-arch passage see ill 58 within the marked area, wall niches with arched lintels see ill 60 and ill. 61. Example ill. 59 ja ill. 62.

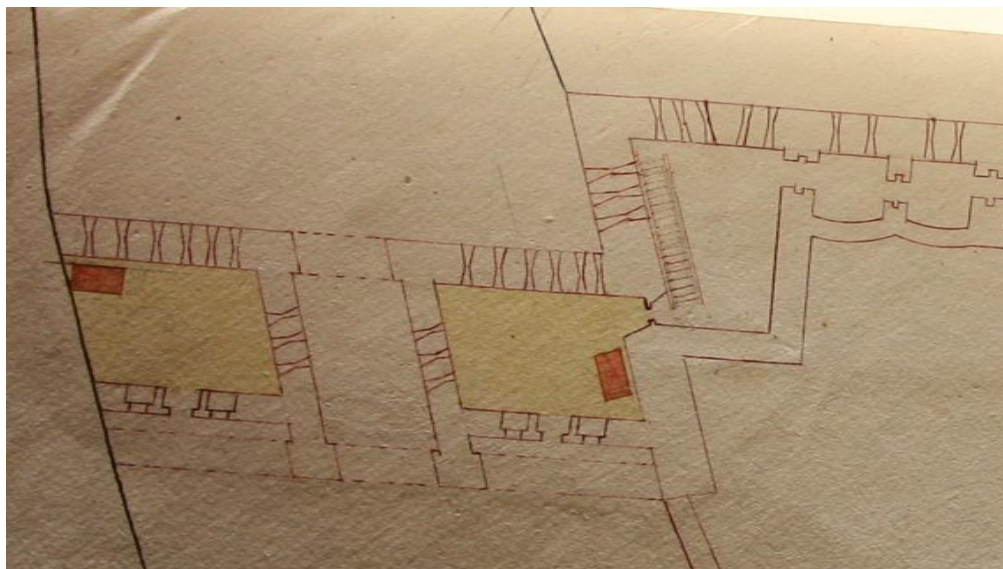
III. 60. Wall parts of the former curved-lintel wall niches marked with red.
