Pantelejevi villa: ehitisest endast

Joosep Metslang

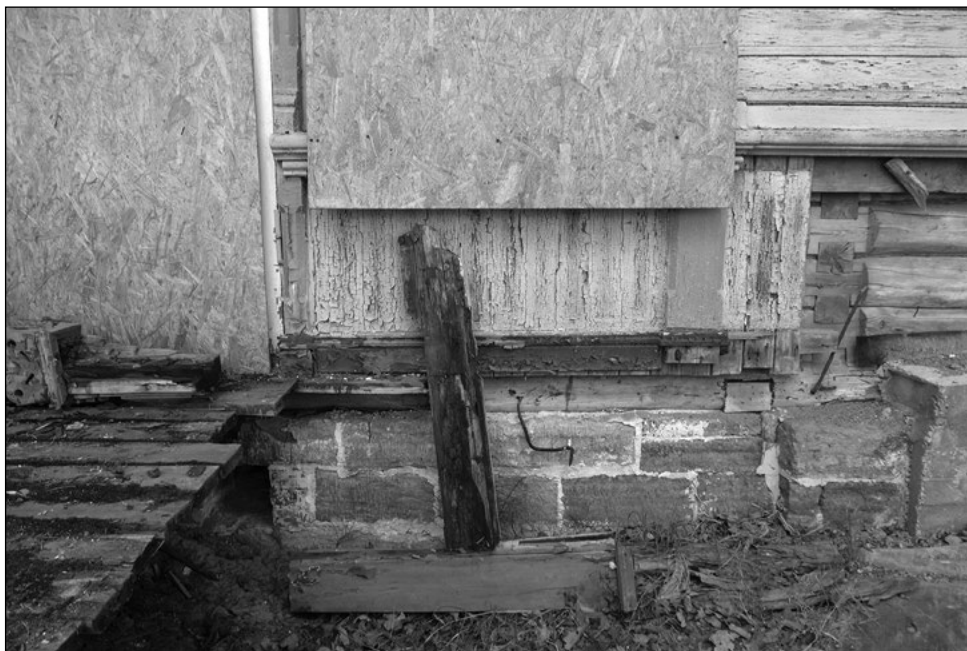
Vanema hoonekehandi paekivivundament, paremal on näha peamiselt kuusepalkide ümar välisosa. Fotod ja skeemid selles artiklis: J. Metslang

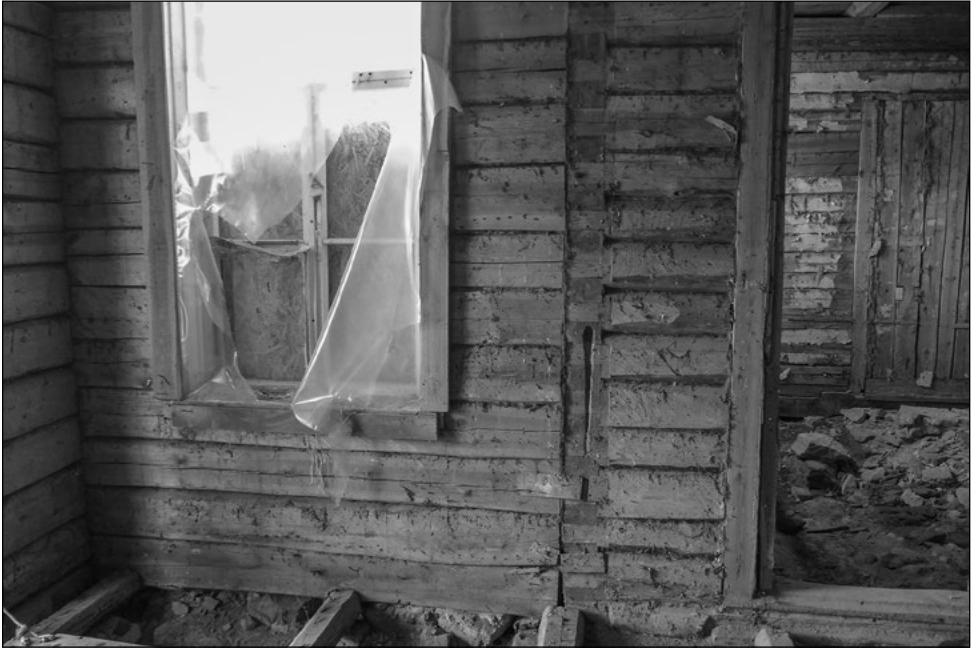
Paremal vana hoonekehand, vasakul teise ehitusjärgu palgid.
Taamal näha vana tapeedi riismeid palkidel.

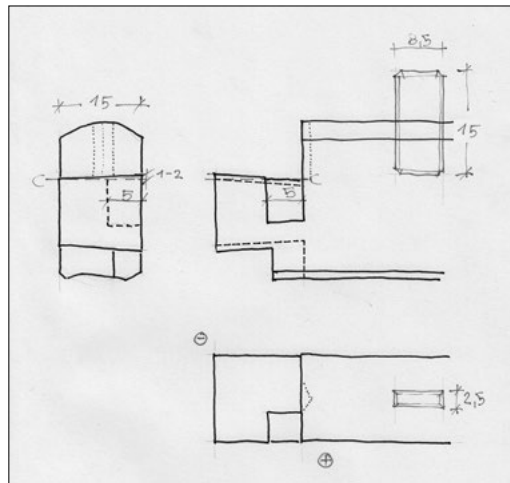
Laiendus rajati samuti paevundamendile. Seinad raiuti üles vana eeskujul 15 cm laiuseks servatud kuuse- ja männipalkidest, ümarmaterjali pole näha. Uued palgid on vanadest suurema läbimõõduga. Kasutatud on puhasnurka, millel on üks alumine hammas ning ülemine soon. Lahtise vara vahele on pandud takku.

Teise ehitusjärgu ajal kasutati palkide ülesraiumisel ühe hambaga puhasnurka.

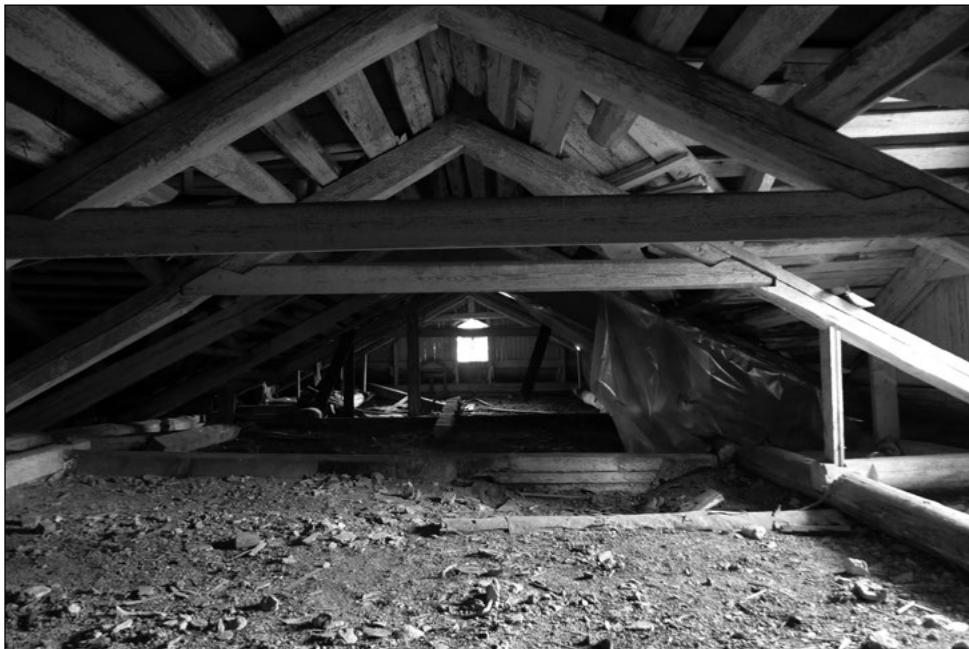
Hoonele valmistati madala kaldega katus, mis kaeti valtsplekiga. Puitmaterjali säilivuse parandamiseks katusetarindi prussid lubjati.

Vaade katusetarindile pööningult.

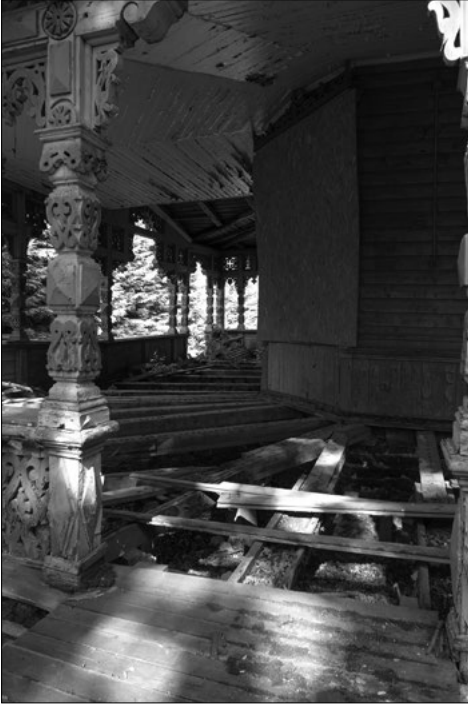
Võib-olla kõige traagilisem on hoone puitdekoori häving, mis on näha juba Aia tänavalt. Esimese ja teise korruse verandade, arkaadide, konsoolide, rinnatiste, postide ja muude väliskeskkonnaga kokkupuutes olevate puitdetailide

Väline hääbuv ilu ja tegelik häving.

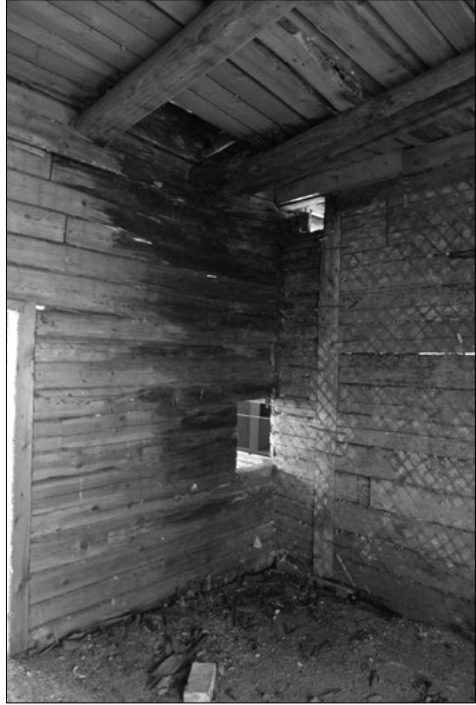
häving on kestnud pikka aega. Vaadeldes mõõdistatud jooniseid lähemalt on kahjustused ka selgelt loetavad. Katuse läbijooksud on kõige enam kahjustanud keskseid kandvaid seinu: ruumide 11, 12 ja 13 vahel, samuti teise korruse ruumide 27, 28 ja 29 vahel. Sama kahjustus jätkub pööningul. Üksikuid lagunemise märke loendamata võib tõdeda, et eriti kurvastab hoone interjööri ulatuslik lammutamine: teise ehitusjärgu viimistluskihiks olnud laudis on suuresti ära kistud; mõlema korruse põrandad (on üksikud erandid) koos kogu inventariga on hävinenud.

Seenkahjustused II korruse ruumis 29.

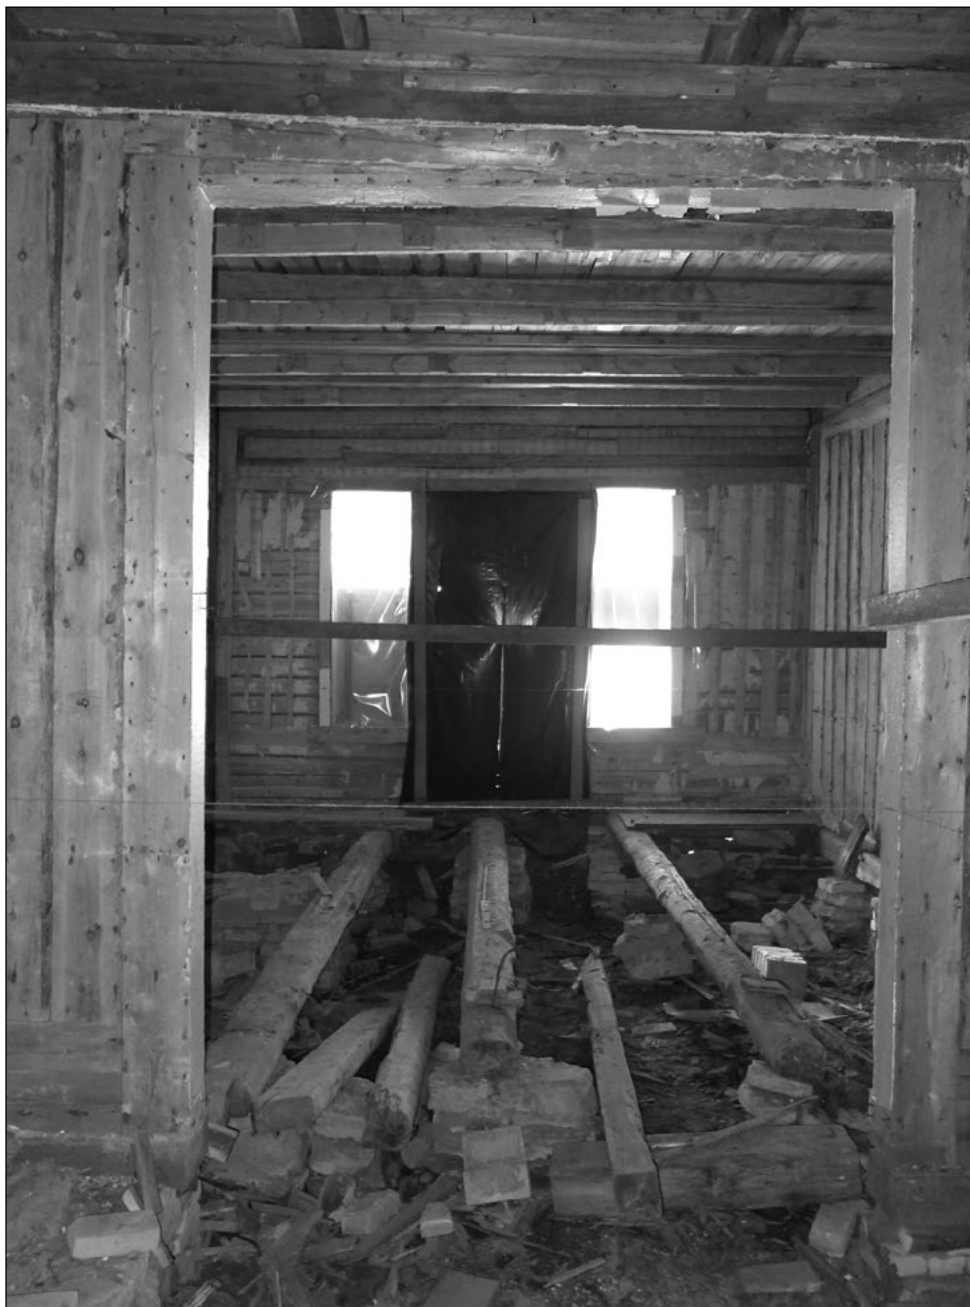
Maja südames oli hoone keskne pidulik saal (ruum 11):
põrandata, seinte viimistluseta, laelaudiseta, avatäideta, küttekehadeta.
