KUNDA RIVER ANCHOR ICE FORMATION

2017-02-08, Tallinn, Keskkonnaagentuur

SITE VISIT PHOTOS 20170208

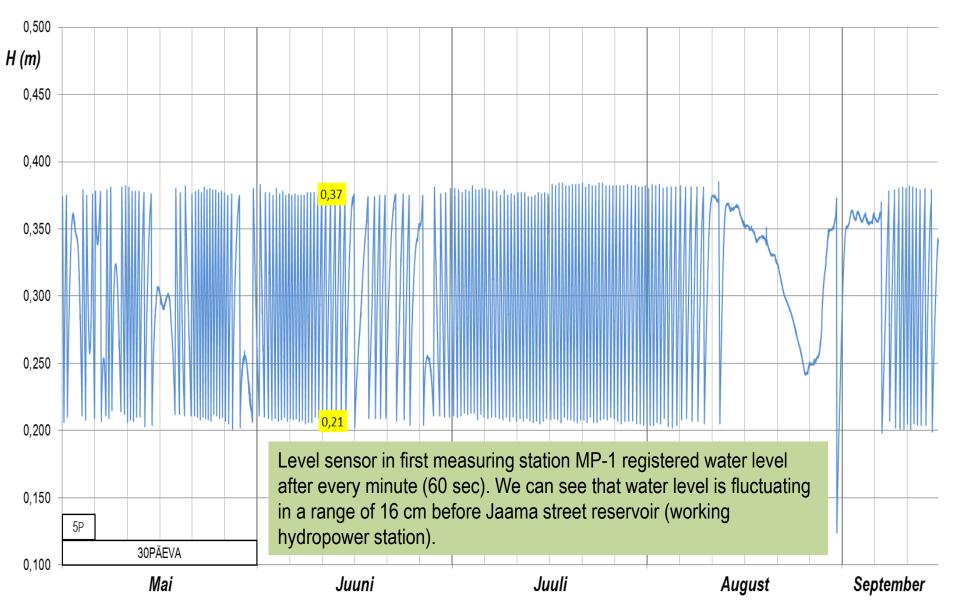
MEASURING LOCATION No 1

Location No 1 = Jaama street reservoir (currently working hydropower station reservoir). Technologically there are three propeller type turbines with flows 1, 2 and 4 m³/s. Flowrate downstream can be one of seven combinations G1..G7.

- Water level is fluctuating in a range of 16 cm before the working HPS (in the reservoir). Allowed range ±5 cm.
- 3. Reservoir filling time is not align with discharge:
 - filling 9 hr
 - discharge 4 hr

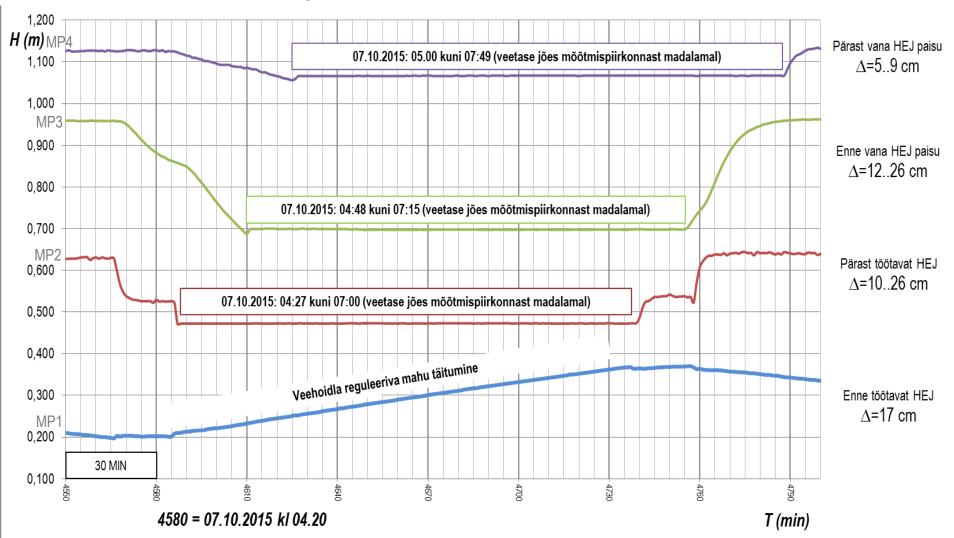
ERROR GAP: 07.10.2015

07.10.2015 out of range 04.27 until 07.49 (*ca* 3,5 h).

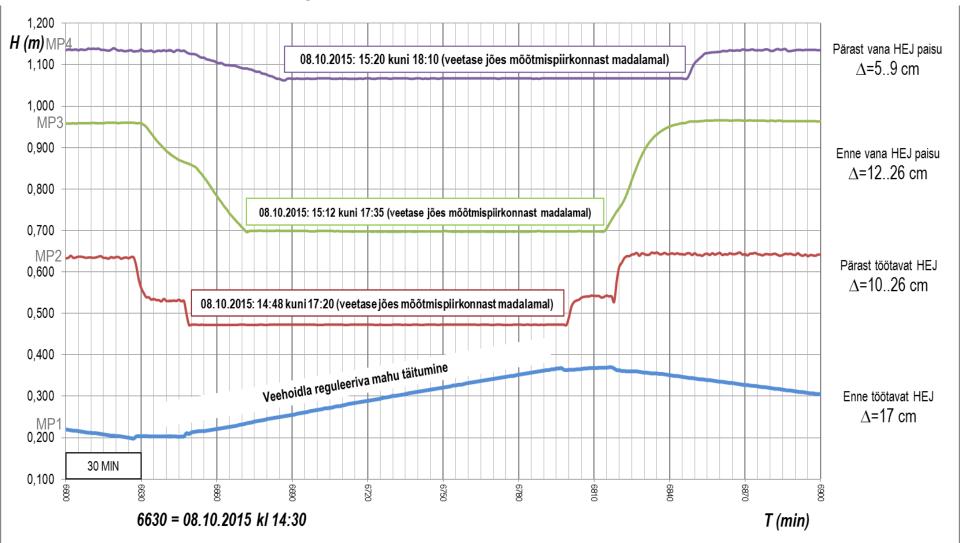
ERROR GAP: 08.10.2015

08.10.2015 out of range 14:48 until 18:10 (*ca* 3,0 h).
