Warehouse Concrete Slab and Joint Repair

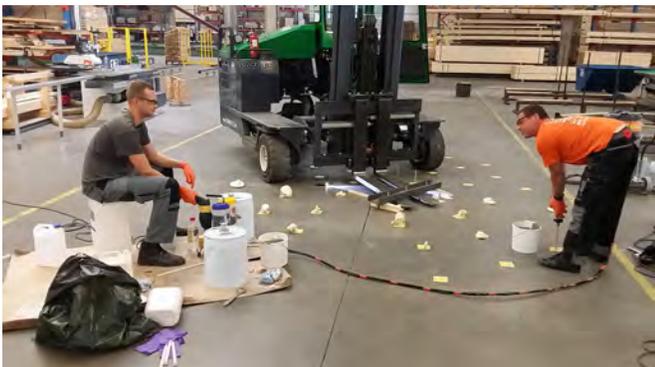
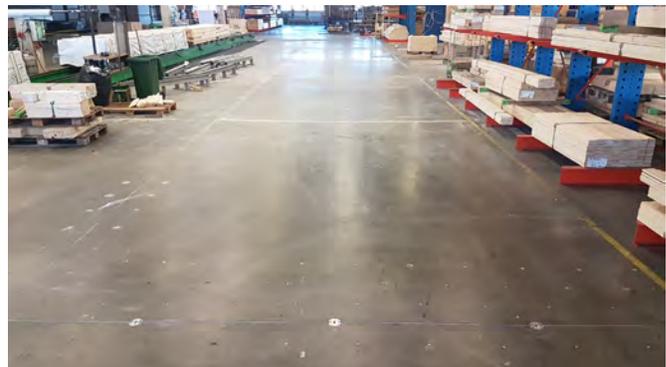
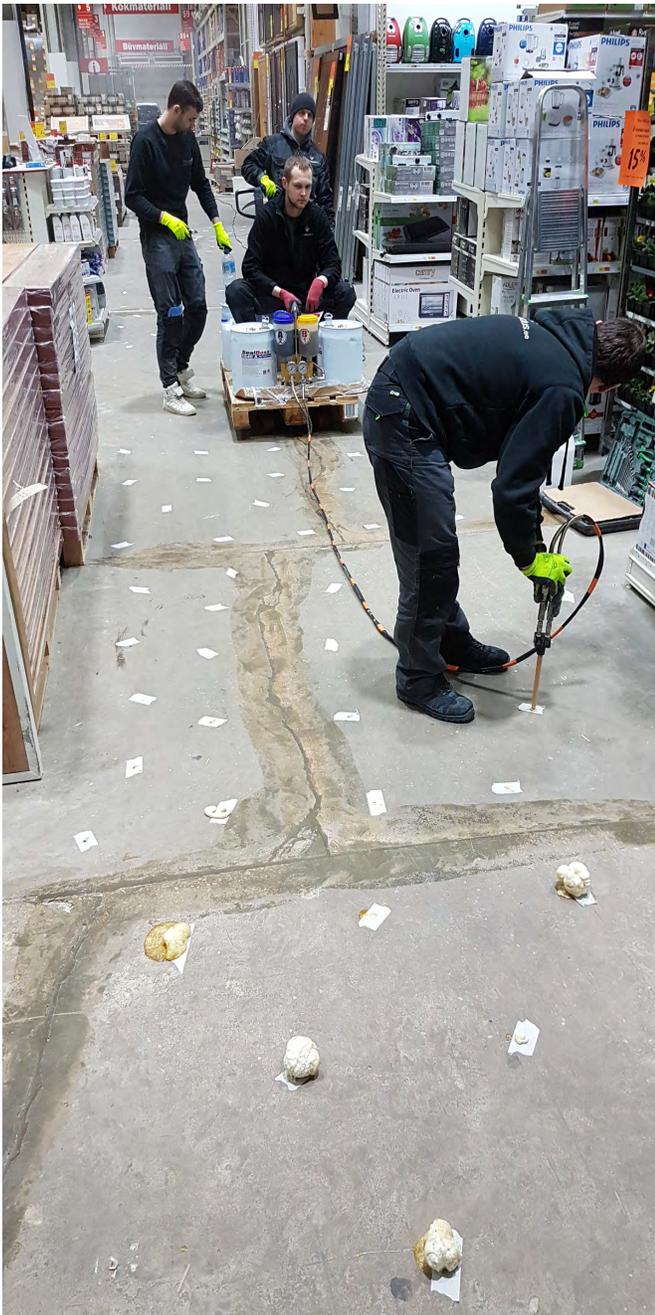
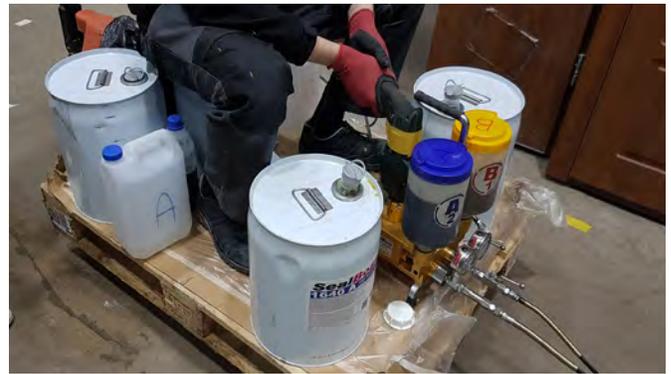
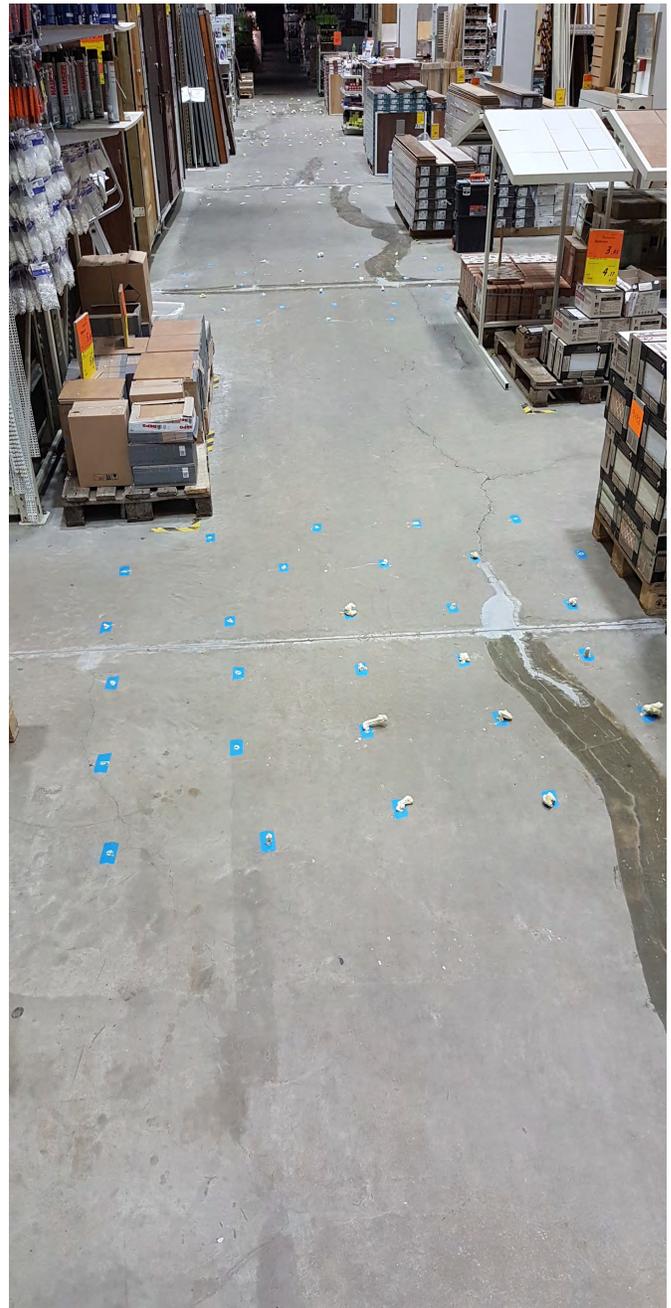
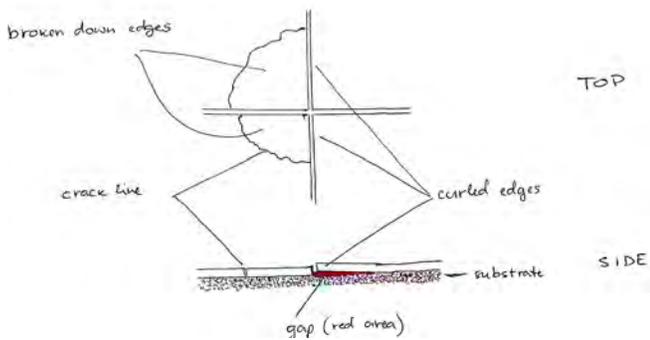
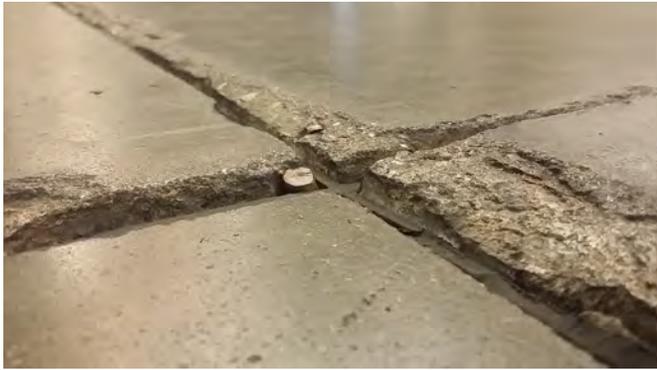
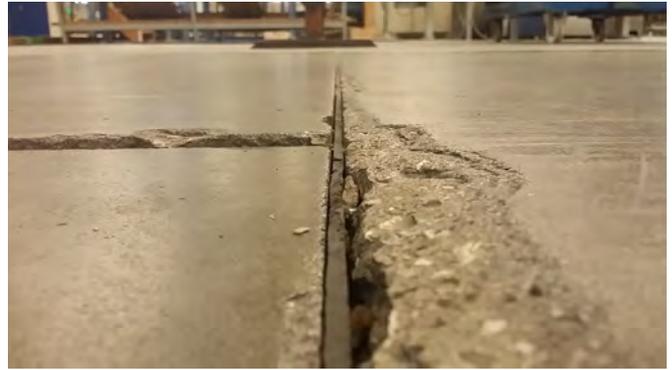
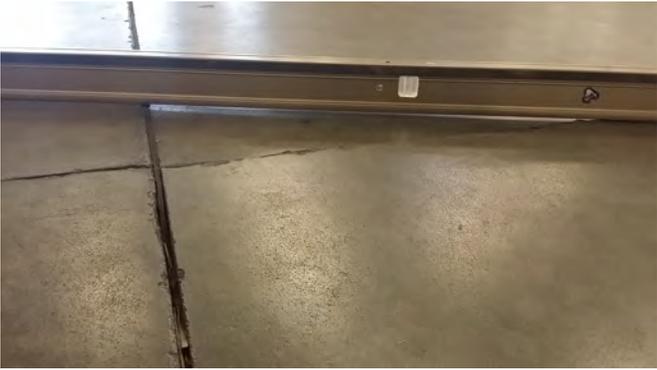
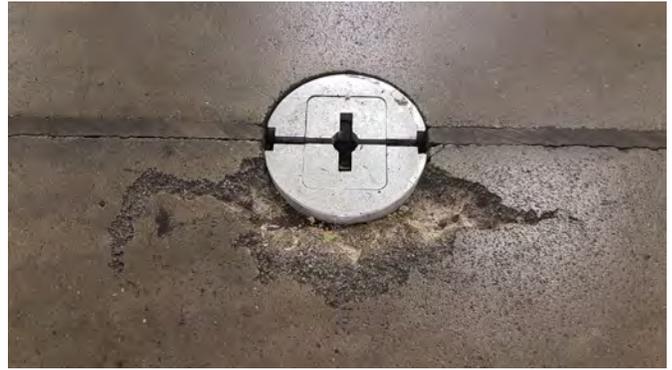
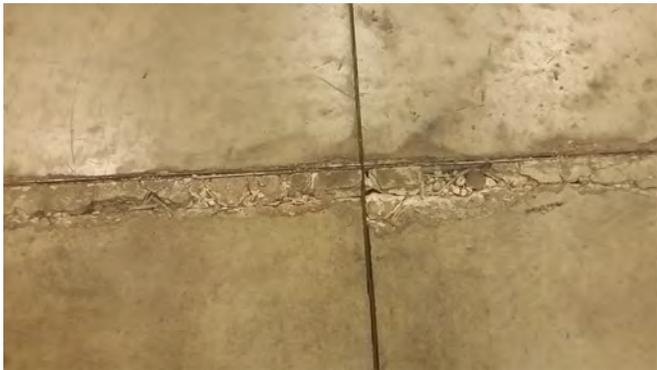
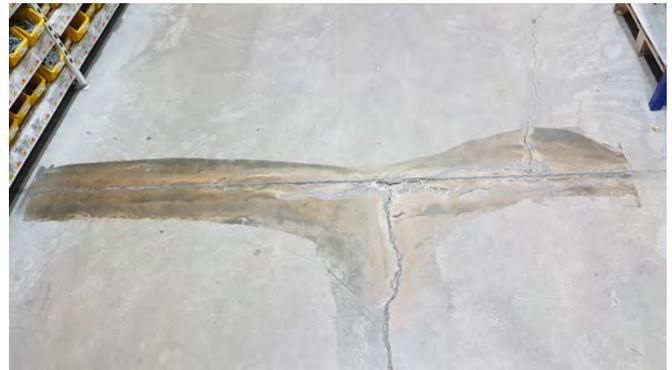
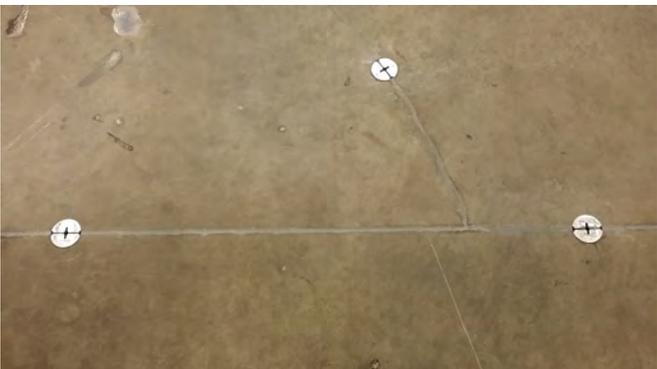
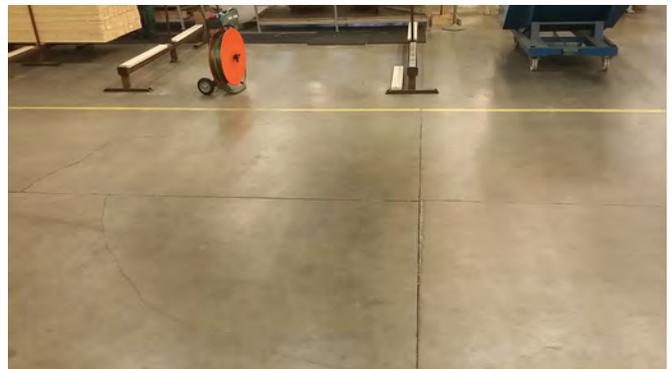
The most difficult site so far where the initial reason was curling due to inappropriate concrete lying methods in a very cold weather. The 6x6m slabs were vertically unstable on most of the fork lift traffic area. They use large 7 ton forklifts. In some cases one of the adjacent slabs was moving, in other cases both. In some areas the curled corners had broken and fallen down but one of the 4 adjacent corners was still up. Or the was a situation contrary to that where one corner was down and others curled upwards. As we did not have a high volume foam pump then we used a 7 ton forklift and special arrangements to rise and fix the height of a broken slab corner before foaming underneath. The vertical difference or movement between slabs was 2-8mm and the problem was escalating. Many joints were severely damaged and they realized the abnormally high cost of servicing forklift axles originates from floor problems. Also forklift drivers had to slow down in many areas which started to affect their output. As the factory already runs 24/7, they analyze everything that restrains production and output.

Some pics of the final result. (foam, cylinders, spall repair, joint reconstruction).

I suggested them to invest into both foam and cylinder installation. The cost of foaming a 300m² area (consisting of 16 smaller areas) and installing 44 cylinders + reconstructing joint edges and refilling all the joints with QF 6500 cost about 13000€+VAT. The minimum team for doing a foaming job is 3 men: a drill/pump operator, a gunman and a pallet driver/re-filler of hoppers. When you install cylinders at the same time you need 2 more men: core drill operator and a cylinder installer/supporting services man.

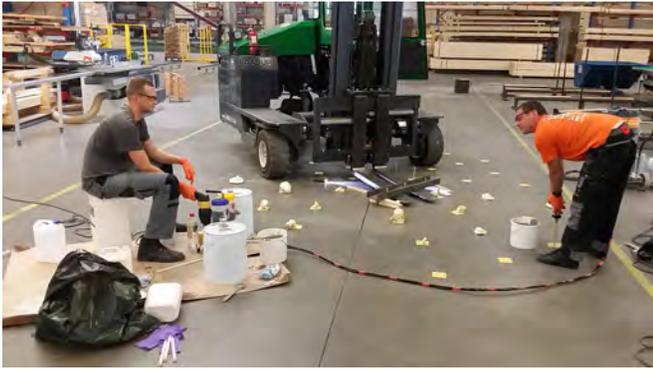
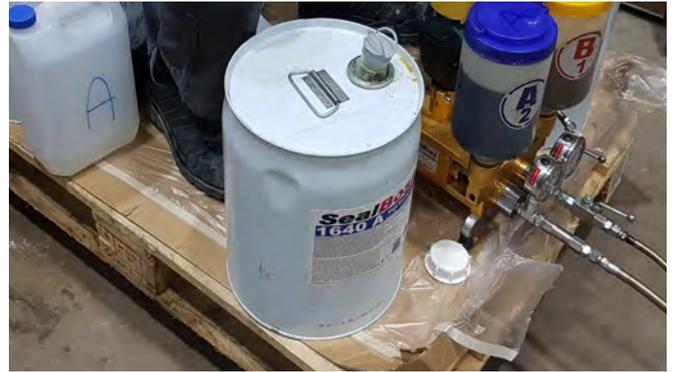
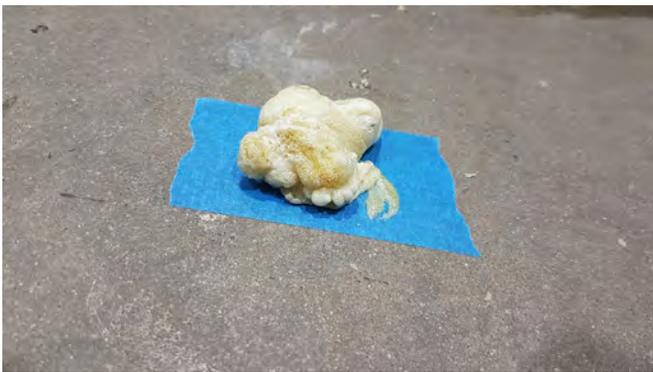
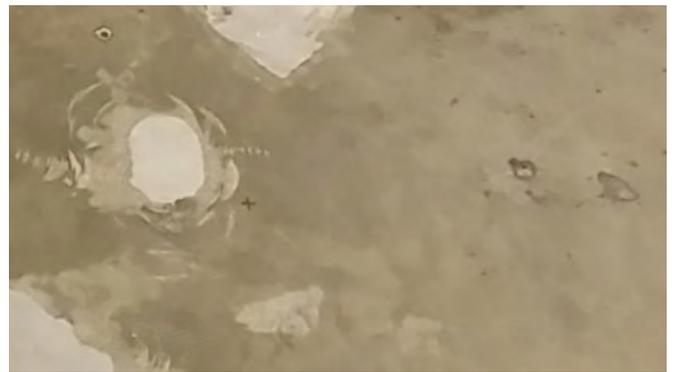
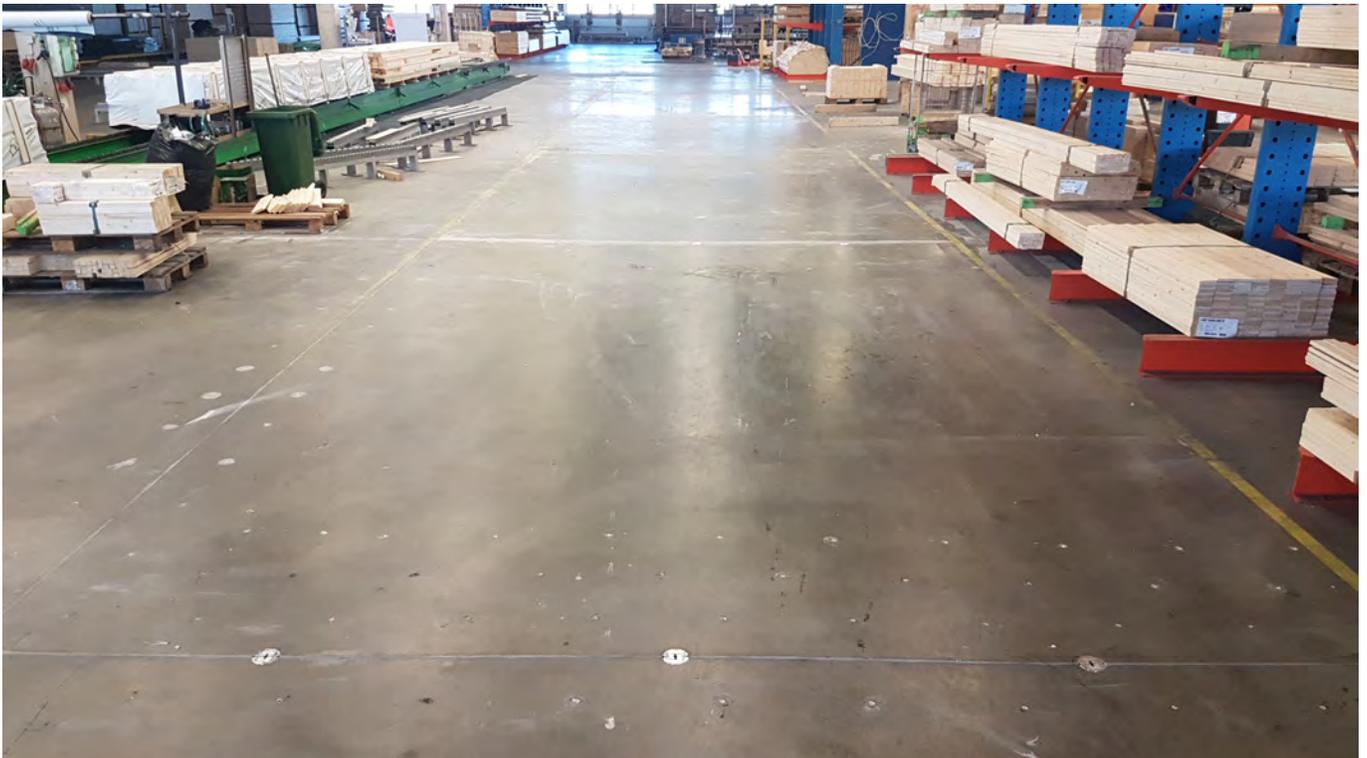
SealBoss® 6060 / 6500 QuickFix 1640 SlabLifter Foam

They had floating slabs in both primary aisles which had caused forklift accidents and negative feedback from customers. The joint areas were repaired with epoxy but everything cracked and broke down very quickly again as the slabs were not supported underneath. We fixed the floor using the same technique as in Lasita Maja. Most slab edges required grinding down before installation of cylinders. Every joint was foamed, cylinders were installed according to a situation on an actual joint. We marked drilling spots with a distinctive tape, drilled holes through it, vacuumed, also foamed through it and finally, when cured, cut off the remains of foam, drilled a 2cm (less than an inch) deep holes into a foam, filled with 6500 (cartridge), cut off the cap and went for a coffee. The tape also acts as a protective layer between a floor and a foam (no stains, applicable in design-sensitive areas).
