Duration Test Report for the TUGE10 turbine tested at the Intertek SEMKO Small Wind test site / foundation 2 / Lilla Båtskär ÅLAND

103254243CRT-006

**Wind Turbine Generator System
Duration Test Report
for the
TUGE10
at
Lilla Båtskär / Åland**

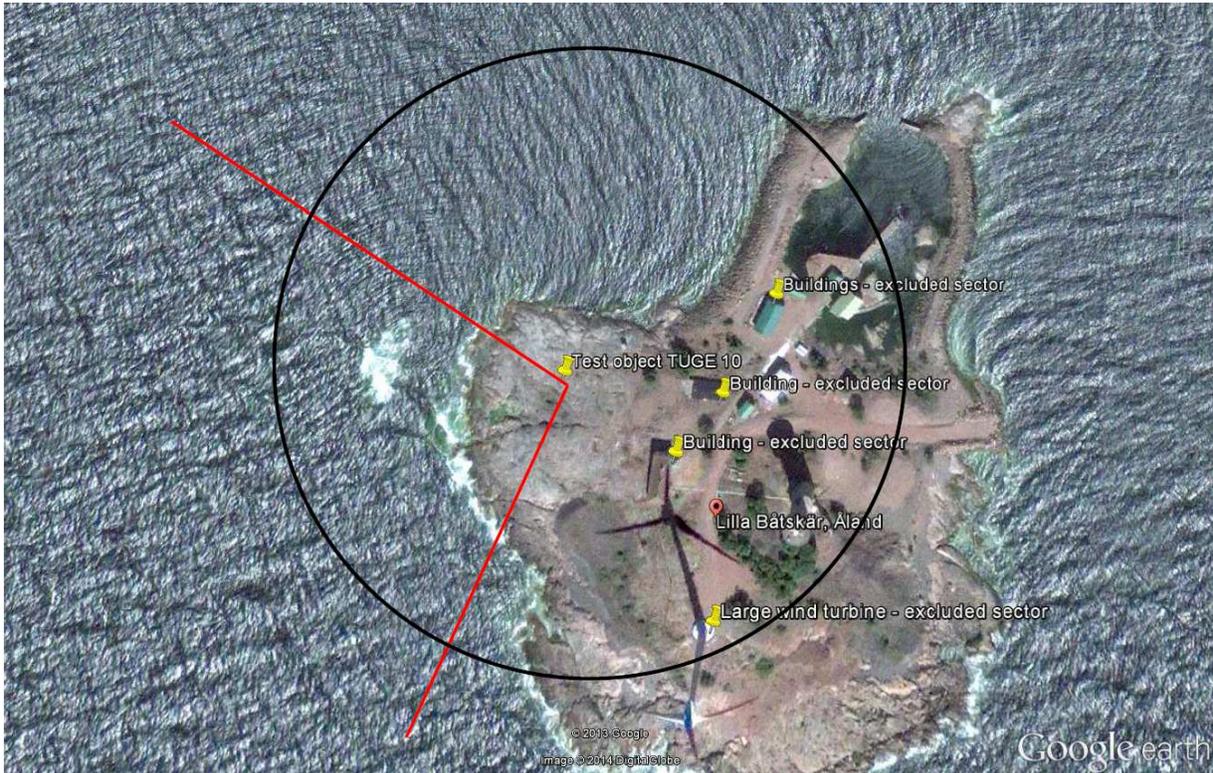
Figure 1 – Aerial view and final valid measurement sector of the TUGE10 test turbine

Figure 1 below is an aerial image that displays the final valid measurement sector resulting from the combination of obstacle assessment and site calibration in accordance with IEC 61400-12-1. A circle indicating 20 rotor diameters is also shown on the map.

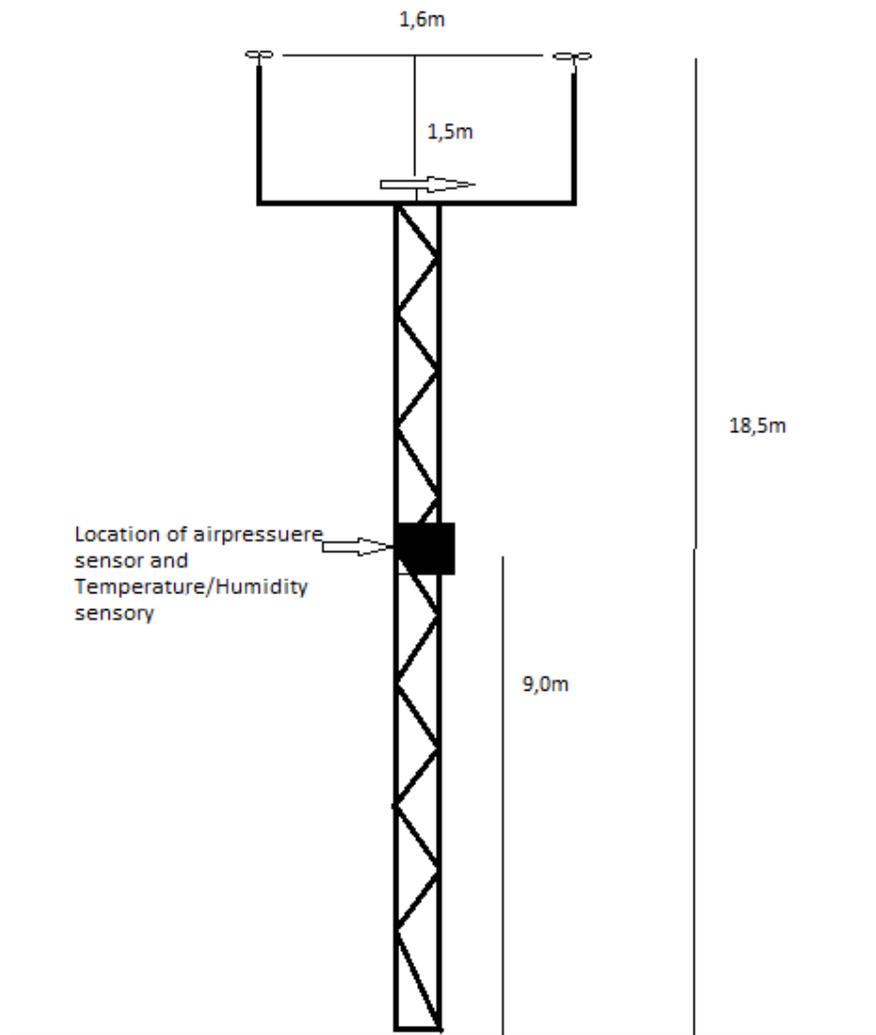
Figure 2 – Meteorological Equipment Tower

Figure 2 below displays the arrangement of the meteorological tower with dimensions of instrument locations.

The anemometers were calibrated prior to and after the testing was completed. The calibration results were compared and indicated regression lines were within $\pm 0,1$ m/s.

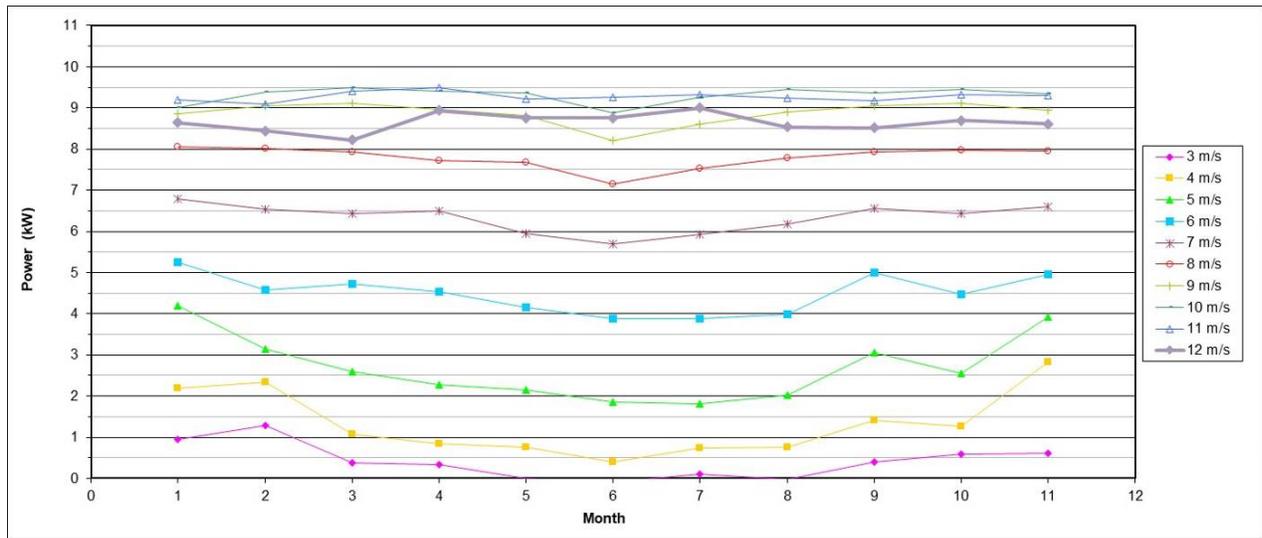
Figure 3 – Power degradation plot for the TUGE10

One of the criteria for reliable operation is that the turbine should experience no significant power degradation over the test period at comparable wind speeds. For each month of the duration test, the power levels were binned by wind speed at integer values. For each wind speed, a plot was made with the binned power levels as a function of time. The plot was analyzed for any visible trends in power production. Figure 3 below shows the plot for each wind speed over the duration of the test period. No visible trends that are consistent over the entire operating range of the TUGE10 turbine system. Data points are only included on the plot if there are more than 6 data points (60 minutes) in the wind speed bin.
