## TESTING OF GLULAM BEAMS IN FIRE WITH SPECIFIC LOCAL MATERIAL PROPERTIES

LIIMPUITTALADE KATSELINE UURIMINE MATERJALI KOHALIKE  
OMADUSTE MÕJU MÄÄRAMISEKS TULEKAHJUOLUKORRAS

Tallinn, 2016

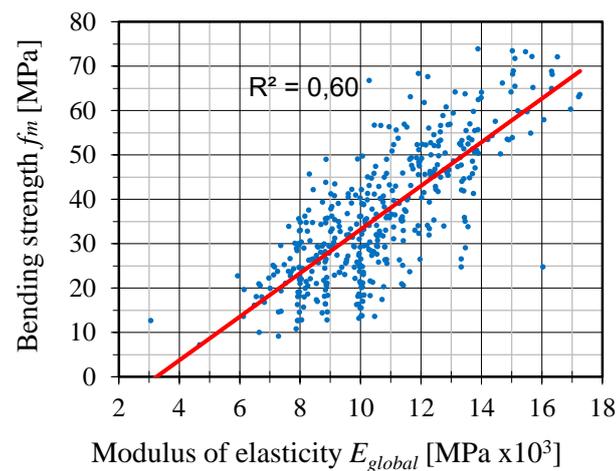
*Figure 1. Bending strength versus modulus of elasticity of ~400 timber boards. Data taken from [5]*

Unlike man-made materials, such as steel and concrete, timber is a natural grown material. Therefore, it is heterogeneous in structure and anisotropic. High variability of properties appears not only between different structural elements but also within single elements. The variability between timber elements is presented in Figure 1. It can be noticed in the chart that bending strength between members with the same global modulus of elasticity may differ up to four times or more.

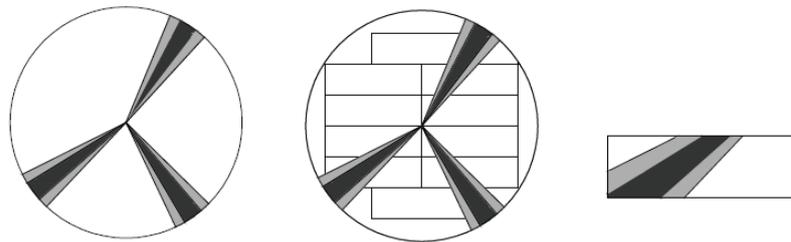
*Figure 2. Knot arrangement in a solid timber board. [12]  
(left) knot arrangement within the cross-section of a tree trunk, (middle) influence of the sawing pattern on the knot distribution within sawn timber boards, and (right) resulting knot area within the cross-section of one timber board.*

Timber boards are sawn out of a trunk of the tree rather parallel to its longitudinal axis and grain orientation is assumed to be parallel as well. As timber is natural grown, grain orientation may deviate globally due to the spiral grain angle, described by Harris [8], or locally because of knots or knot clusters. For Norway spruce specimens the magnitude of the spiral grain angles has been found to vary in general between zero and five degrees. The strength and stiffness properties are about 15 - 20% lower for a timber board with a spiral grain angle of four degrees compared to a timber board with no spiral grain angle [9], [10], [11]. Local changes in grain orientation around knots, especially considering sawing patterns, may result in significantly lower strength properties of a single board. Some knot arrangements within a timber board is illustrated in Figure 2.

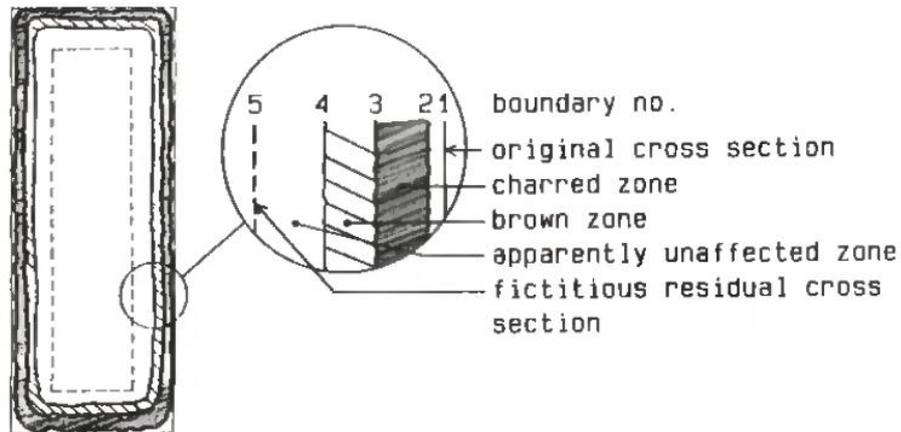
Figure 4. Cross-section of timber after being exposed to fire by Norén. [1]

Unfortunately, only very few test results exist on timber members exposed to fire where the 'cold' strength properties were predicted with sufficient accuracy, which makes it difficult to compare calculation models with test results. A report Joakim Norén [1] presented at the International Conference on Timber Engineering in Seattle in 1988 of research to investigate the behaviour of loaded structural timber elements when exposed to fire, can be introduced as an exception. Norén performed loaded bending tests with four groups of solid wood beams of dimensions 45x120x2300 mm of high and low strength grades, about 20 specimens in each group. In order to evaluate the effect of being exposed to fire to the strength properties, carefully matched (including matching or symmetrical cutting of knots) pairs of specimens were chosen. First, bending stiffness in normal condition of all specimens was determined. Then bending strength of one specimen of the pair was tested in normal conditions and the other one, loaded with 1/3 or 1/6 of the ultimate moment in normal conditions, was tested until failure in fire. The most significant findings were that the loss of load bearing capacity involves in addition to charring of wood also temperature-dependent reduction of strength and stiffness of the uncharred residual cross-section. Presented in Figure 4.

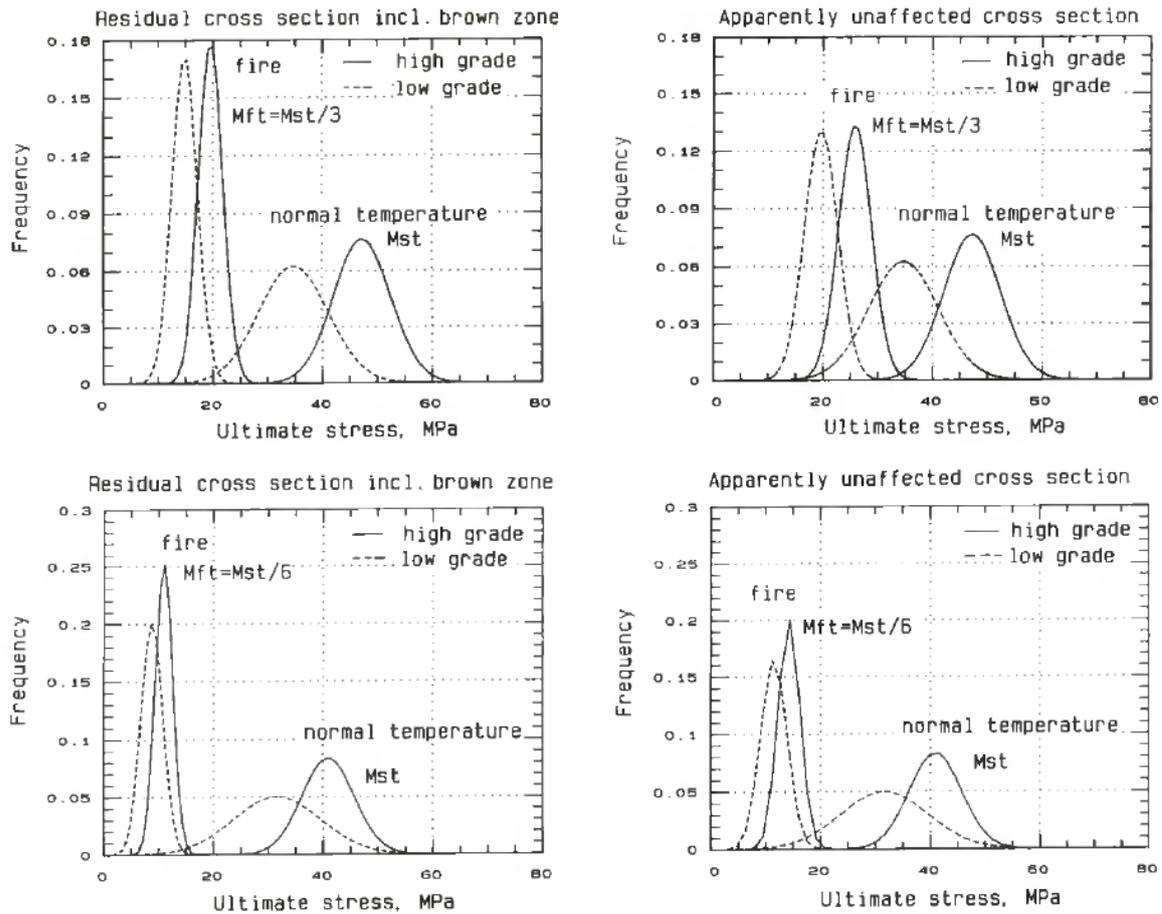
Figure 5. Fitted normal frequency curves for bending strength, under fire exposure conditions ant at normal temperature, of high grade timber (solid curves) and low grade timber (dashed curves). The bending strength is calculated on the residual cross-section including the brown zone (to the left) and on the apparently unaffected cross-section (to the right) respectively. Image and caption [1]

Norén also compared the distribution of the calculated bending strength in normal conditions and in fire. From the tests, a decrease of the scatter in the fire situation was observed (see Figure 5); however, this fact was not the main reason of the decision of using 20% fractile values.

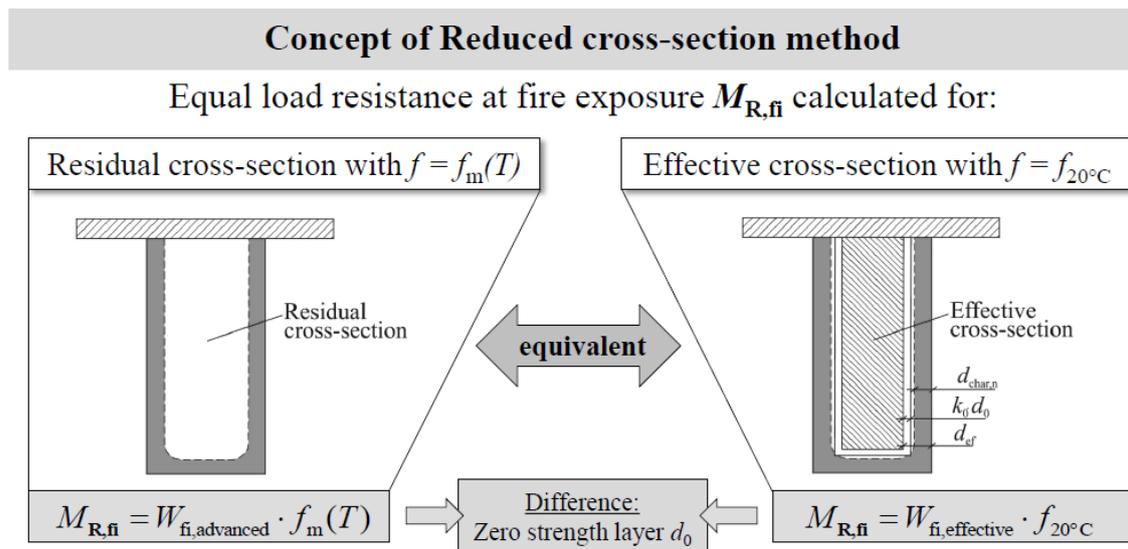
In Section 5.5.2 the depth of zero strength layer for specimens is calculated. The concept is illustrated by Klippel [21]. The illustration is presented in Figure 6.

Analysis of the depth of zero-strength layer can be found in Klippel [21].

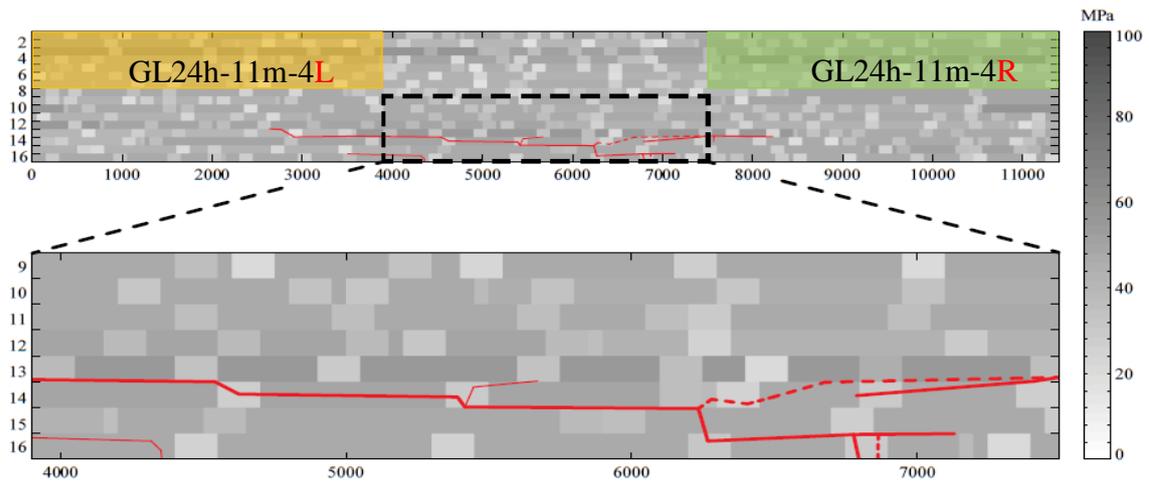
Figure 9. Positions of the fire test specimens in the original beam tested at normal temperature; here example for beam GL24h-11m-4 (Stadelmann, 2015)

Six glued laminated timber beams in total with well-known local material properties were tested in fire in the present research. These specimens were cut out of least influenced parts of glued laminated timber beams of originally larger dimensions, previously tested until failure in four point bending tests in normal conditions. The bending tests were performed at ETH Zürich in the master thesis of Stadelmann [25]. Figure 9 shows the original position of the beams in the longer beams already tested.

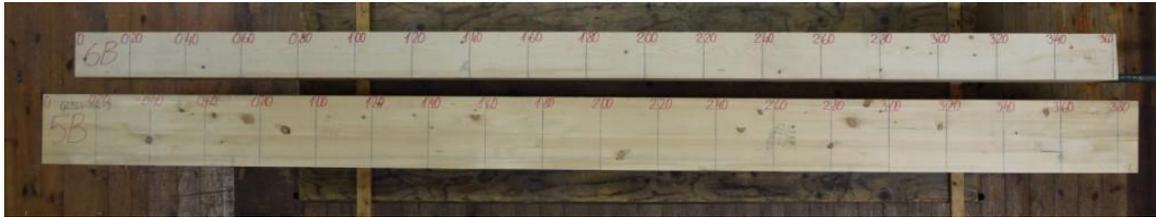
Figure 10. Beam face markings on specimens 5 and 6

Furthermore, each face of every beam was given a face identification letter, „A“, „B“, „C“ or „D“, and 200mm step markings were drawn in order to determine the exact positioning in the data processing phase. Detailed photographs of each side of each specimen have also been taken. Pictures to describe the assembly of the specimens can be found in the

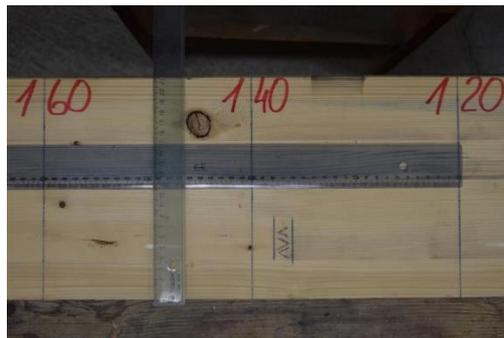
Figure 11. Local detail of a specimen

After photographing, all specimens were thoroughly inspected for cracks or any other kind of deteriorations which might have an influence on the load bearing capacity and thus also to the fire resistance of the beams. Prior to the fire tests, all beams were weighed, their geometric dimensions and moisture content measured and density calculated. The gathered data is presented in Table 3 and in Table 4.

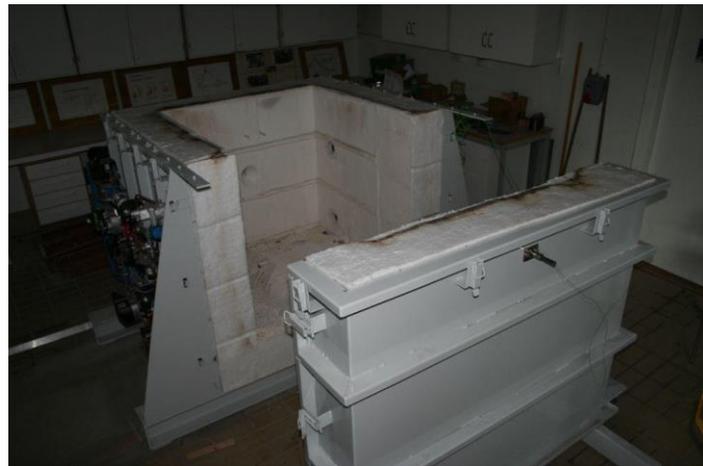
*Figure 14. Furnace's removable front and inner ceramic fibre insulation. Photo: SP*

Inside, the metal construction furnace has a 230mm ceramic fibre heat insulation layer, which can be noted in Figure 14. Open inner dimensions are 1000 x 1000 x 1000 [mm], i.e. 1m<sup>3</sup> of volume. Liquefied petroleum gas is used as fuel, delivered through 4 burners on two different heights on two sides of the furnace. The exhaust gases are mechanically ventilated through an opening in furnace inner floor. The temperature inside the furnace is measured by a pair of plate thermometers, illustrated in Figure 15. The furnace is semi-automatically operated, temperature and pressure inside the furnace must be controlled manually throughout the whole process to follow ISO 834 standard fire curve [20] using a touchscreen interface, see Figure 16.

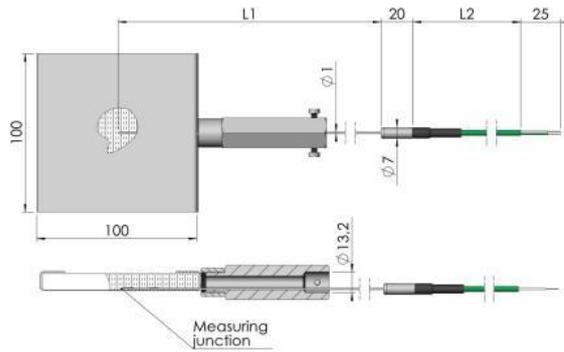
Figure 15. Plate thermocouple in furnace. Image: Pentronic.se

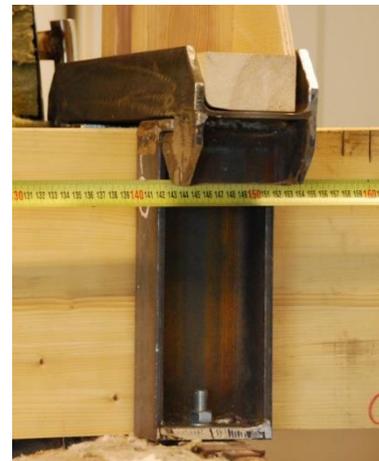
Figure 17. Support details on furnace's

The supports in these fire tests were custom constructed and made for this project. One support consists of three different details. Two columns are bolted to the furnaces edge using M14 8.8 bolts. The sliding upper detail is quickly removable when not loaded. A standard profile UNP100 and a steel sheet -8mm were used for making the support details. The support in position is presented in Figure 17.

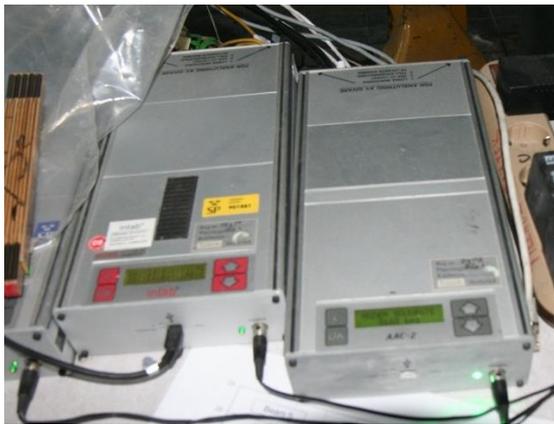
Figure 19. PC-loggers.

In order to expose the specimens to fire on three sides only the top faces had to be protected. Hard stone wool bats secured with light concrete blocks, 8kg apiece, were fixed on top of the glulam beam using countersunk 6x240mm screws with washers or 8x340mm screws with washers and coil springs. Relative displacements were digitally measured saving readings from LVDT-s with 1 second interval with similar PC-loggers as in Figure 19.

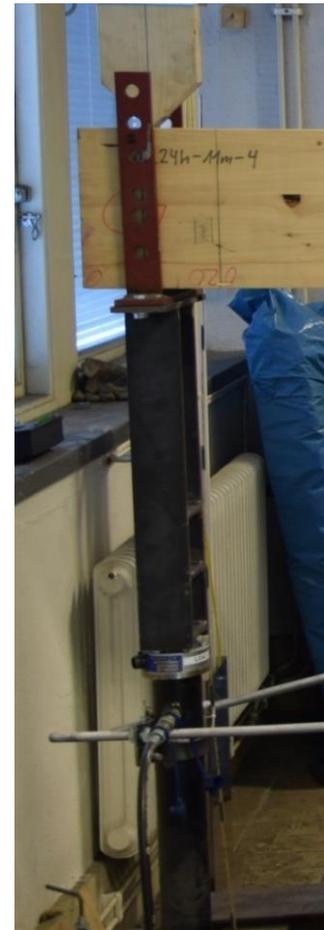
Figure 18. Hydraulic cylinder with extensioning and load cell sensor in between.

The load was applied to the glulam beams using a hydraulic system of two cylinders and an electric powered oil pump. The oil pump is manually controlled, but enables easily fine pressure tuning. The length of the cylinders demanded use of additional steel extensioning construction to reach the specimen. The load cell sensors, type AB 50, placed between cylinder's piston rods and extensioners, sent readings to the PC-Logger (see Figure 19) once a second. Load cells were replaced between after the first session of experiments. Please see illustration in. More detailed information is given in Table 6

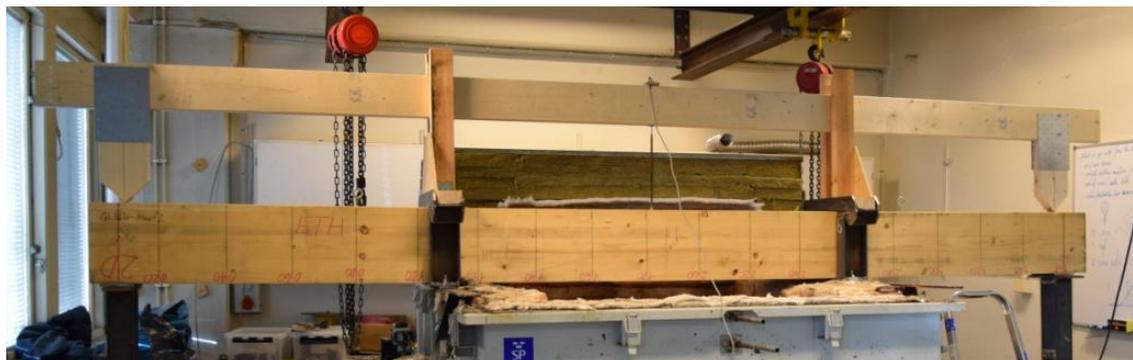
*Figure 22. Construction for LVDTs during first session.*

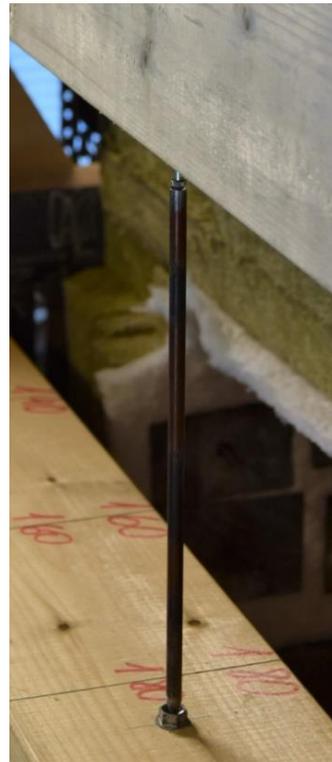
*Figure 25. Steel rod between LVDT and lag screw.*

span, two of 50mm near supports. To take readings from the surface of the beams 8mm steel rods were placed between specimens and the LVDT-s. Short lag screws with cavity on top inside the beams prevented the rods from displacing horizontally. The rods had pointed the lower tip and the cavity in the upper end. As the LVDT-s have coil spring inside, all rods stayed stable during the fire tests. Please see Figure 25. In order to preclude the possibility of receiving false readings because of local crushing of the LVDT holder's legs, their pointed tips were reinforced with aluminium profiles, as shown in Figure 23 and Figure 24.

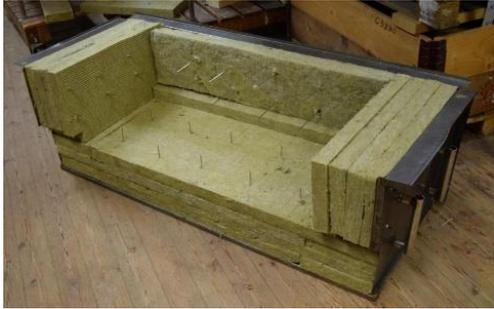
*Figure 26. Placing stone wool insulation on a furnace cover.*

The height of the specimens and the three side exposure to fire demanded using special furnace covers. The steel sheet covers were also custom made. A 1.5mm steel sheet was used for construction. Three layers of soft 50mm stone wool ( $30 \text{ kg/m}^3$ ), one layer of 50mm

hard stone wool ( $120 \text{ kg/m}^3$ ) and one layer of 10mm ceramic fibre insulation were used for inner heat insulation. See Figure 26 and Figure 27.

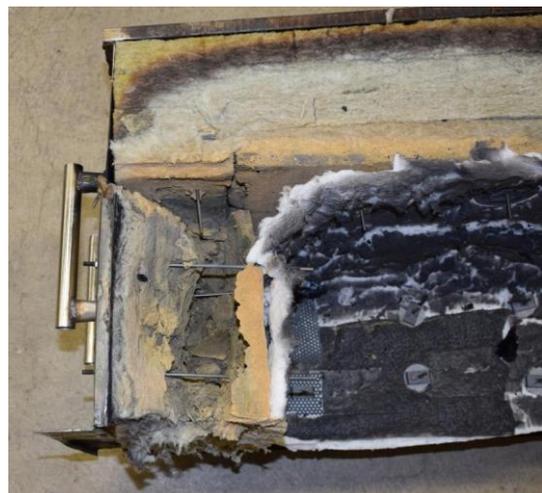
*Figure 28. Result of exposing wool sheets to fire alongside.*

For the third test, tightening wool was properly cut and carefully placed between covers and specimen. Innermost layer of 50mm hard wool and three next layers of 50mm soft wool. This change led to a remarkably diminished leak of smoke. However, an aftermath of forgetting the fact of hard wool not being elastic enough was gaps between the innermost layer of cover insulation and tightening wool, letting fire through to next layers and alongside direction of the sheets. The extent of the fire damage is presented in Figure 28. Obviously,

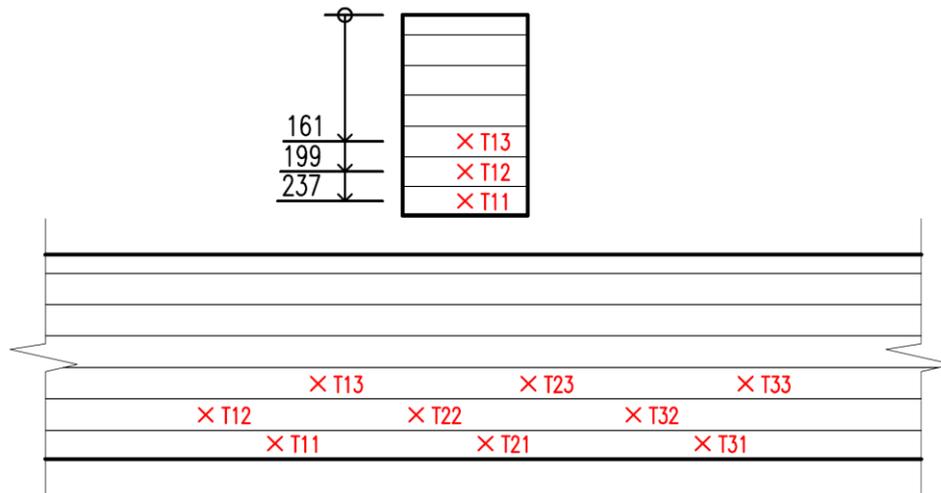
Figure 29. Locations of thermocouples in specimen no. 3.

One specimen of the second series, no. 3, had thermocouples placed inside. Type K (chromel-alumel) wire thermocouples were used. The aim was to measure temperature distribution in the middle of the three lowest lamellas in three different locations, illustrated in Figure 29. Three step hand drilling without guidance using 70mm, 153mm and 306mm long 1.5mm drill bits created the channels for the wires. Considering the latter, only trustworthy coordinate is depth, which was easily controllable. Uncertainty of the location of the thermocouples explain received unexpected readings.

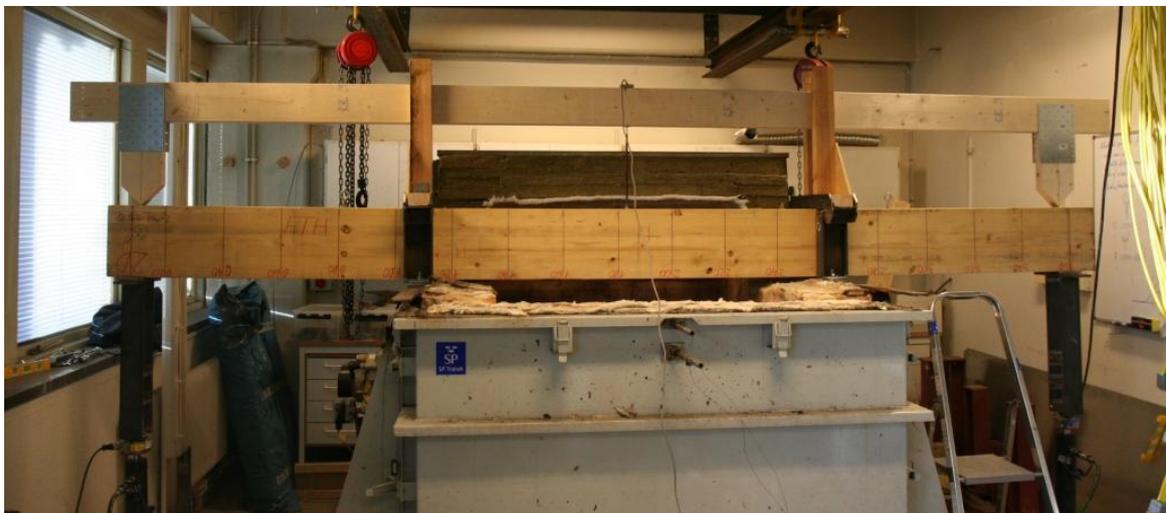
*Figure 30. Test set-up: specimen positioning, supports, load application, displacement.*

All fire tests in this series were performed as “reversed four point bending tests”, which means that the load was applied on both ends of the beam and the supports placed in the middle part, see Figure 30 and Figure 31. This reversed set-up still results in a pure bending zone in the mid part of the beam on one hand, but enables the use of a model scale furnace in limited space conditions on the other hand. The load was applied using hydraulic cylinders for pushing beams’ ends up, the support details were attached to a furnace’s reinforced horizontal edges. The relative displacements were measured using LVDT-s; the comparative absolute displacements were measured by hand at the beam ends using folding ruler. For temperature distribution inside the specimen Type-K wire thermocouples were used.

During the first session of tests, glulam beams were placed onto the furnace and photographs were taken of their exact location with a ruler in the background. Before the second session of experiments, the positioning had been improved. Prior to the actual fire tests, specimens pervaded a short preparation process. Locations for supports and load application points were marked, top centre line drawn and lag screws for LVDT extension rods inserted. While already in the laboratory, specimens were placed according to prepared markings. Detailed positioning dimensions can be found in Table 7.

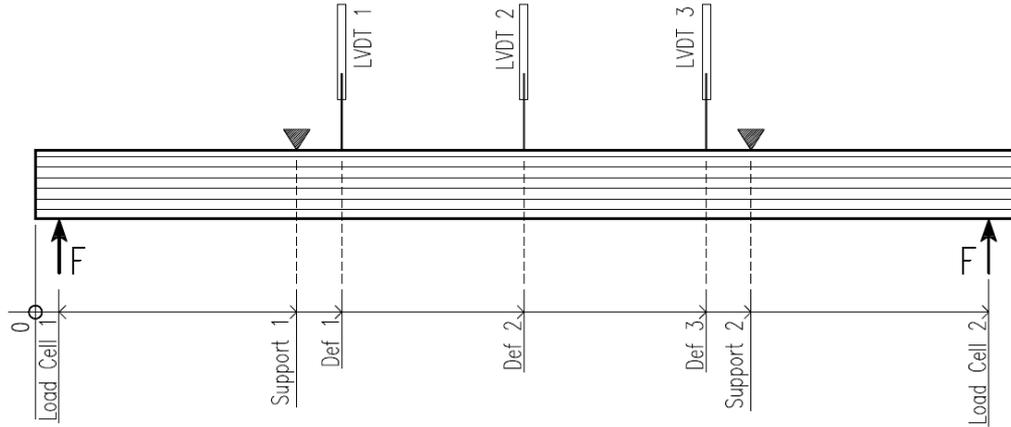
Figure 31. Test set-up: explanatory drawing for Table 7.

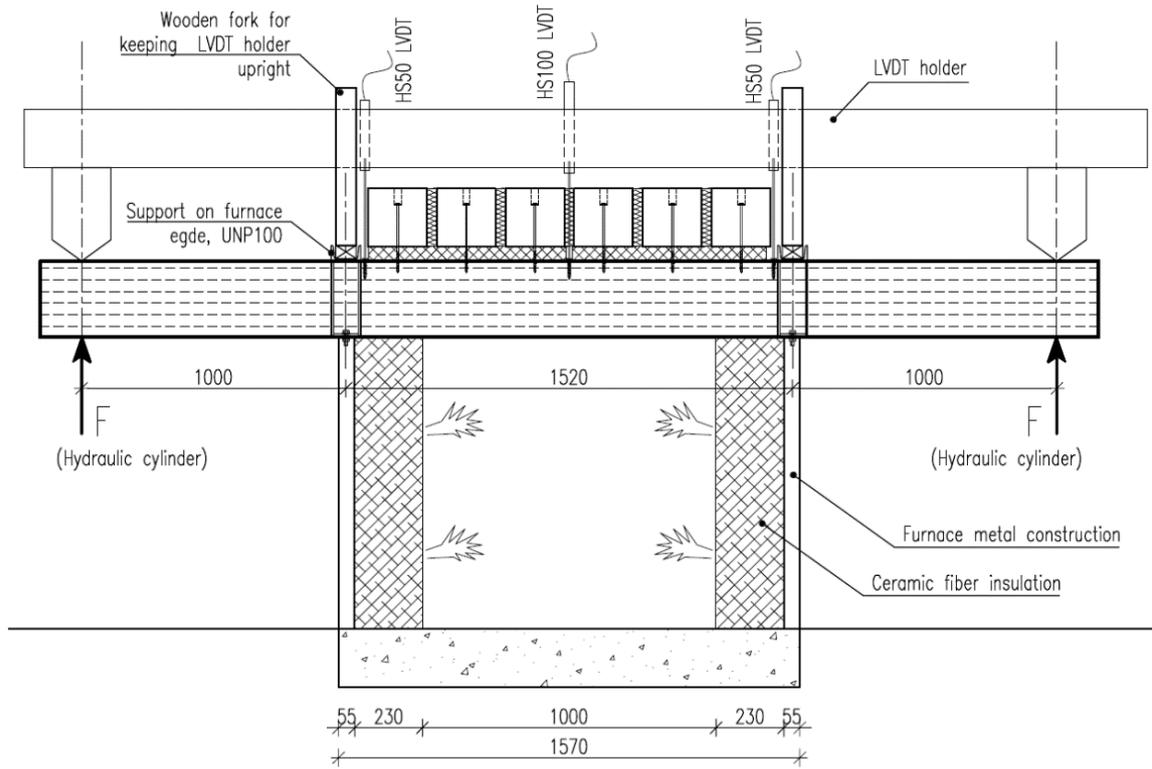
Figure 32. Test set-up: front view, second test session.

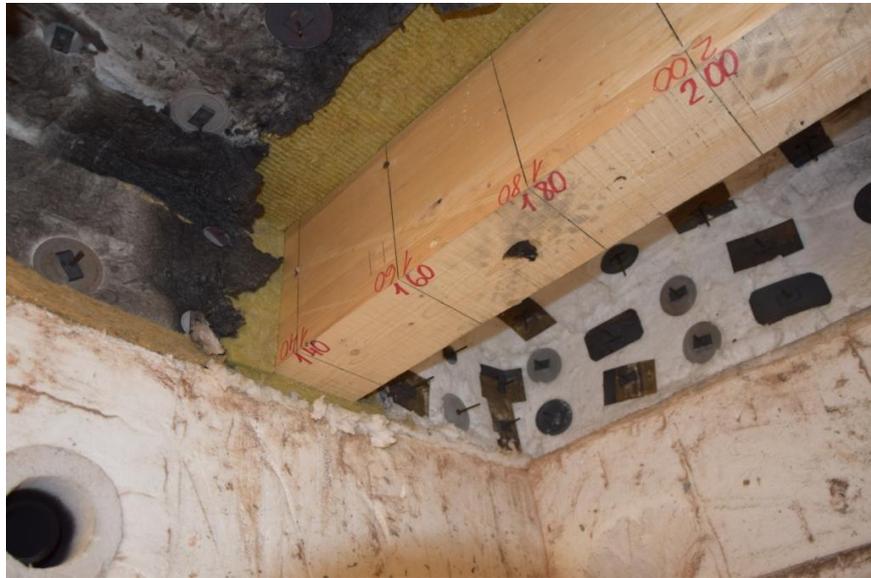
Figure 33. Specimen from inside the furnace before ignition the furnace.

For further tests all the tightening bits were cut out of soft stone wool and carefully placed. Please see Figure 33 as an example. Even an extra layer was added in case initially planned four layers did not fully cover and protect the edges of the insulation of the metal covers. Minimum sinking of smoke. Covers could be used for all three remaining fire tests. Must be noted that the covers are not to be used anew without a proper examination.

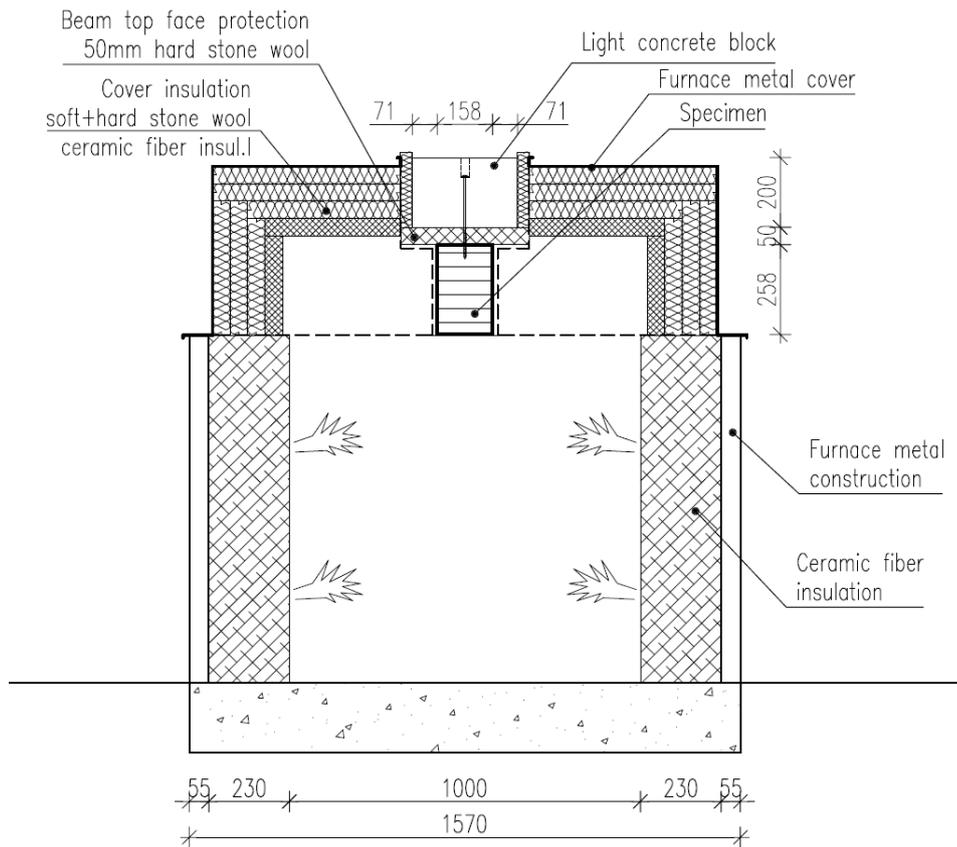
Figure 34. Set-up: section of test set-up.

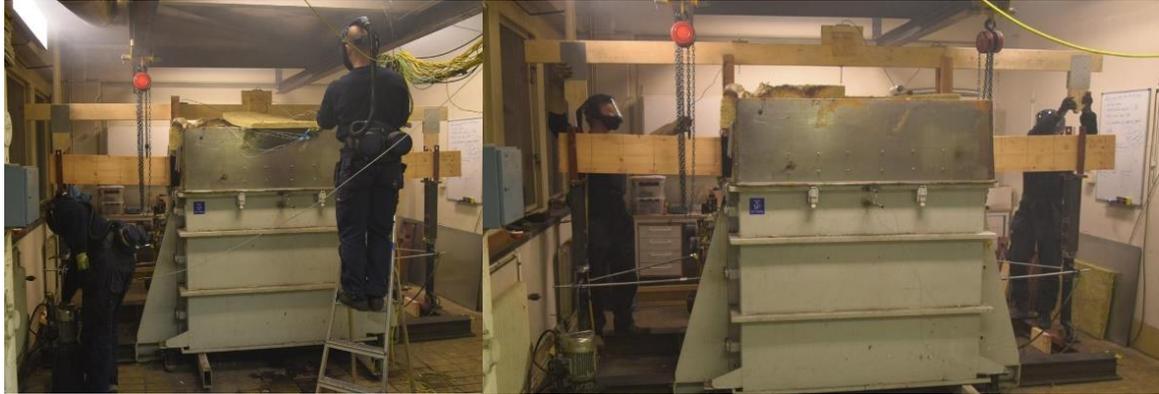
*Figure 36. Disconnecting and removing LVDTs.*

*Right after switching off the furnace disconnect LVDT and thermocouple plugs, remove the LVDT holding frame.*

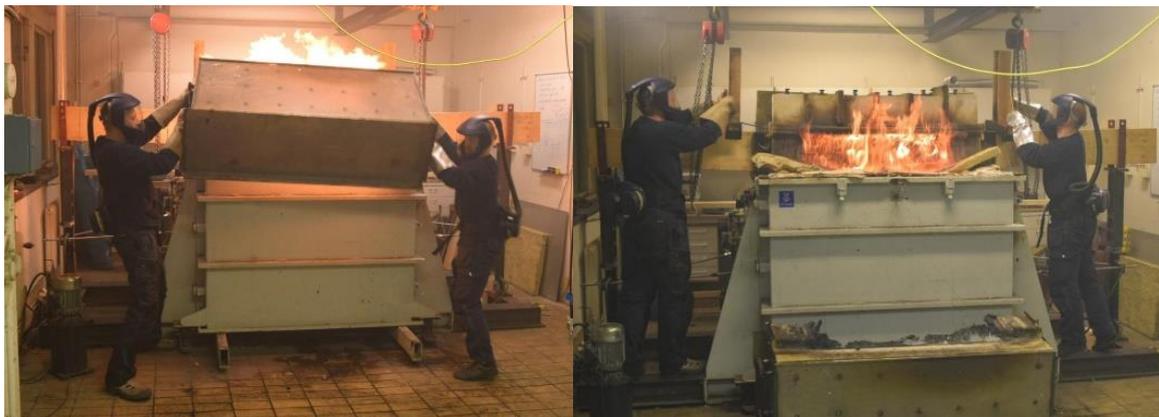
*Figure 37. Removing the cover, unlocking the supports.*

11) Removing the cover, unlocking supports.

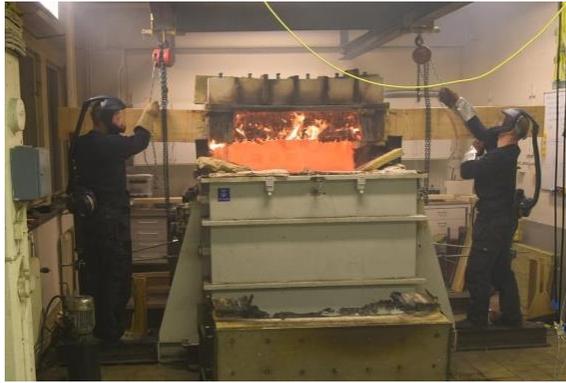
*Figure 38. Removing specimen*

*Removing the specimen from the furnace using chain block, pull it to the more open centre of the room.*

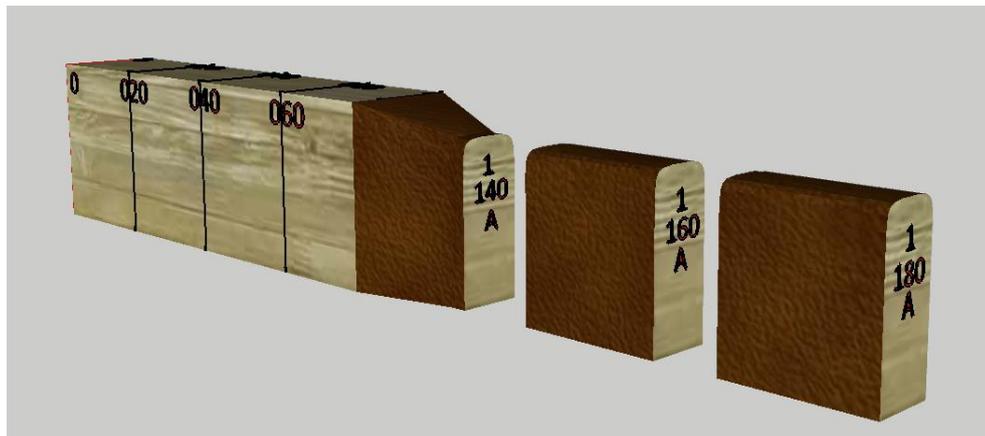
Figure 40. Labelling of the cuts. Faces with surface normal pointing towards the end of the beam were marked with letter “A”.

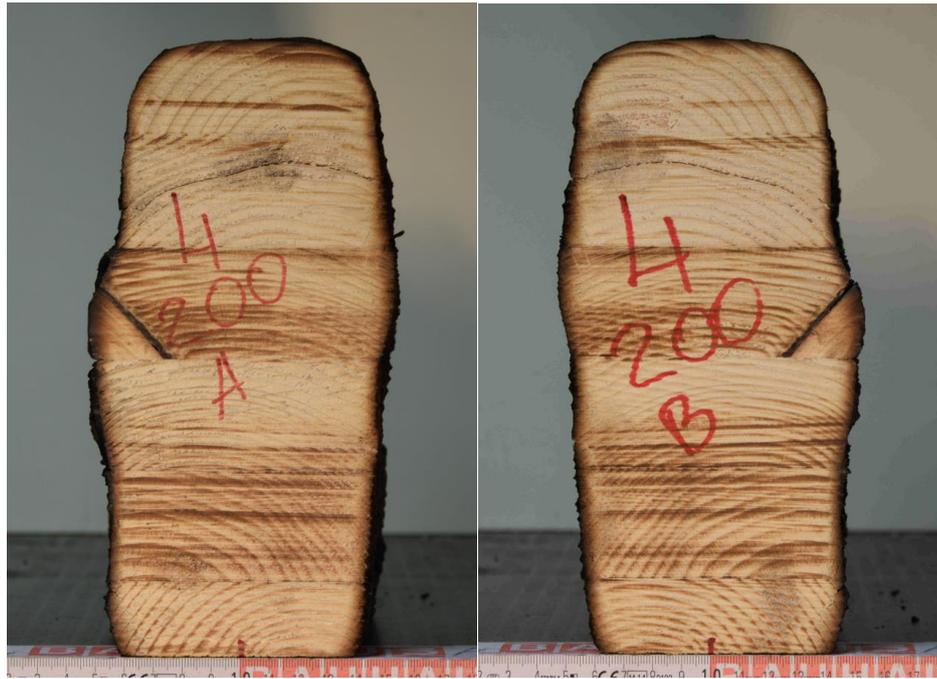
Figure 42. Mirrored shapes of the faces of the same cut. Presented using specimen 4, cut at 200cm from reference starting point “0”.

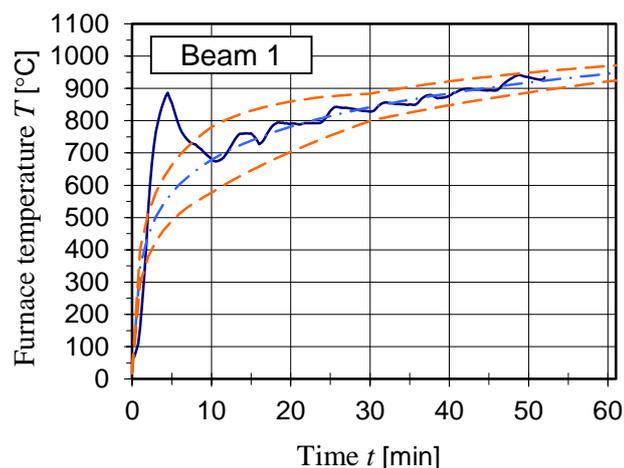
Graph 1. Furnace temperature in fire test on Beam 1 compared to ISO 834 curve and tolerances. Dark blue line represents an average value of two plate thermometers.

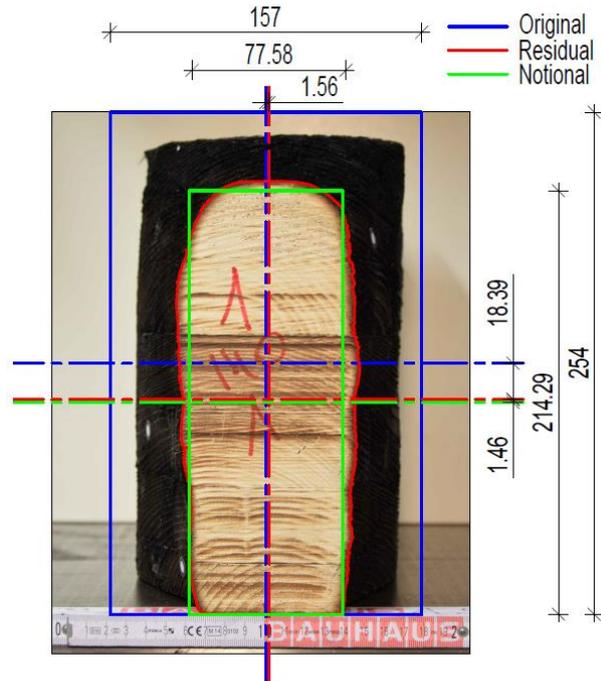
Figure 43. Charring of the Beam 1 cut 140

Original section	
h	254mm
b	157mm
W	1688169mm <sup>3</sup>
Time in fire	
	52:00 min
W (actual residual-140)	593781,8 mm <sup>3</sup>
Notional section	
h <sub>notional</sub>	214,29 mm
b <sub>notional</sub>	77,58 mm
W <sub>notional</sub>	593748,2 mm <sup>3</sup>
Notional charring rate	
$\beta_n$	<b>0,76 mm/min</b>

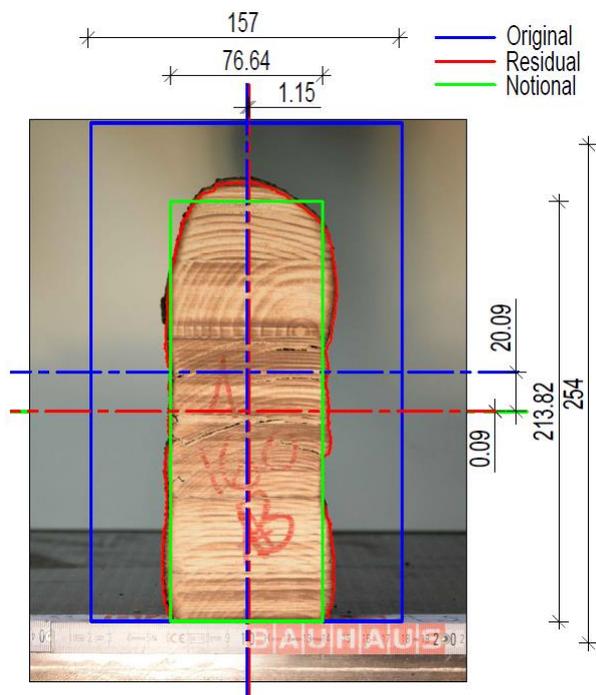
Figure 44. Charring of the Beam 1 cut 160  
Note: Graphically corrected.

Original section	
h	254 mm
b	157 mm
W	1688169 mm <sup>3</sup>
Time in fire	
	52:00 min
W (actual residual-160)	584105,3 mm <sup>3</sup>
Notional section	
h <sub>notional</sub>	213,82 mm
b <sub>notional</sub>	76,64 mm
W <sub>notional</sub>	583983,9 mm <sup>3</sup>
Notional charring rate	
$\beta_n$	<b>0,77 mm/min</b>

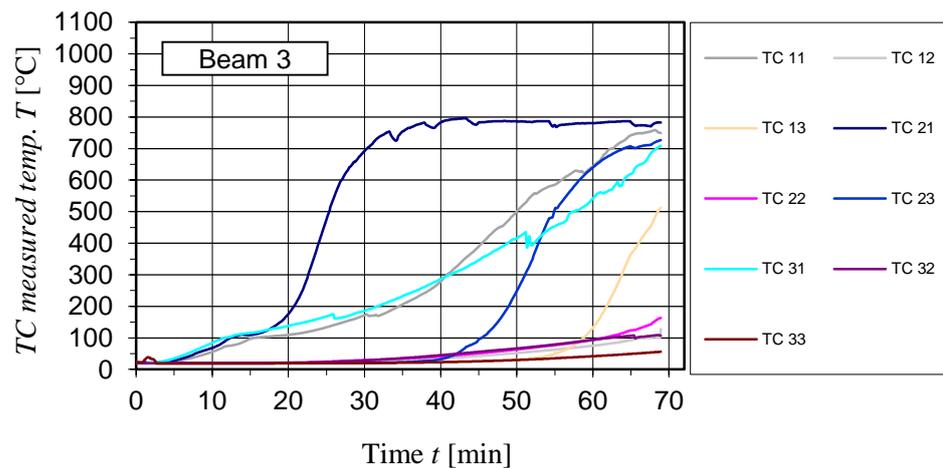
Graph 4. Thermocouple readings inside the Beam 3, position of the thermocouples see Figure 29.

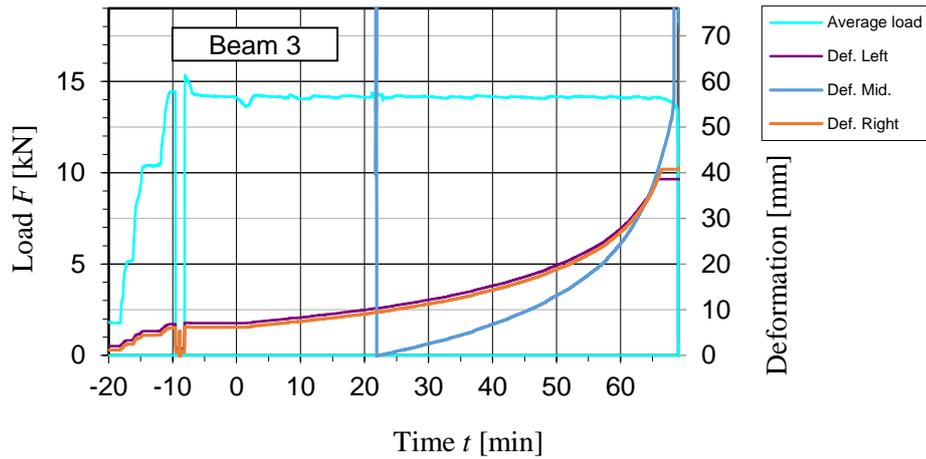
Graph 8. Average load and displacement measurements of fire test with Beam 3. Load  $F$  is the applied load per jack, as shown in Figure 32.  
 Note: Def. Mid. starts from 22-nd minute as "zero" and presents displacement since this moment of time.

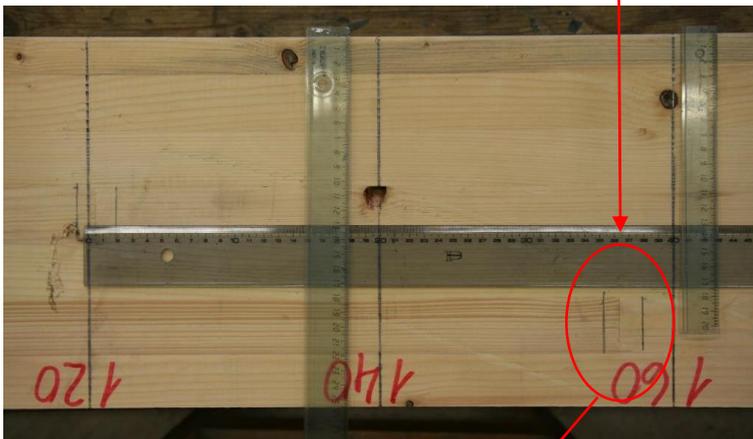
Figure 76. Failure zone of Beam 3 face "D" before the fire test.

In Figure 75, a failure location in the unburnt beam is shown and in Figure 76 the exact failure location before the fire test. Location of the failure reason, the finger joint, has been marked with red on the photograph. In Figure 80 the location of finger joint on the opposite side of the beam has been exhibited.

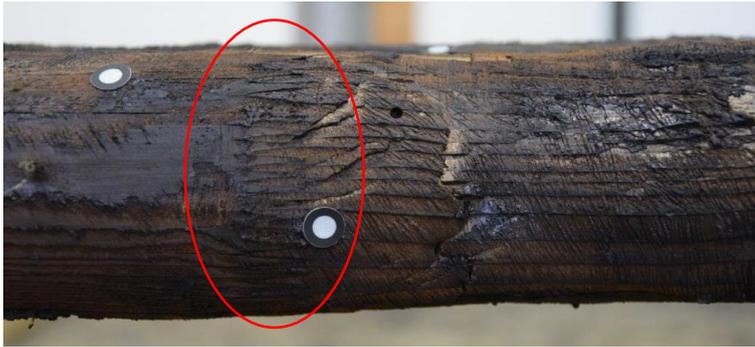
Figure 78. Bottom of the failure zone of Beam 3 after the fire test. Note the share failure on the right from finger joint.

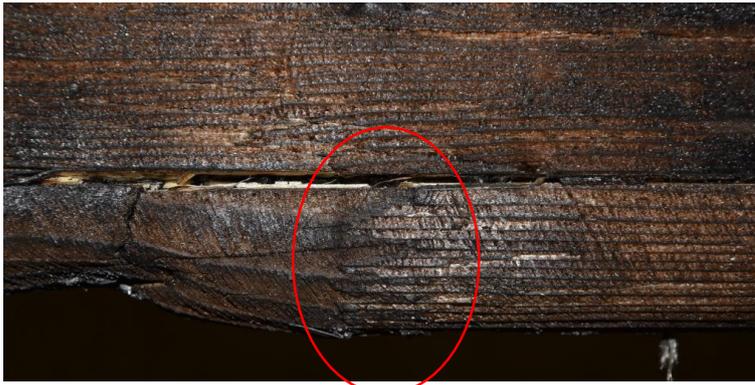
Figure 79. Failure zone of Beam 3 face "B" after the fire test.

Failure of the Beam 3 may be called a mixed type; partly finger joint failure, partly clear wood failure. A deeper local charring zone in lamella 6 can be noted in Figure 77 on the right from the finger joint. As uneven charring created a significant deterioration on one side of the finger joint, tension in the lower part of finger joint remained unanswered as material's resistance to share is about ten times lower than tension along the grain, stresses in lamella were redistributed to only upper part of the finger joint. Redistribution resulted in failure. Clear wood failed of exceeding its shear capacity; note the shear cracks on the mid height of finger joint in Figure 77 and Figure 78. Figure 79 shows how lamellas have been torn apart in the location where tension should be transmitted to upper lamella.

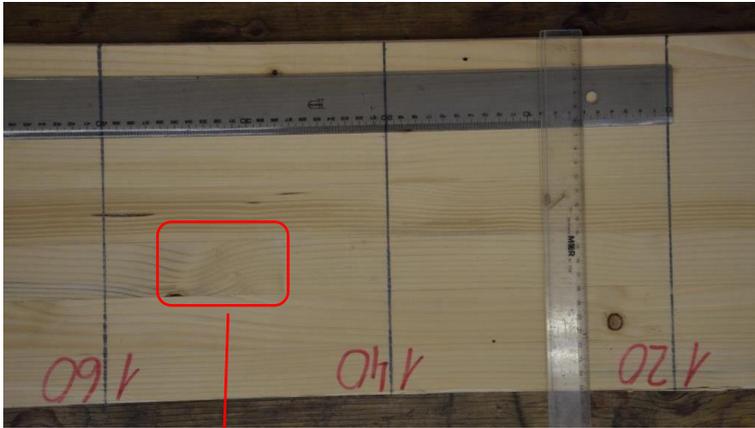
Figure 84. Failure zone of Beam 4 face "B" before the fire test. The red box indicates on the high  $K_m$  value area marked in red in the lamella 5 in Figure 82.

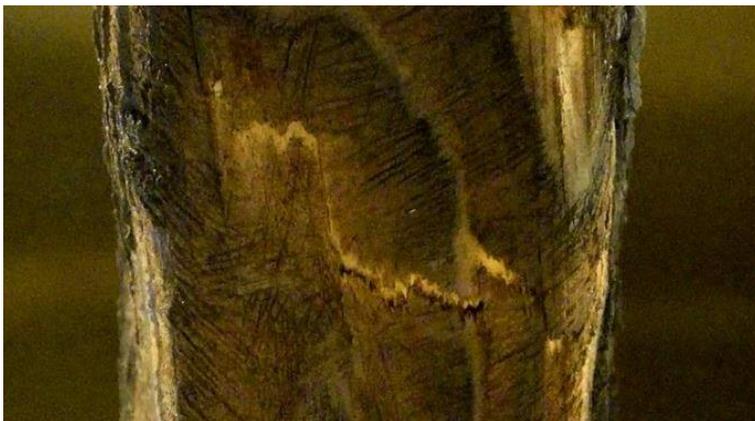
Figure 86. Bottom of the failure zone of Beam 4 after the fire test.

Failure of the Beam 4 can be called a mixed type; partly clear wood, partly a knot cluster. The bottommost lamella 6 has diminished about a half of its height because of charring and thus not enough of it is left to resist all the stress of tension zone, it is ruptured. Cracks of torn wood are visible in Figure 86. The reason why most of the tension was redistributed to lamella 6 is the knot presented in Figure 85 and its already mentioned high  $K_m$  value. Fact that the knot cluster of that size cannot be spotted on unburnt beam indicates that the deterioration of the structure of wood is larger deeper inside. In fire the visible undisturbed wood outside will char and the relative area of knot cluster is higher than before the test. Meaning, in this location lamella 5 is not able to reinforce adjacent lamella 6 at all and the latter will be torn.

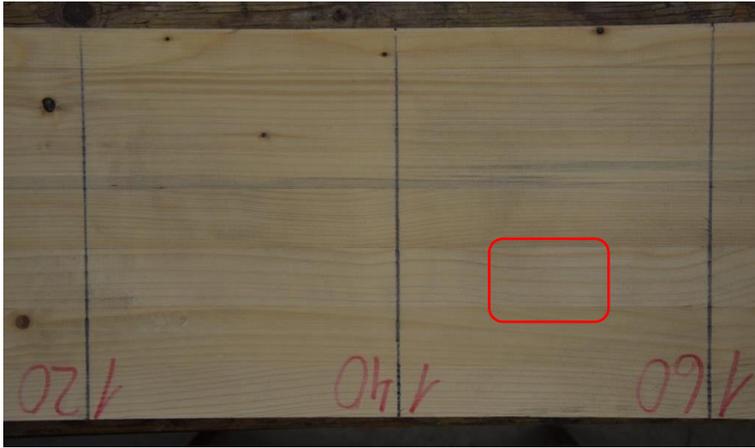
In Figure 83, a failure location in the unburnt beam is shown and in Figure 84 the exact failure location before the fire test. Please note that in Figure 84 and in Figure 87 a knot cluster of extra high  $K_m$  value surrounded with red in Figure 82 is hardly noticeable on the unburnt specimen, which means that the knot is located in the middle of the lamella.

*Figure 87. Failure zone of Beam 4 face "D" before the fire test. The red box marks high  $K_m$  value in the matrix in Figure 82.*

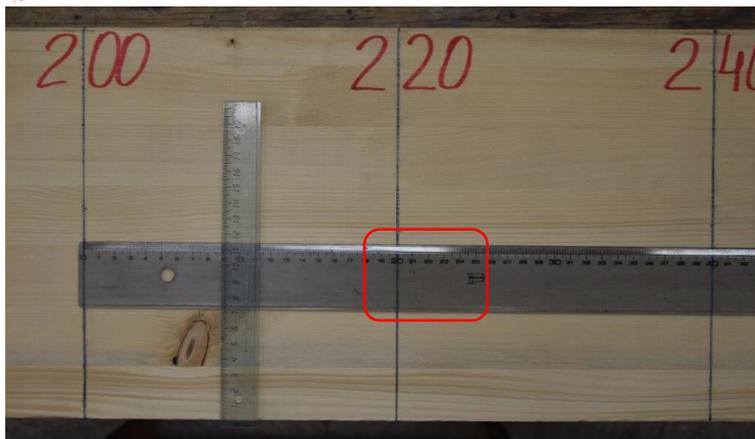
Beam 5 showed the longest fire resistance of the specimens of the same load level (0,3) which thus means it charred to a greater extent. The location of failure before the fire test is presented in Figure 91 on one side and in Figure 94 on the other side of the beam. The position of the failure zone in the unburnt specimen is shown in Figure 90. Causes of failure are similar to beam 4 – rupture of clear wood underneath a knot cluster of high  $K_m$  value; the upper lamella is not able to offer expected reinforcement to the bottommost one. Please see rupture cracks and knots on both sides of the burnt beam in Figure 92 in Figure 93. Please note in Figure 91 and Figure 94 that neither of the knots was visible from outside before the test.

Figure 91. Failure zone of Beam 5 face "B" before the fire test. The red box marks a high  $K_m$  value zone in the lamella 5 in Figure 89.

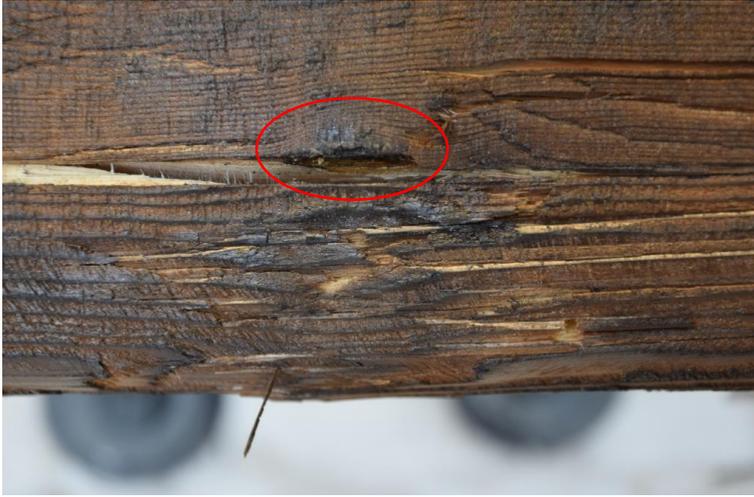
Figure 92. Failure zone of Beam 5 face "B" after the fire test. Note the knot marked with red and clear wood rupture below it.

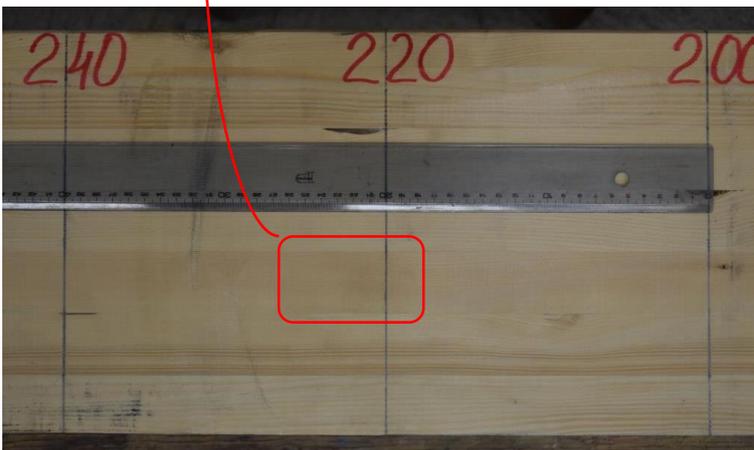
Figure 94. Failure zone of Beam 5 face "D" before the fire test. High knot indicator  $K_m$  zone marked in red.

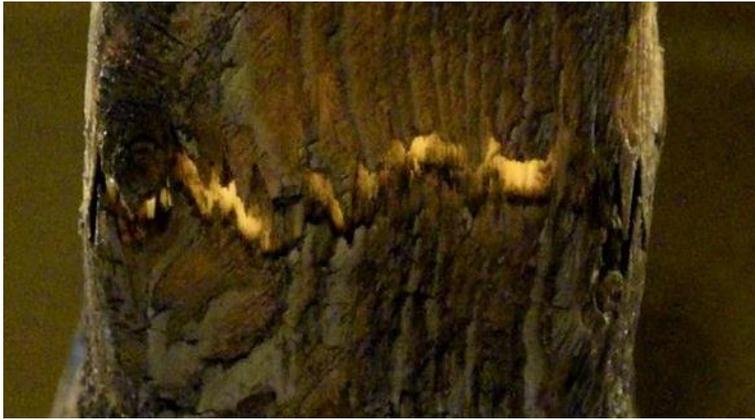
*Figure 100. Bottom of the failure zone of Beam 6 after the fire test. Note the fingers of the finger joint.*

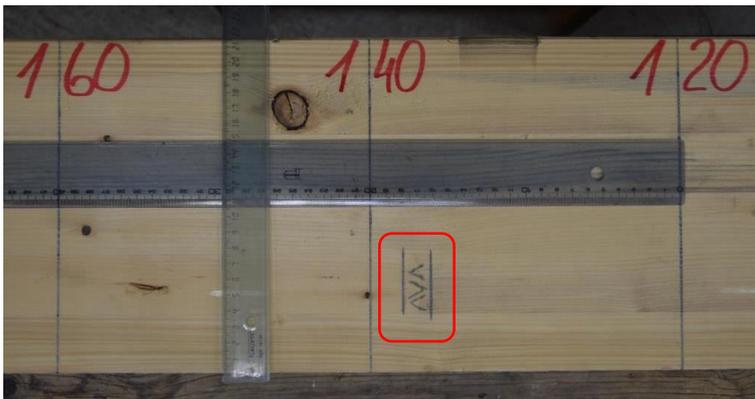
*Figure 101. Failure zone of Beam 6 face "C" before the fire test. Finger joint location at 1360mm is marked with red.*
