TALLINNA TEHNIKAÜLIKOOL
TALLINN UNIVERSITY OF TECHNOLOGY

**AIR PERMEABILITY PROPERTIES OF CROSS
LAMINATED TIMBER EXTERNAL WALL**

MASTER'S THESIS

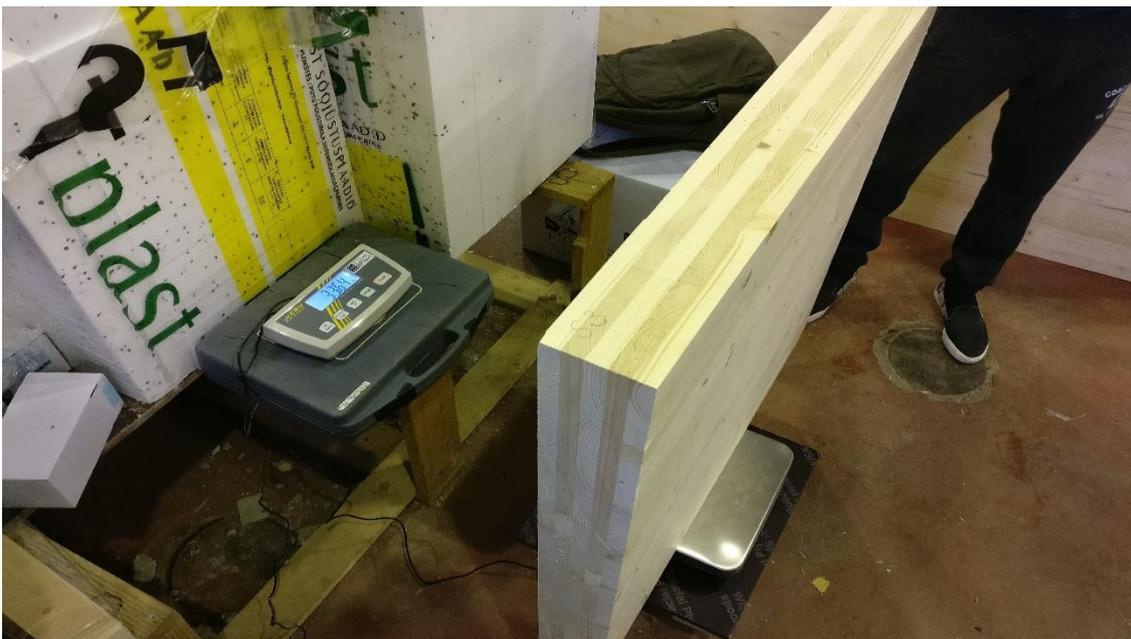
The test specimens in this research consist of 12 CLT panels in total. The specimens (Figure 2.1) are arranged into three different test walls which would be further described in details in the next sub chapter. The specimens are 5 layer CLT panels made from spruce (*Picea abies*) boards (19 x 120mm) and have bonded connections with 1K PUR (one-component polyurethane adhesives) adhesives. All 12 CLT panels were supplied directly from the manufacturer with the dimension 850x850x100 mm.

Figure 2.1: CLT specimen used for the research

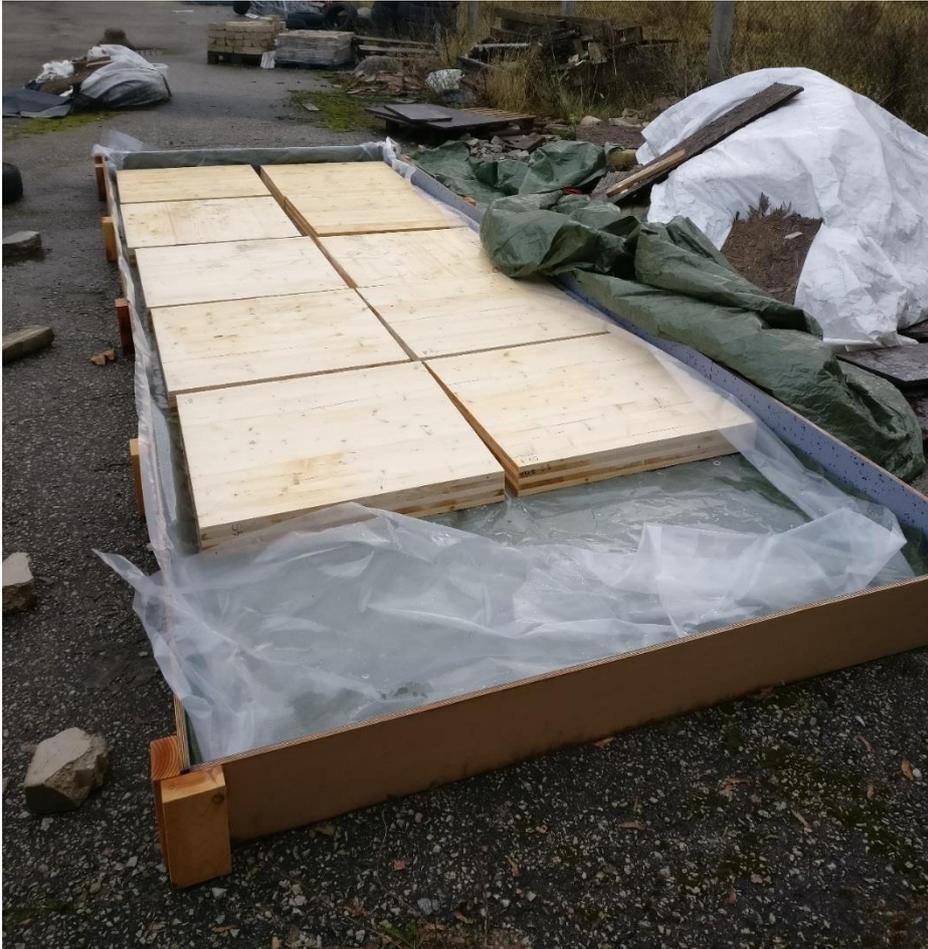
Transferring to the pool: Having completed the building of the pool and the amount of water required for wetting, CLT test panels were transferred to the pools for wetting. After transferring, the panels were wetted with the quantity of water that had been calculated beforehand and then finally covered with a nylon in order to ensure the M.C intake is equally distributed between all the CLT panels placed into the pools. For consecutive period of time, the panels were checked and MC measured in order to confirm if the panels had gotten to the required M.C.

Figure 2.5: Arrangement of CLT panels inside the pool

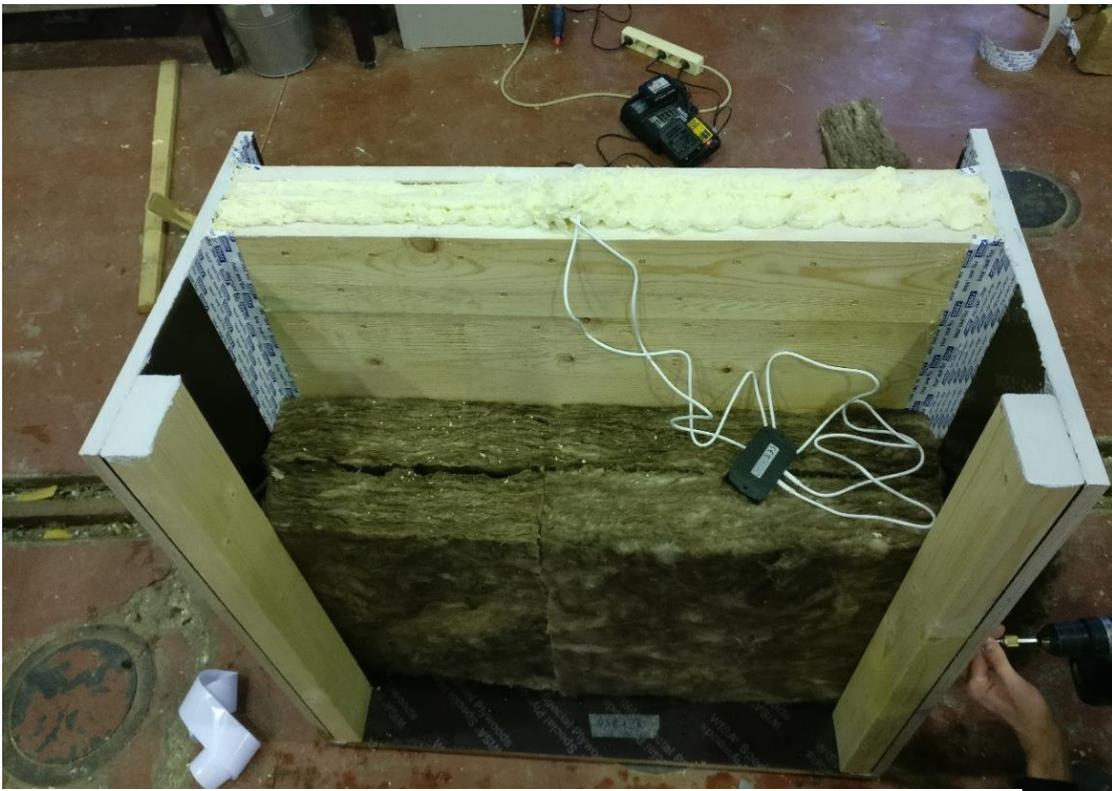
completely sealed along the corner with a sealing tape. An 18mm water proof (film faced) plywood was used to create a wall for the test sample as shown in figure 2.6

Figure 2.6: *One of the test wall used in the research with mineral wool as insulation*

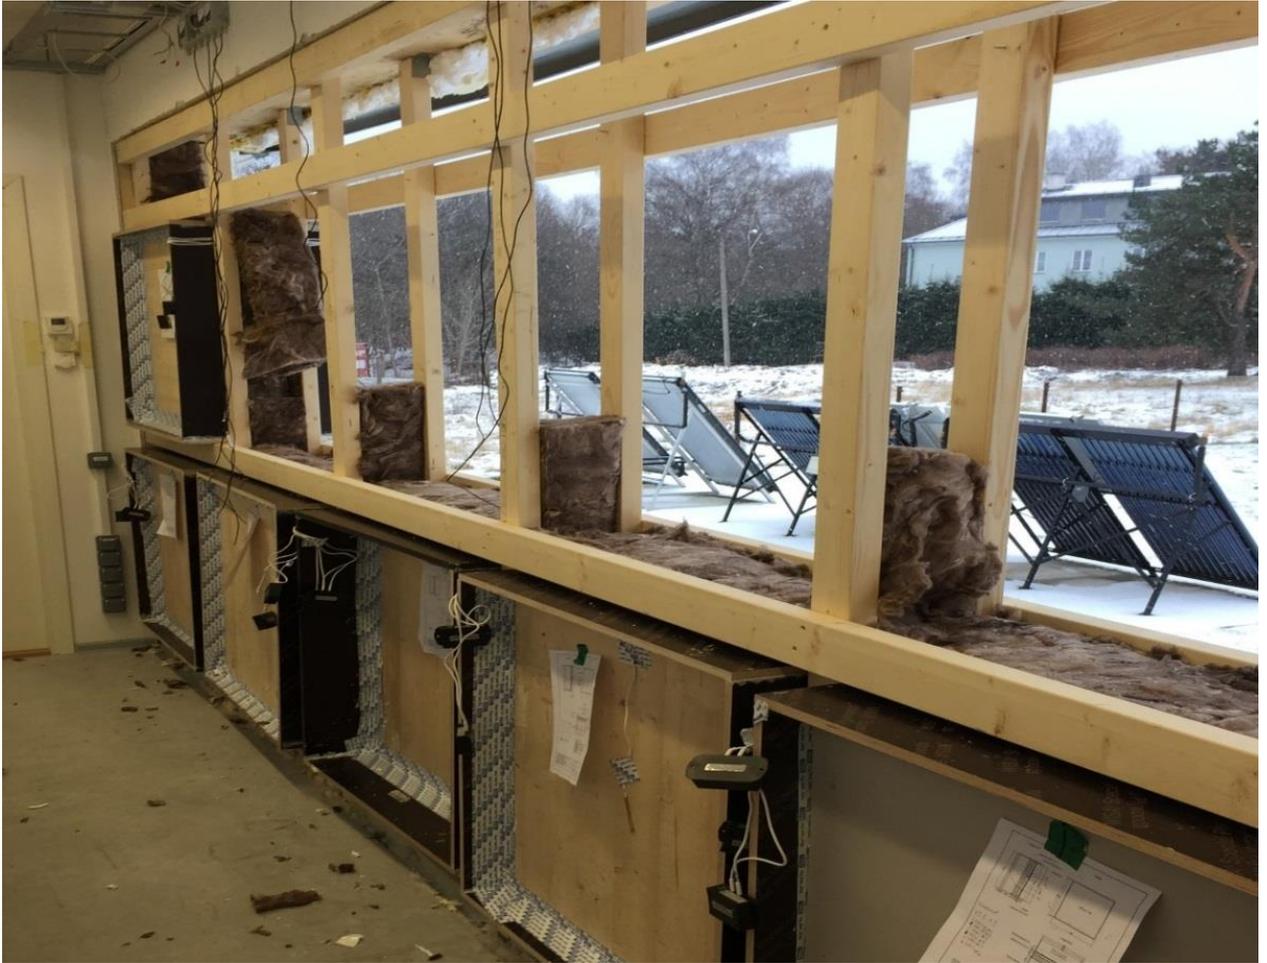
The mounting of the test walls was achieved with frames and beams already constructed as shown in fig 2.8, hence all that was needed was to transport the test walls from the TTU civil engineering laboratory to the nZEB technological test facility shown in appendix . All the 12 test walls were mounted on both North (six test walls) and South side (six test walls) as shown in fig 2.8 with the 12-14% M.C test walls arranged at the top while the 25-27% M.C arranged below. The architectural drawing in figure 2.9 gives a detailed information about the arrangement of the test walls.

Figure 2.8: Picture showing test walls already mounted in technological test facility

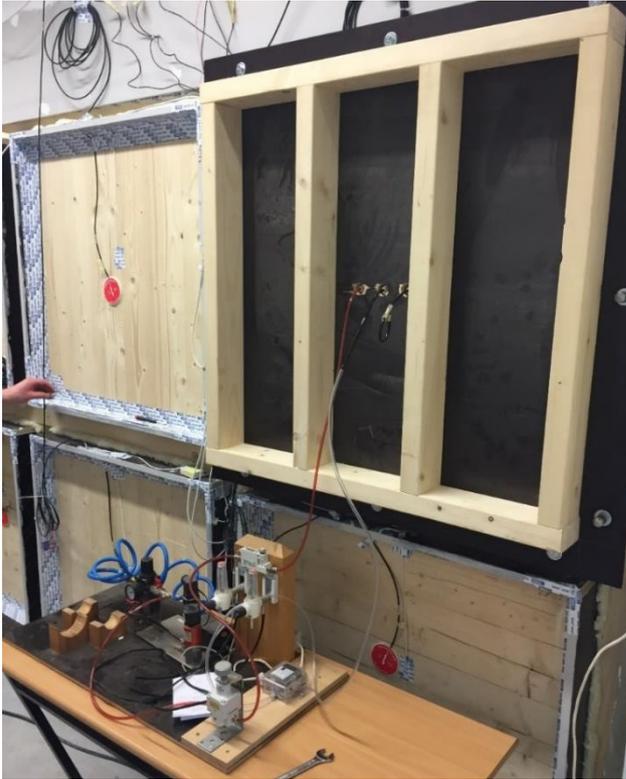
Figure 2.10: A scheme of the apparatus to be used for the air permeability test

For this research, test was carried out at the TTU nZEB technological test facility (Figure 2.8 and 2.9) at positive pressure differences with the apparatus provided for in Figure 2.10 and 2.11. The ambient temperature and humidity in the apparatus is between 15 °C to 30 °C and 25% to 75% RH as specified in EVS-EN 12114: 2000.
