KUNDA RIVER ANCHOR ICE FORMATION

2017-02-08, Tallinn, Keskkonnaagentuur

SITE VISIT PHOTOS 20170208

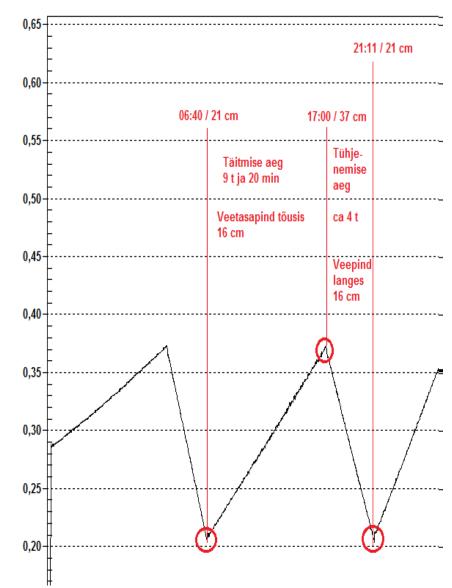
LOCATION No 1: explanations

Location No 1 = Jaama street reservoir (currently working hydropower station reservoir). Technologically there are three propeller type turbines with flows 1, 2 and 4 m³/s. Flowrate downstream can be one of seven combinations G1..G7.

- Water level is fluctuating in a range of 16 cm before the working HPS (in the reservoir). Allowed range ±5 cm.
- 3. Reservoir filling time is not align with discharge:
 - filling 9 hr
 - discharge 4 hr

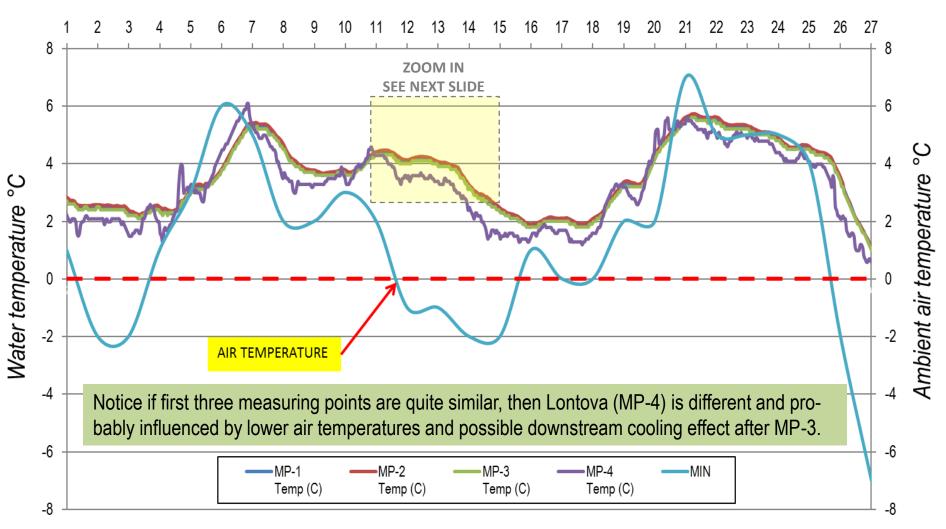
RIVER WATER TEMPERATURE

Measuring water temperature once per hour. Ambient air MIN temperature from Wunderground (daily min).

01. - 27. December 2015

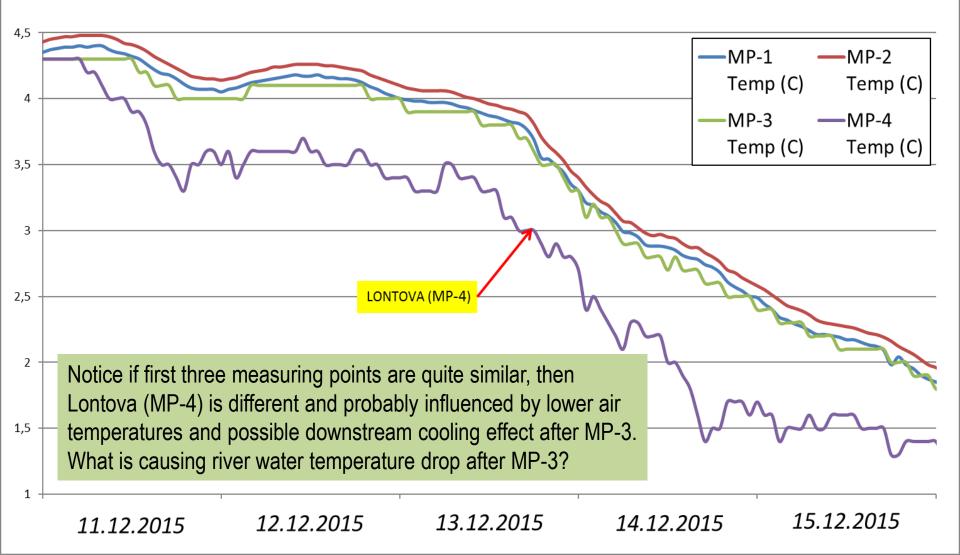
RIVER WATER TEMPERATURE

Period: 11.12.2015 - 15.12.2015 Measuring water temperature once per hour.
