RISTKIHTPUIDUST MAJA RUUMTULEKAHJUKATSE – TULE LEVIK LÄBI LIIDETE JA LÄBIVIIKUDE

LARGE SCALE FIRE TEST OF CLT – FIRE SPREAD THROUGH THE JOINTS AND
PENETRATIONS

MAGISTRITÖÖ

Tallinn, 2018

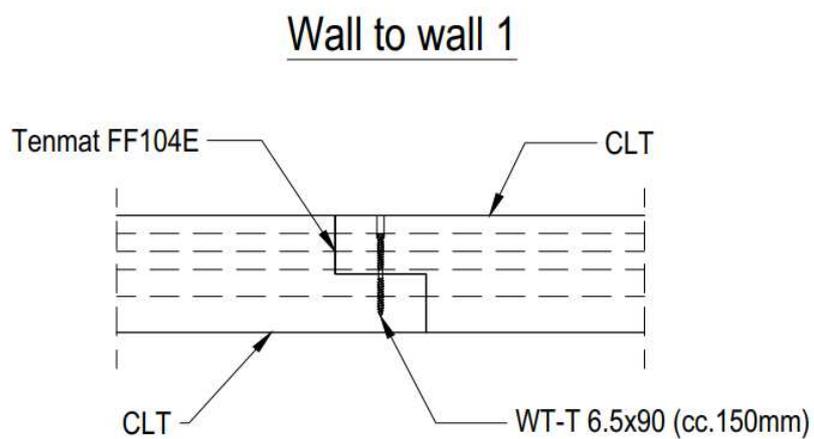
Figure 2.7 CLT+CLT overlapping joint

The conducted experiment also set out to show how correctly designed joints can be very fire-resistant and contain the fire in a real situation. The CLT panels' continuation joints were designed to be overlapping, with an overlap of 100 mm, fastened by self-tapping screws spaced 150 mm apart, see Figure 2.7.

The temperatures shown on Figure 3.16 indicate that the other joint type was also not penetrated by heat, which is logical due to having gypsum protection from each side, which did not fail during the test. The figure also shows that the CLT + CLT overlapping continue joint (see Figure 2.7) in the middle of the room had very low temperatures during the duration of the fire. As seen on Figure 3.2 and Figure 3.3, some thermocouples were placed inside the joint in front of the intumescent tape and some behind it. The results however show, that the three layers of gypsum protection on the ceiling kept the temperature inside the joint low and the intumescent tape did not even need to expand.

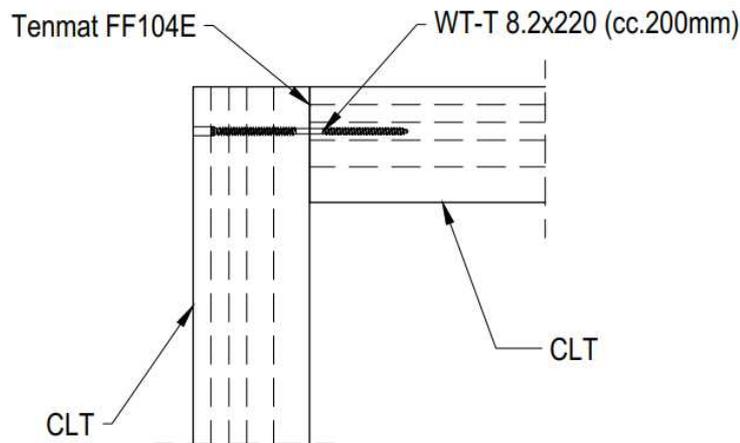
Figure 2.8 CLT + CLT corner joint

The corners of the house had a wall to wall connection where one wall crossed on top of the other and the two walls were connected by self-tapping screws with a spacing of 200 mm, see Figure 2.8.

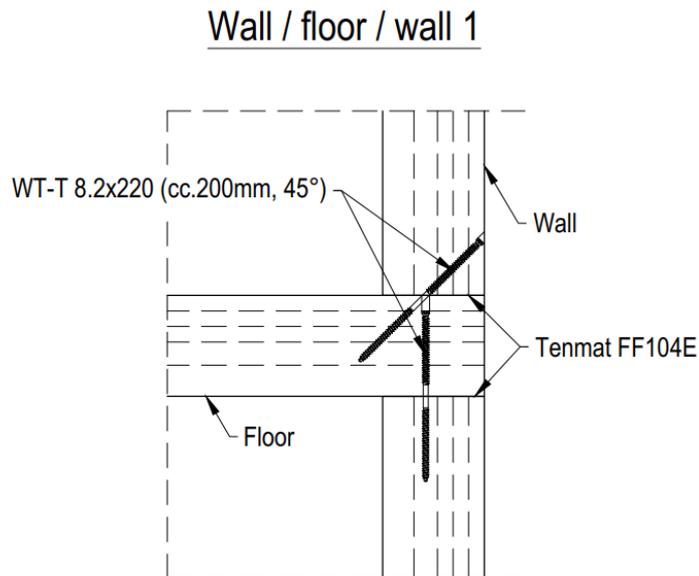
Figure 2.9 Wall-floor-wall joint to be used in smaller buildings

The first of these is designed in such a way that the floor/ceiling is placed between two wall panels and connected with 2 self-tapping screws per cross-section with an approximately equal distance between screws, see Figure 2.9. This type of joint is to be used when designing lower and smaller buildings. All types of wood have a small resistance to perpendicular compression. When compressed perpendicular to the grain of the wood, timber quickly loses its strength capabilities and is to be regarded as having reached its ultimate limit state. This limits the usage of such a joint to smaller scale buildings, simply because the floors timber would receive perpendicular compression forces far above its tolerance. Problems would also occur in the serviceability limit state, because the deformations would be too big and cause unwanted deflections for the building.

The joint meant for smaller buildings was behind layers of gypsum, therefore it was to be expected that it would work properly. The results confirm that, with Figure 3.16 showing that the thermocouple J1 (see Figure 3.3 and Figure 3.5) that was behind that joint did not even surpass a temperature of 5 °C. The lower side of said joint has been discussed as J3 in the previous chapter, which was deemed to have worked as well.

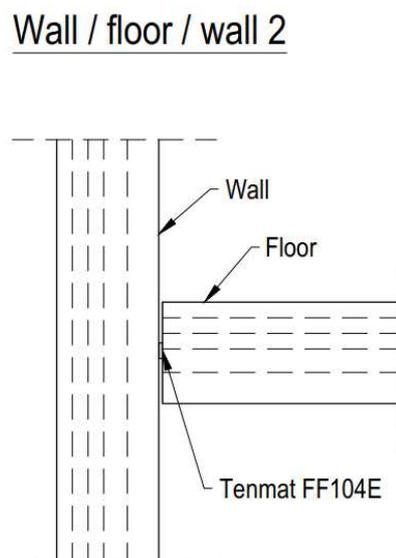
Figure 2.10 Wall-floor-wall joint for larger buildings

The second joint solution was with a continuous wall panel, see Figure 2.10. The floor should be connected to the wall panels with special clamps, brackets or corners of some sort that would be able to transfer the forces from the floor to the wall. The fastening system must also be fire resistant or thoroughly isolated from fire. Since the compression forces inside the wall are not transferred through the floor panel, there is no perpendicular compression and therefore the floor panel only needs to withstand internal forces created by that floors loads, enabling the use of this design in high, multi-storey buildings.

It is to be noted that this principle was used in two walls of the test house, however, these walls were not mechanically fastened to the wall panel, because the span of the room was small and the other two walls were already attached following the design principle of the first joint solution described above.

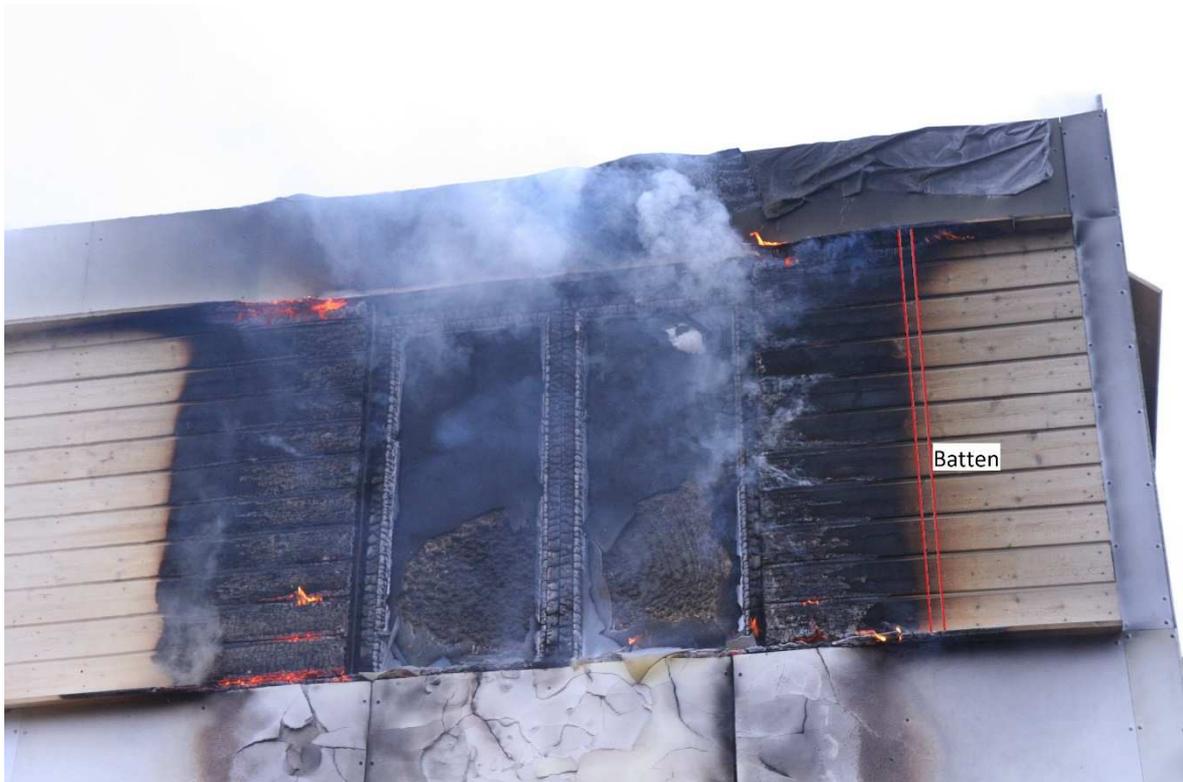
Figure 2.11 EI30 window on the upper floor

The windows of the upper floor were fireproof windows, rated to EI30. The hypothesis was that these windows' first layer of glass would break, revealing the thin, completely transparent material that is between two layers of glazing, which becomes intumescent and protects the inner glass from breaking.

Even though the fire brigade made some slight scratches on the glass on the lower floor for it to break more easily, in the actual test the windows did not break from the fire. The fire brigade broke the glass manually, thus letting the fire develop. The outer layer of the windows on the upper floor broke and the transparent protective material was revealed.

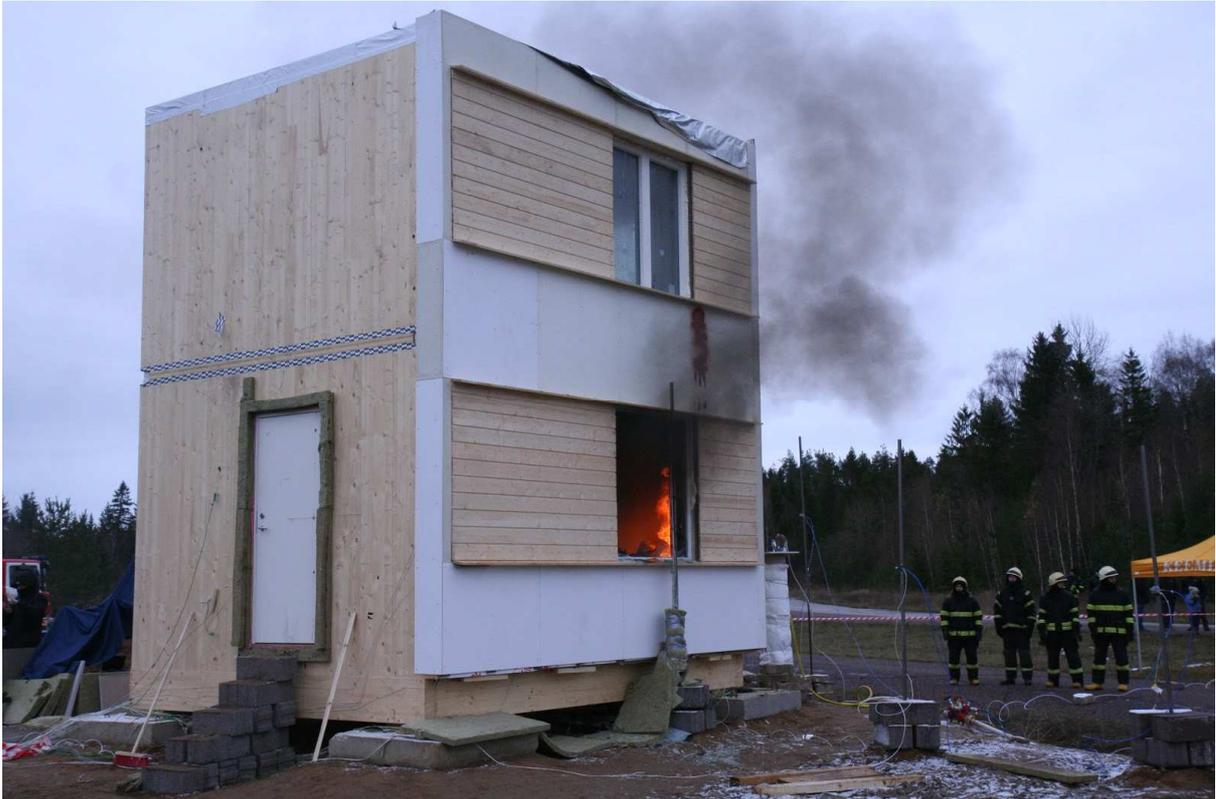
Figure 2.13 After breaking the first window the fire starts to develop

0:20:58 The first window is completely broken on facade 1-1. More grey smoke comes out of the window. Smoke continues slowly blowing out of the window. See Figure 2.13.

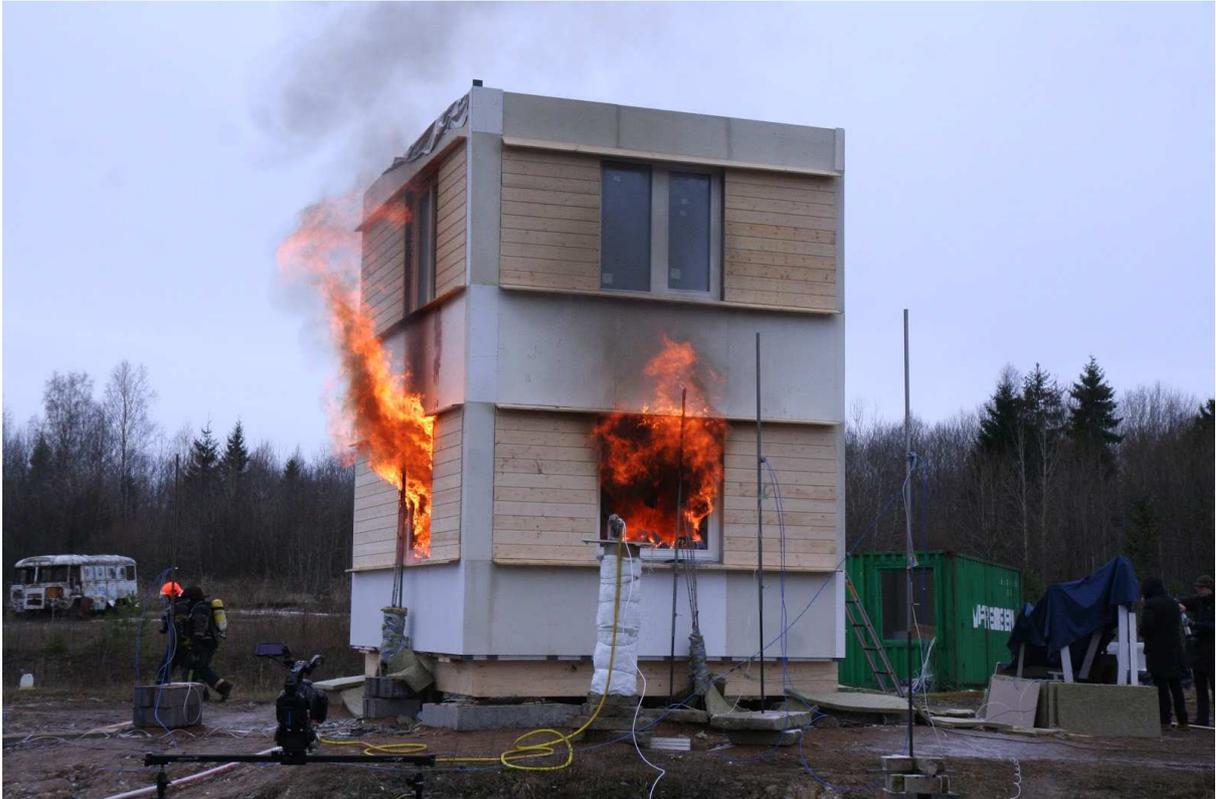
Figure 2.14 Flames are reaching the facade of the upper floor

0:46:32 The fire stop is completely burning; the flames are getting out of the window that was broken second, see Figure 2.14.

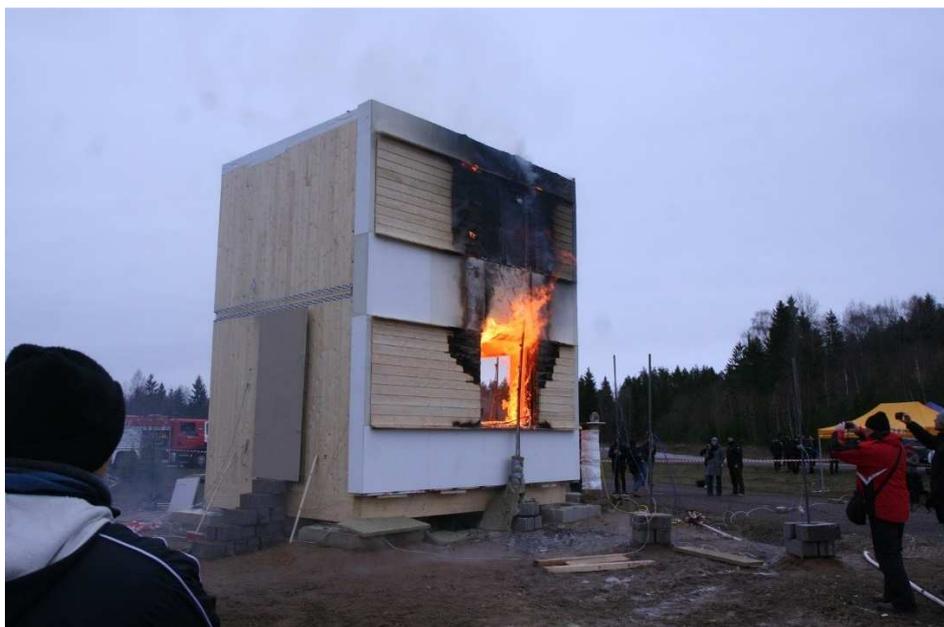
Figure 2.16 The flames are subsiding

1:05:00 The fire starts fading. The CLT inside the building is burning (see Figure 2.16). On the outside, the fire stops on the upper floor are burning. All the fire stops on lower floors' windows are burned. The cement-based board has not broken off, but the layer of paint is peeling.

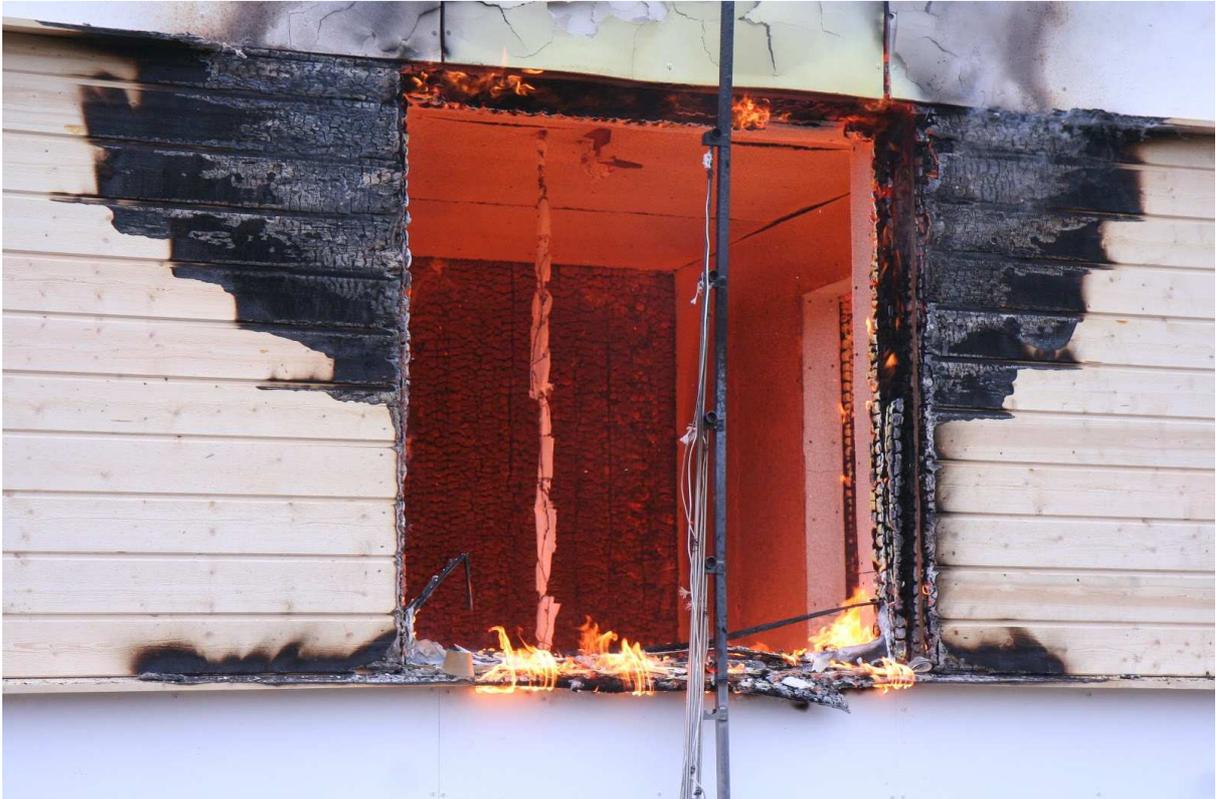
Figure 2.17 The CLT is smouldering

1:09:00 Exposed CLT walls are smouldering with no visible flames (Figure 2.17). The fire is dying. Upper floor has not been on fire throughout the whole test although the facade has small flames.

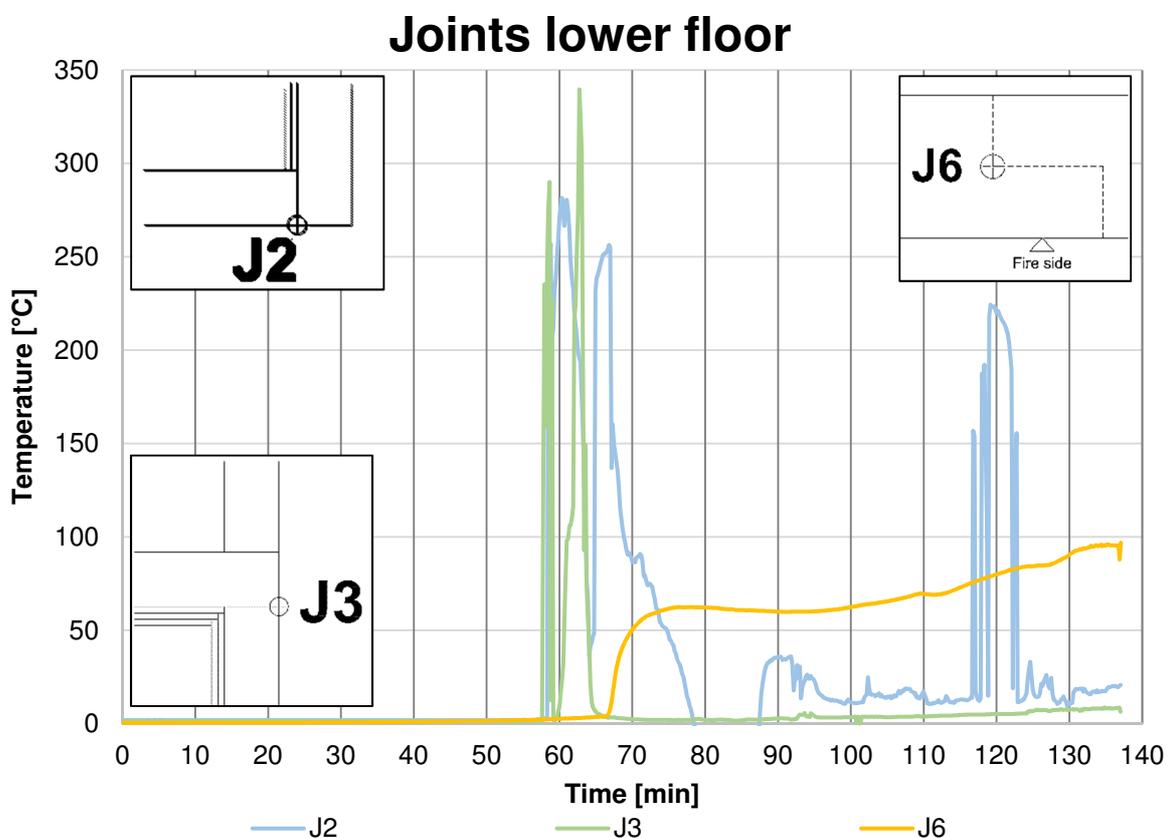
Figure 3.6 Joint temperatures of the lower floor joints

Data recorded during the test has shown that temperature within the joints was extremely low for the first 58 minutes of the test, after which a sudden spike can be seen for the thermocouples labelled J2 and J3. This is shown on Figure 3.6. The location for J3 can be seen on Figure 3.2 and Figure 3.3. As seen from the figures, J2 and J3 were both near the ignition point of the fire with J2 being in the middle of the wall panel, placed between the panel and stone wool insulation and J3 placed behind the wall-floor joint.

The sudden temperature rise is thought to be caused by heated gases penetrating the joint after the flashover occurred, which also set all the gases on fire. This means that the joint was not 100% airtight and the heat from the flashover pressed through between the gypsum edges and CLT. Another thing to be noted is that these wall corners did not have gypsum from two sides, but only from one.

Figure 3.6 shows that right after 60 minutes, the thermocouple labelled as J6 also had a rise in temperature. As seen from Figure 3.1, J6 was placed into the joint on the uncovered CLT wall opposite to the room from the fire ignition point.

Figure 3.6 also shows that slightly before and at the second flashover, J2 had another sudden, albeit slightly lower than before, temperature spike, which can be accounted to either the same situation as already happened previously, and some heat somehow penetrated the joint, or the heat reached the thermocouple via a corridor behind the stone wool. J3, however stays at a very low temperature until the end of the test and J6 maintains a steady temperature below 100 °C.

An overlapping joint as such could be able to entirely seal the connection and shield it from heat, if guaranteed to be built very accurately and tightly. An additional recommendation would be to add another strip of intumescent paper behind the gypsum, just to where the CLT + CLT joint starts. This would ensure the fire and heat never to spread through the joint.
