EENSALU & PIHEL

**Object:** Defence barracks, building monument reg.no. 8485

**Address of the object:** Kalaranna St 28, District of Põhja-Tallinn, City of Tallinn, Harju County

#### SPECIAL CONDITIONS FOR HERITAGE CONSERVATION

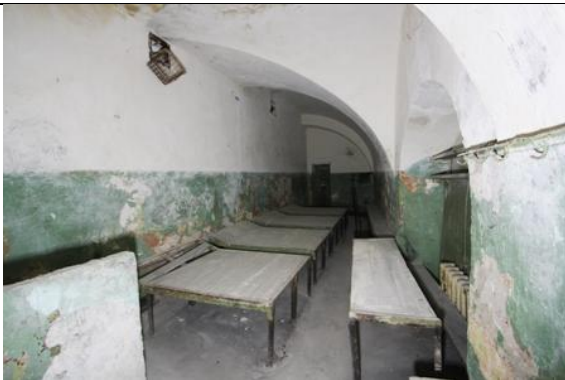
| VD19 | Cells with integral furnishing No. 82, 101, 102, 105, 105A, 106 | <p>cell 101</p> |

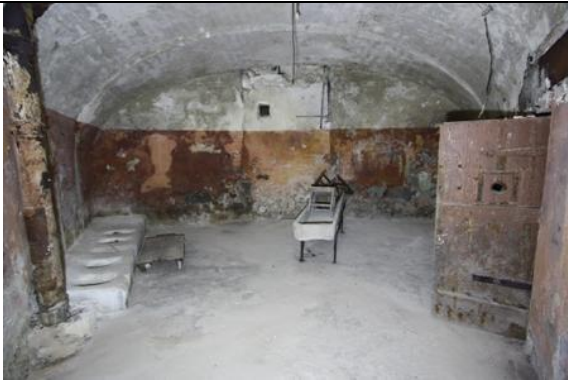
| VD20 | Older type laundry room with furnishing | |

| VD20 | Prisoners' wash room and toilet<br>2 <sup>nd</sup> floor<br>Sector 1 | 1 original wooden door with iron hinges, degrades doorjamb, 1 concrete washbasin on cast iron feet, 5 concrete sitting holes, 1 drain | 310-312 | Fully conserve the room with details and finishing layers |

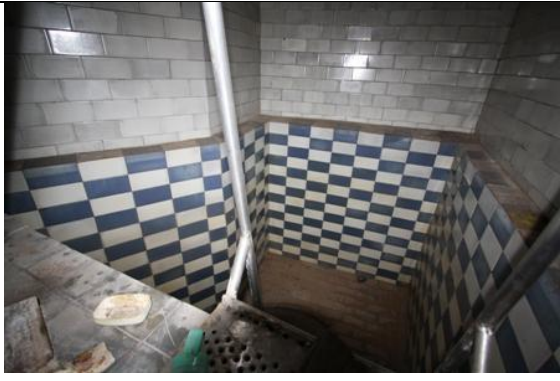
| VD35 | <p>Staff resting<br/>complex: gym,<br/>break room with a<br/>fireplace, sauna,<br/>pool</p> | |

| VD35 | Staff resting complex 1 <sup>st</sup> floor sector 1 | In the gym, punching bags, wrestling mat on the platform, hanging consoles for the punching bags, 2 pcs. In the sauna rest room, fireplace, seats with leather backrests, table, shelves with carvings, hooks, 2 pcs mirrors, sheet metal lampshade, | 522, 523 | Preserve the named details at their location. Wooden boards in the break room to be processed or exchanged to replicas due to dry rot. |

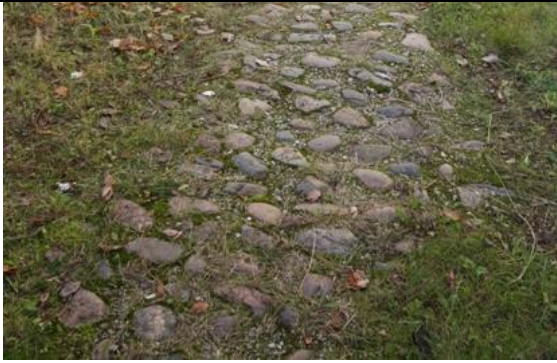
| VD37 | Breakages of the cobblestone pavement in front of the gorge courtyard façade | | |
