TALLINNA TEHNIKAÜLIKOOL  
INSENERITEADUSKOND

# RISTKIHTPUITKONSTRUKTSIOONIDE KÄITUMINE TEGELIKUS TULEKAHJUS

BEHAVIOUR OF CLT STRUCTURES IN NATURAL FIRES

MAGISTRITÖÖ

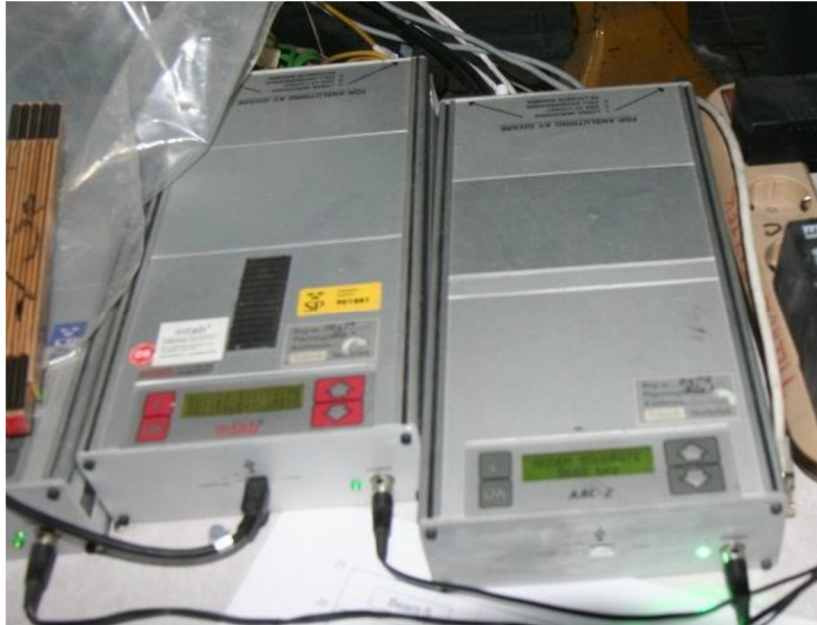
Figure 2.4 PC-loggers (Intab).

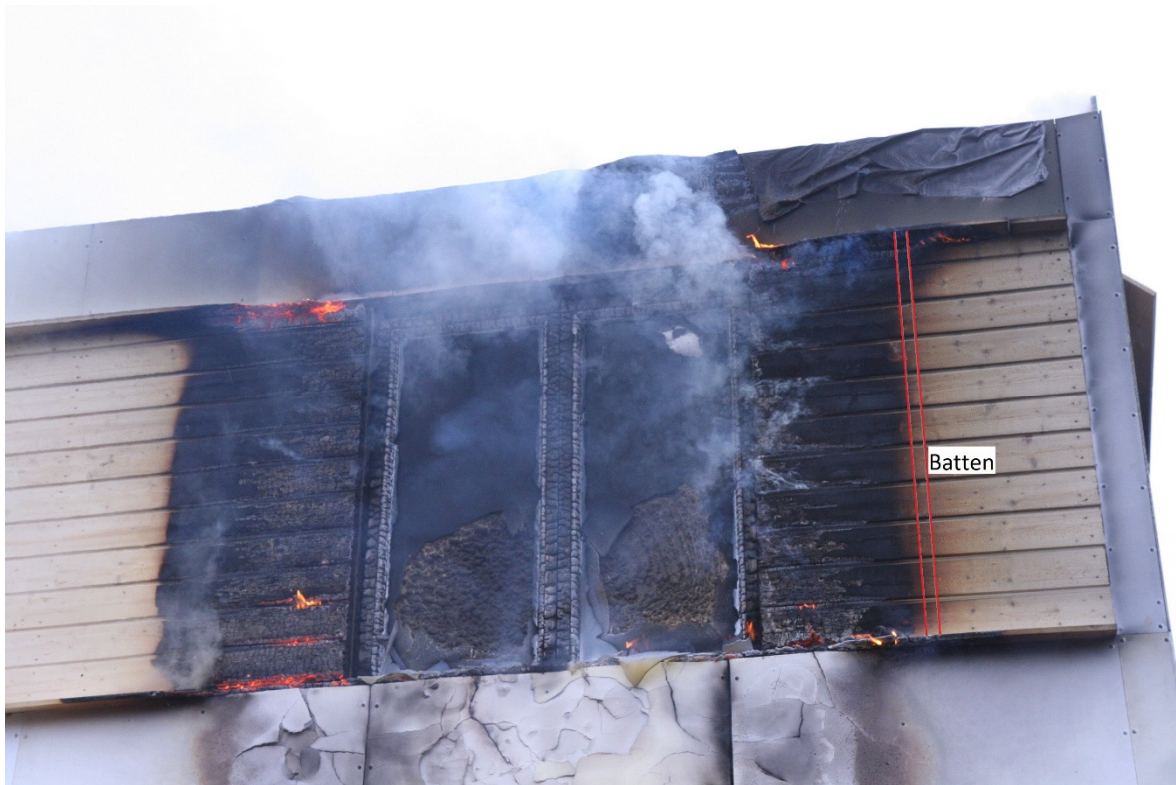
Figure 2.11 EI-30 window on the upper floor

The windows of the upper floor were fireproof windows, rated to EI30. The hypothesis was that these windows' first layer of glass would break, revealing the thin, completely transparent material

Even though the fire brigade made some slight scratches on the glass on the lower floor for it to break more easily, in the actual test the windows did not break from the fire. The fire brigade broke the glass manually, thus letting the fire develop. The outer layer of the windows on the upper floor broke and the transparent protective material was revealed.

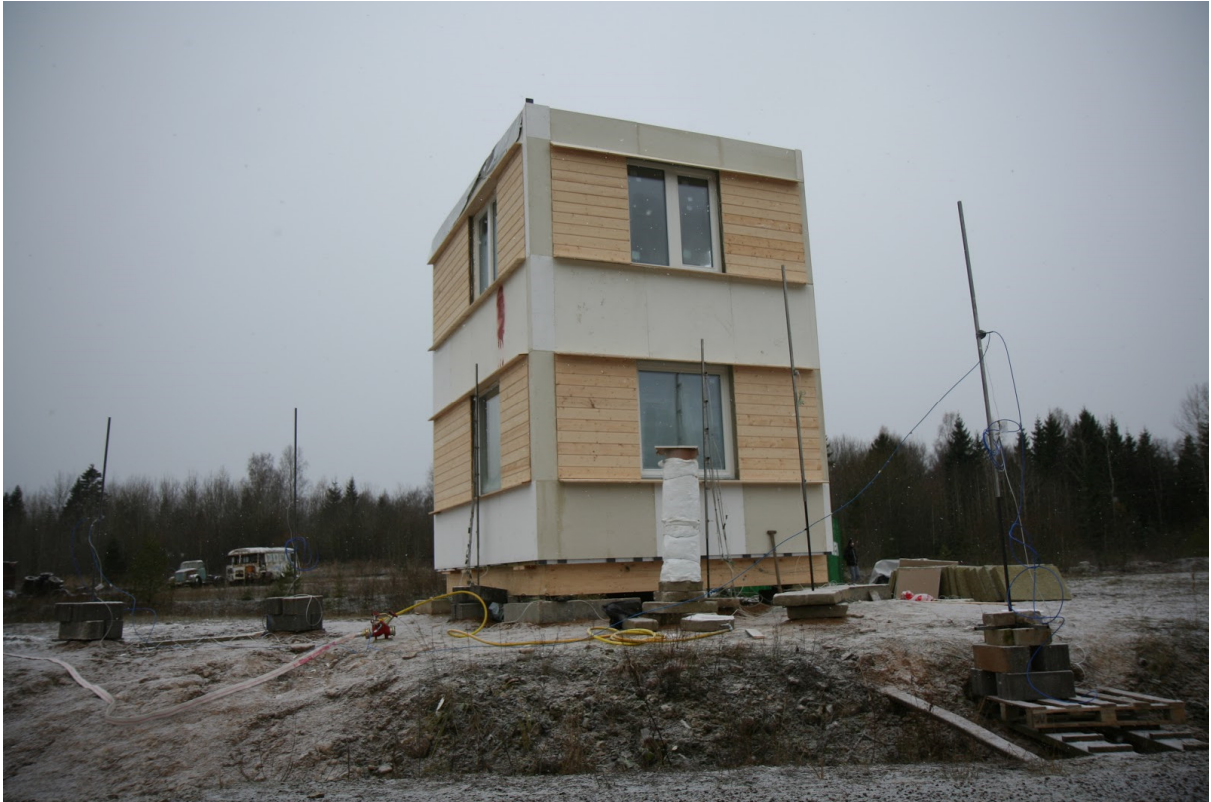
Figure 2.12 The test house before the ignition

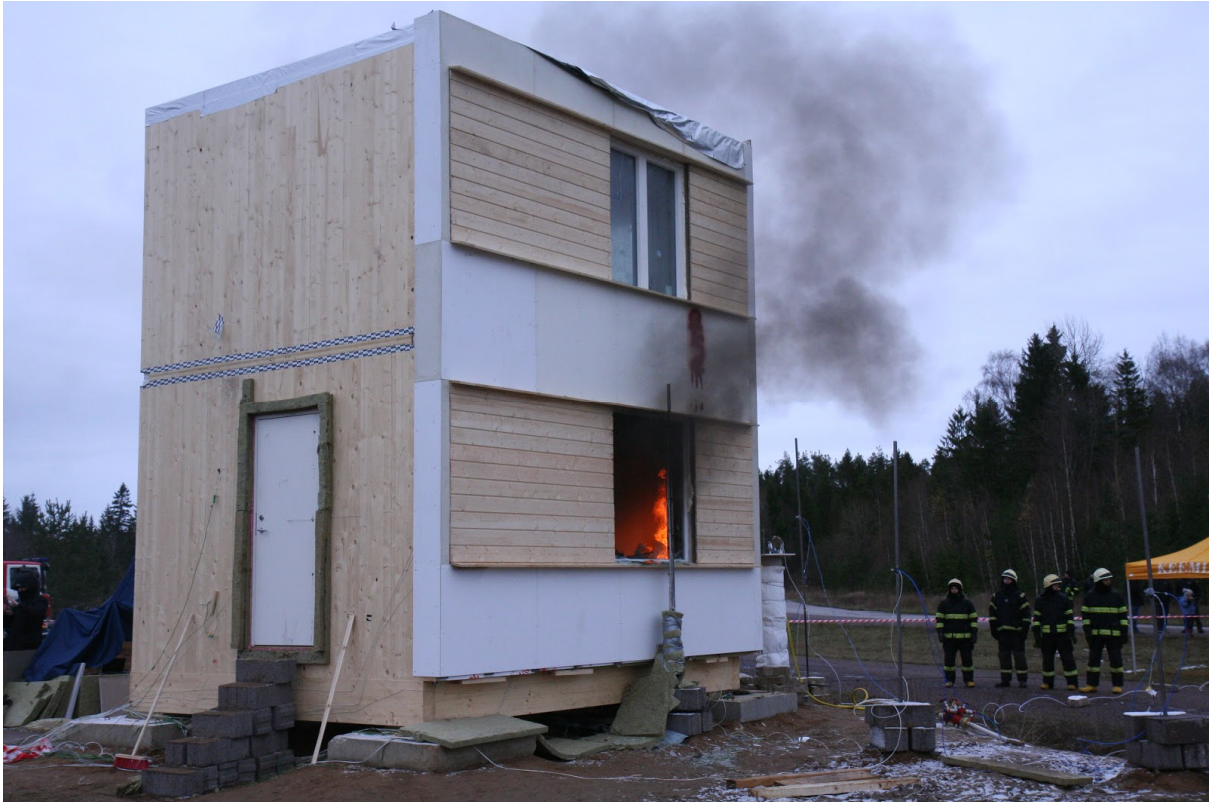
Figure 2.13 After breaking the first window the fire starts to develop

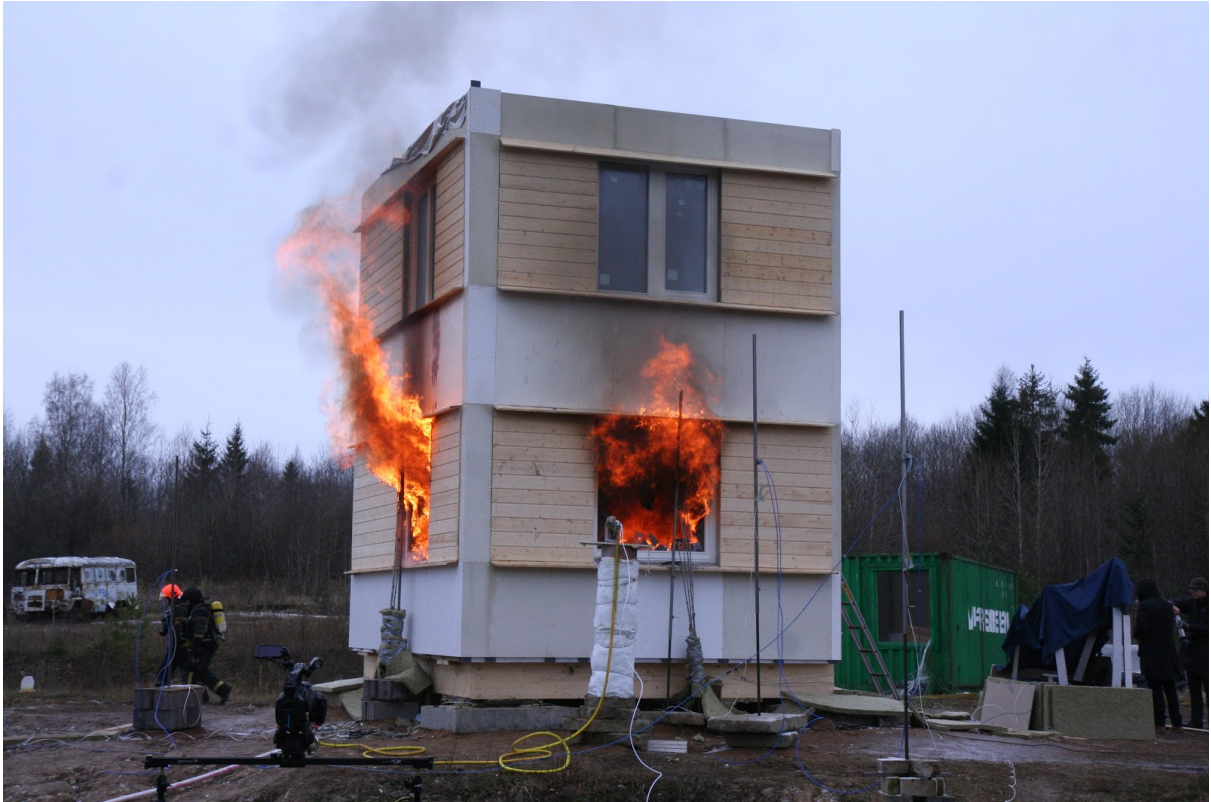
Figure 2.14 Flames are reaching the facade of the upper floor

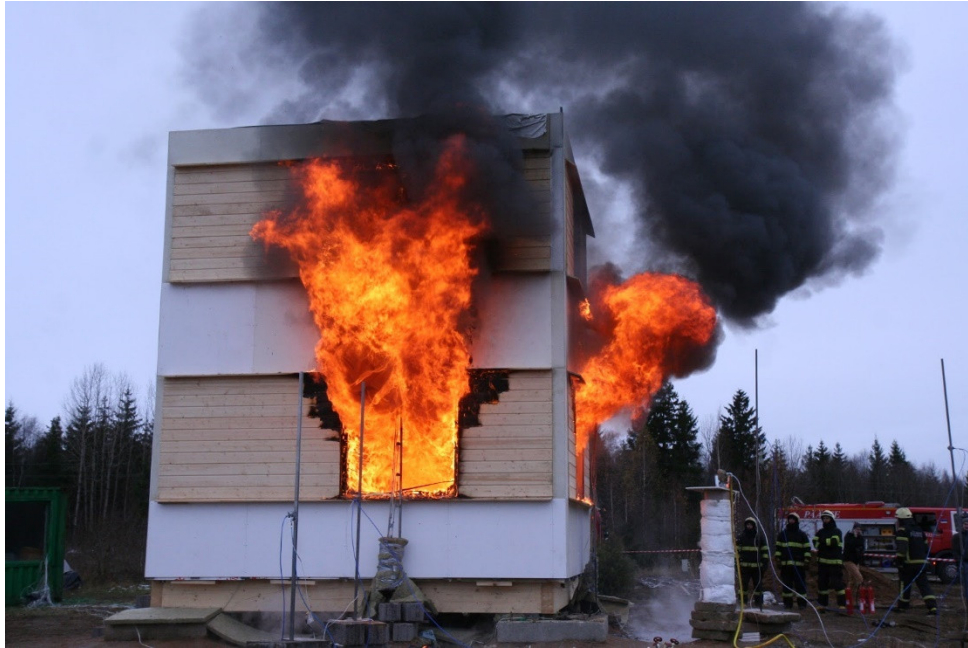
Figure 2.15 Fire has spread to the facades

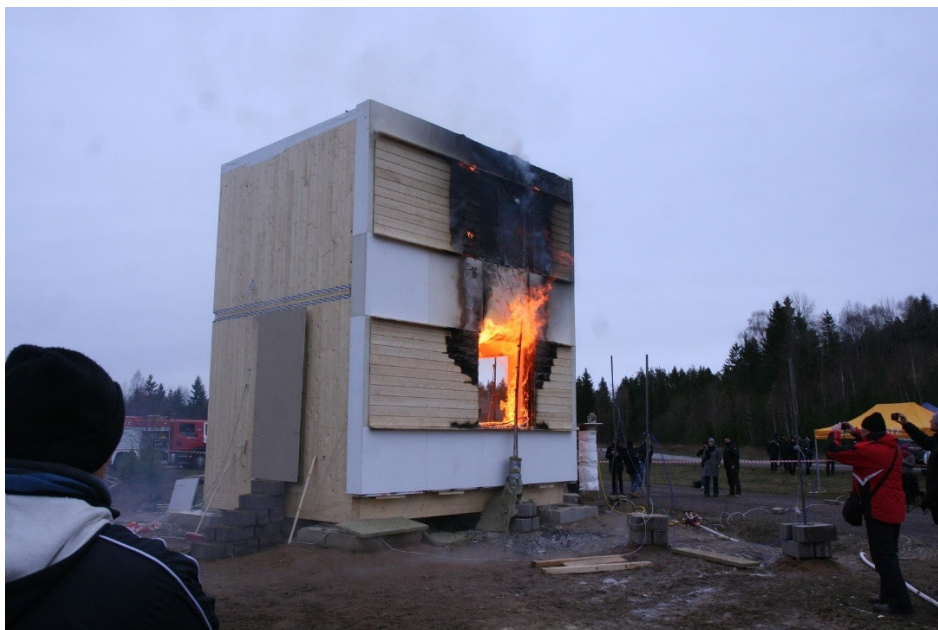
Figure 2.16 The flames are subsiding

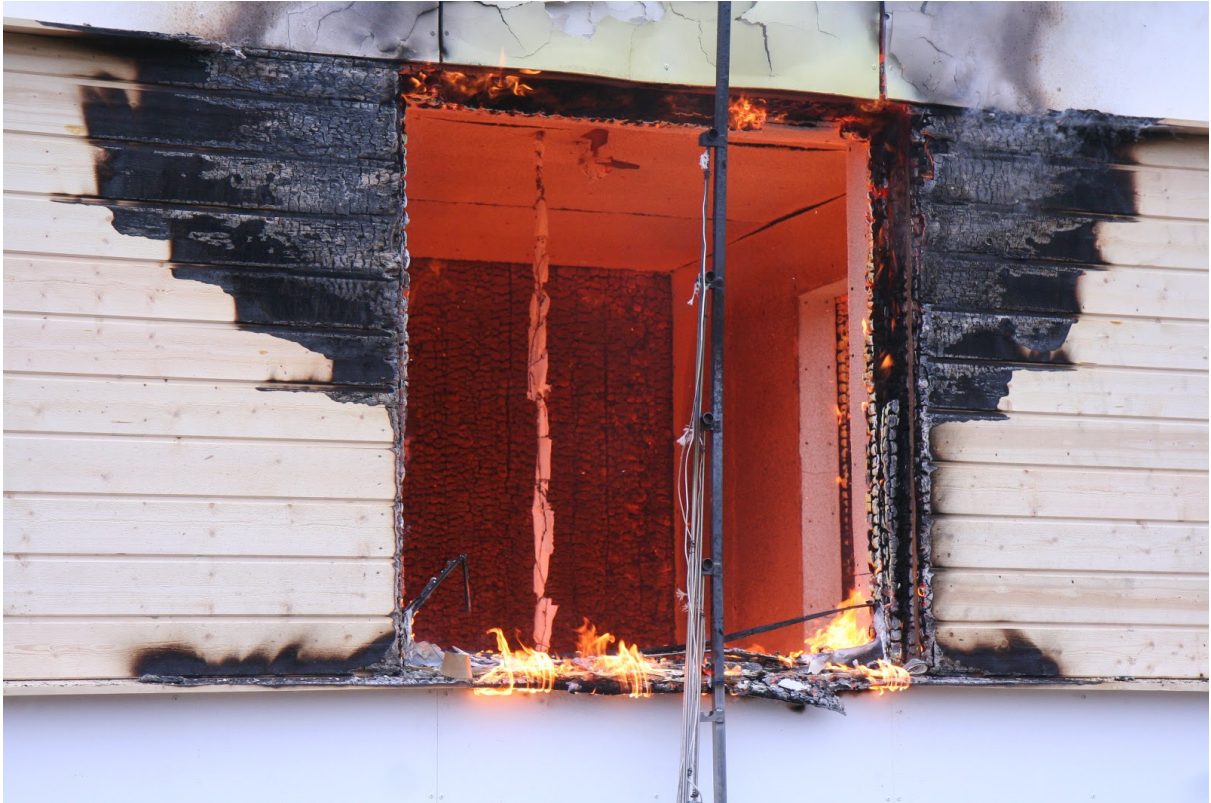
Figure 2.17 The CLT is smouldering

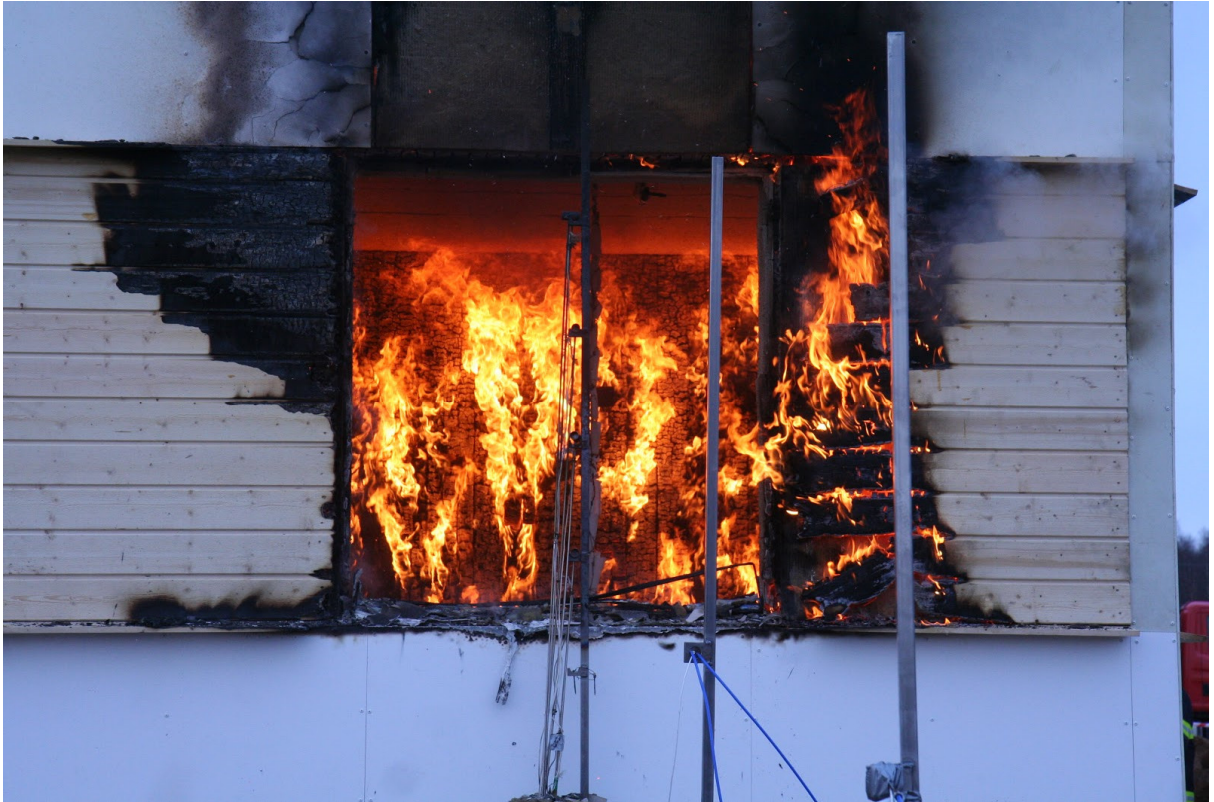
Figure 2.18 The second layer of CLT is burning

1:51:00 The charred layer of the CLT falls off and the second layer of CLT starts to burn with increased rate due to being preheated.

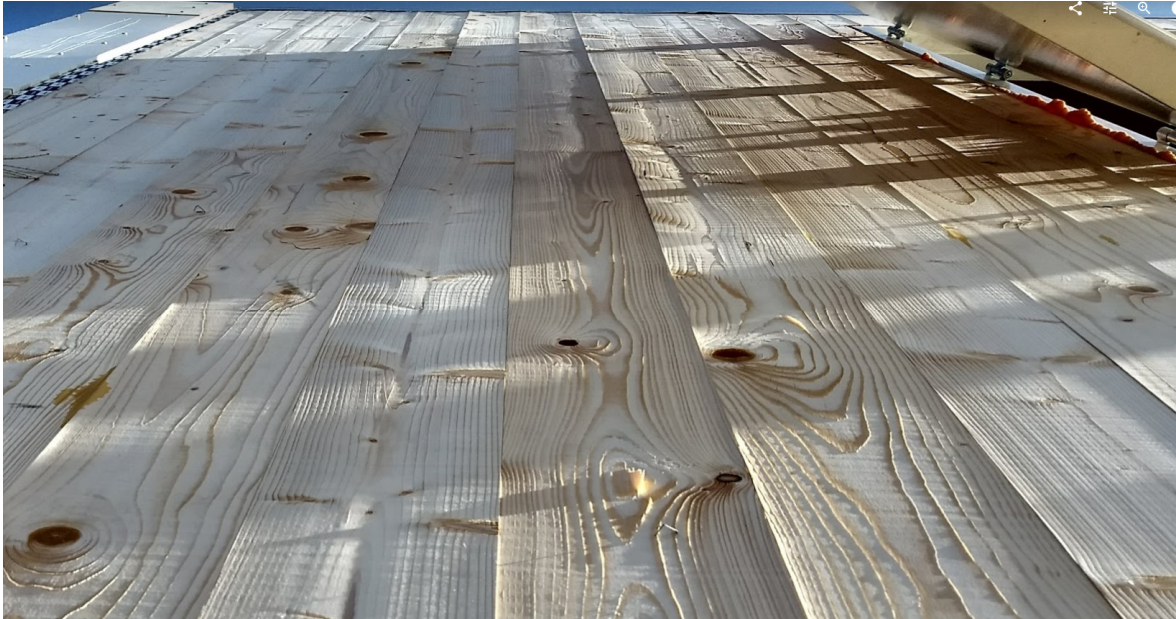
Figure 3.1. Visible deformation of boards exposed to weather conditions. Photo is taken six months after the test

Cross-laminated timber, or CLT, is an engineered wood panel product that consists of an odd number (typically 3, 5 or 7) of layers. These layers are stacked crosswise at 90-degree angles. Layers with even numbers consist of longitudinal boards and layers with odd numbers have transverse boards. It is not recommended to use CLT in conditions that meet service class 3 [15]. Deformations caused by exposure to conditions meeting service class 3 are shown on Figure 3.1.

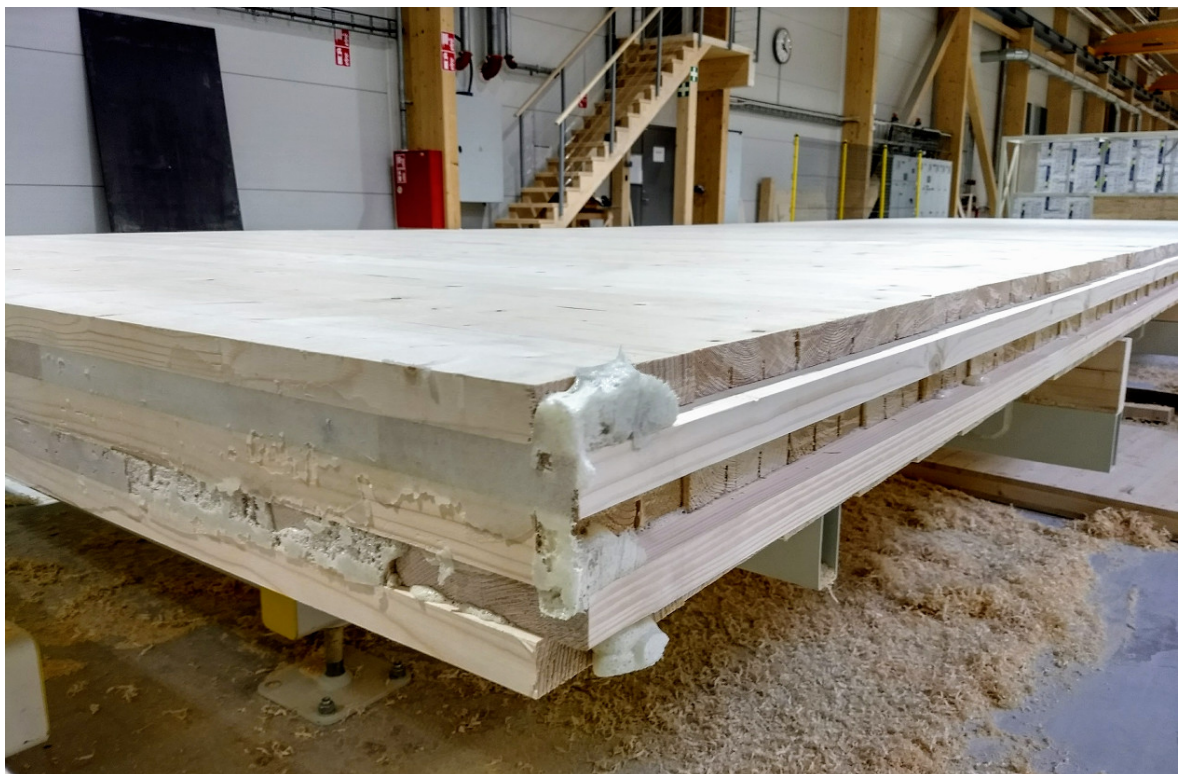
Figure 3.3. CLT panel prior to machining

The boards are then planed on four sides. This increases the gluing effectiveness and helps to keep the required thickness within tolerance. On Figure 3.3, a cross-laminated timber panel prior to machining is shown.

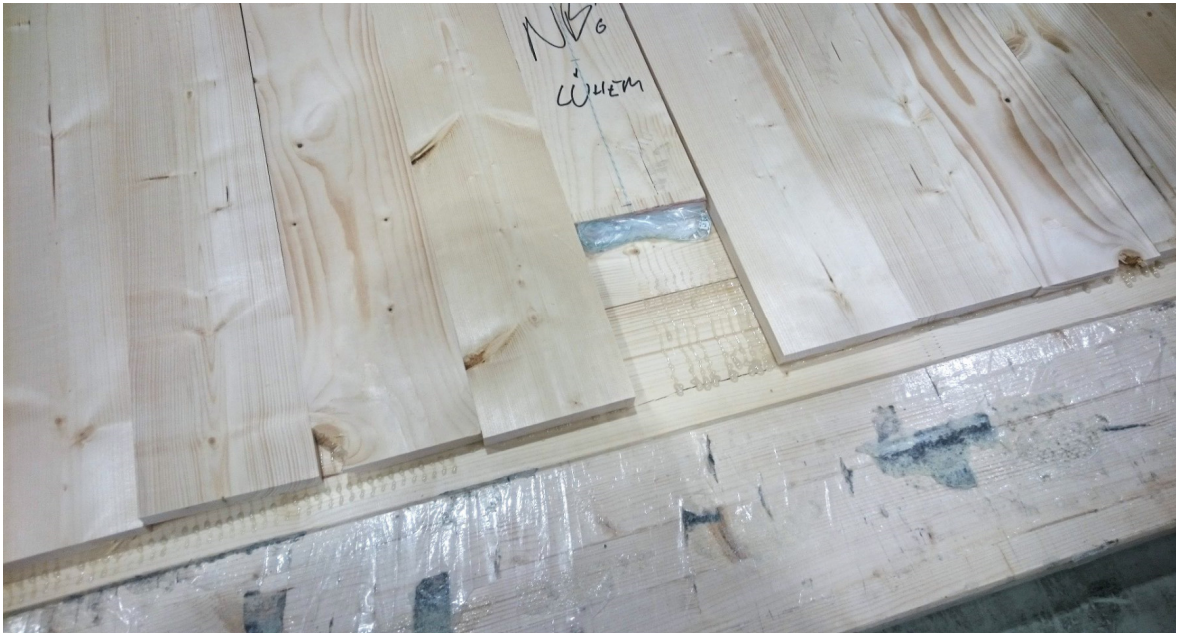
Figure 3.4. Thermocouples were put away before CNC machining

To avoid deformation caused by moisture, Peetri Puit usually makes small cuts along the boards used in CLT. To make the panel as air tight as possible and to avoid stack effect, it was decided not to use the cuts. Prior to CNC machining, in order to protect the cables from cutting, they were put away in a void (see Figure 3.4). Once the CNC was done, a hole was drilled for leading the cables to

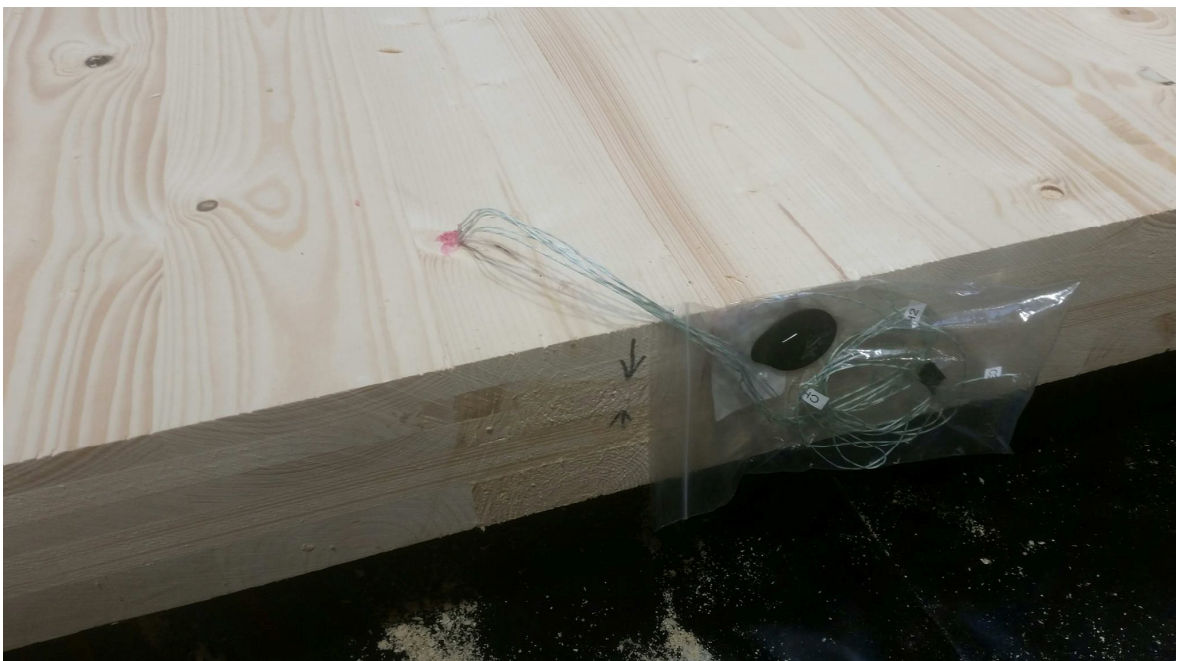
Figure 3.5. Finished CLT panel

the outer side of the panel. The hole was then filled with fire resistant PU foam (see Figure 3.5). Additional boards were installed to close the voids.

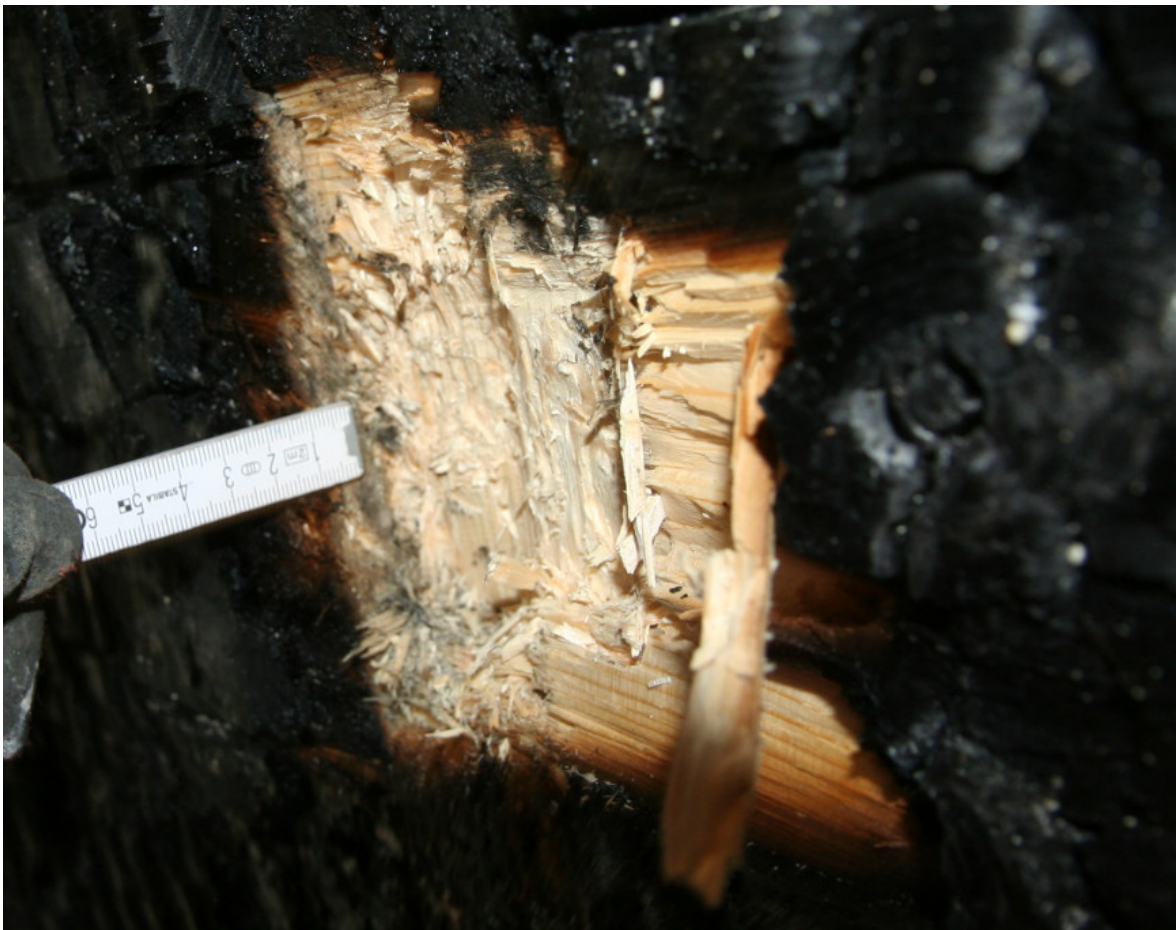
Figure 4.3. Measurements after test showed that approximately 20 mm of the second layer was charred

Thermocouples WA1...WA3 and WB1...WB3 were placed between layers of exposed cross-laminated timber (Figure 4.5 and Figure 4.6). As shown in Figure 4.7 and Figure 4.8, temperatures behind the first layer of CLT exceeded 300 °C for both cases. The first layer of CLT fell off on both walls and the second layer of CLT started to burn. However, at no point did the temperatures rise above 300 °C behind the second layer. This indicates that the delamination of the second layer was highly unlikely. The charring of the second layer was measured to be approximately 20 mm after the test as shown in Figure 4.3.

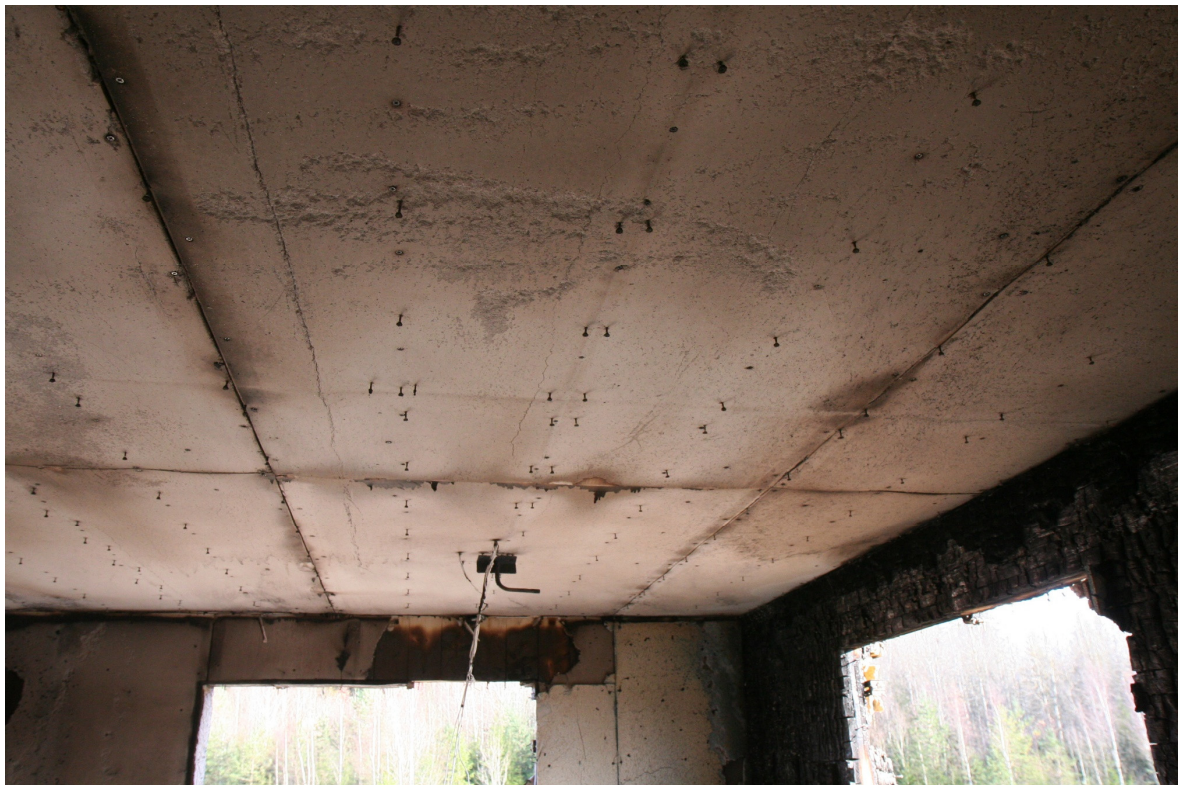
Figure 4.13. The third layer of gypsum fell off during extinguishing
