EstBatLIFE project "Improving the Pond Bat (Myotis dasycneme) habitats in Estonia"

Project Action A1 "Technical designs and building permits of project sites"

Content summary and list of documents for culvert placement in Piusa project site

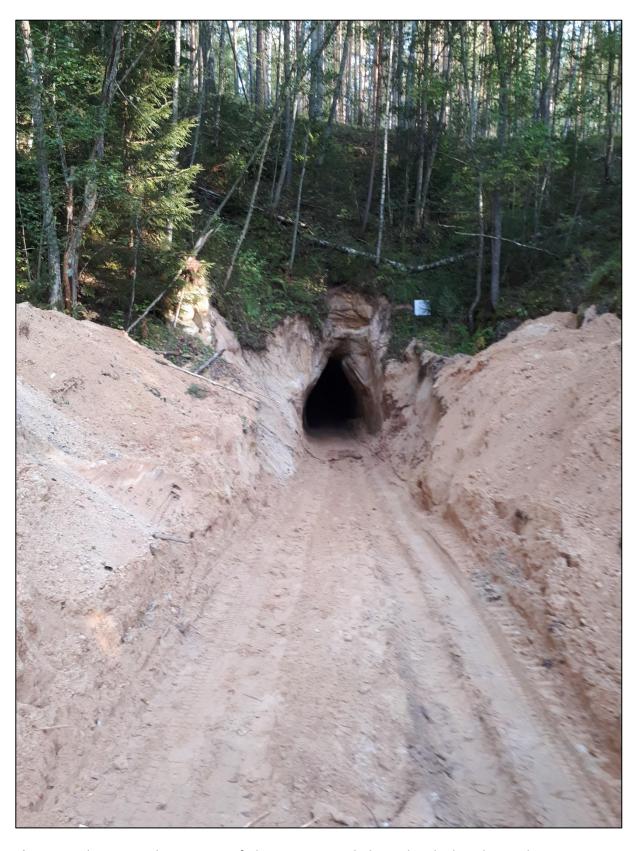
Photo 1. The opened entrance of the cave tunnel through which culvert elements were brought into the section with collapsing risk.

Placed culvert system measurements were as follows: length 24m and inner diameter 2m. Culvert system consists of four culverts with length of 6m each that are attached together with unique locking system built already into culvert ends. Placement of culvert system took three days of work, starting with opening of the closest entrance from where there was safe enough to enter with culvert (look photo 1). Carrying culver elements in and through the tunnel by pulling culvert with one and pushing with other small size four-wheel loader (look photos 2 and 3). After all four culvert elements where in place tunnel entrance was closed (look photo 4).

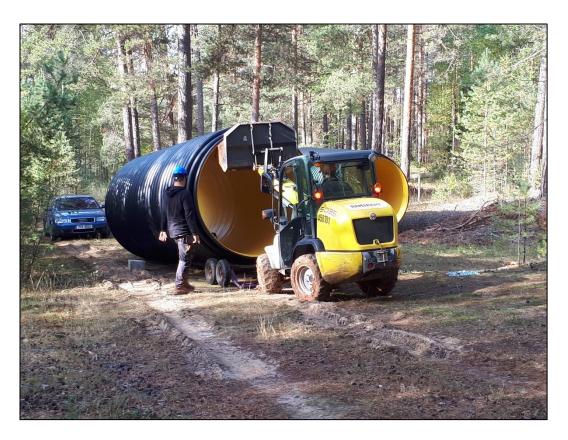
Photo 2. Preparation of pulling-pushing culvert elements with two small size four wheel loadres outside of the cave tunnel.

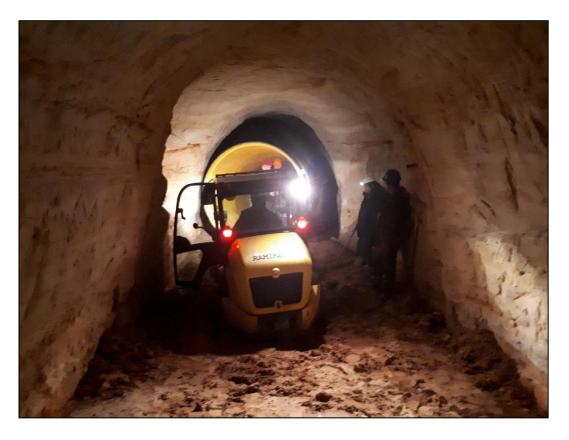
Photo 3. Pulling and pushing culvert elements with two small size four wheel loadres inside of the cave tunnel.

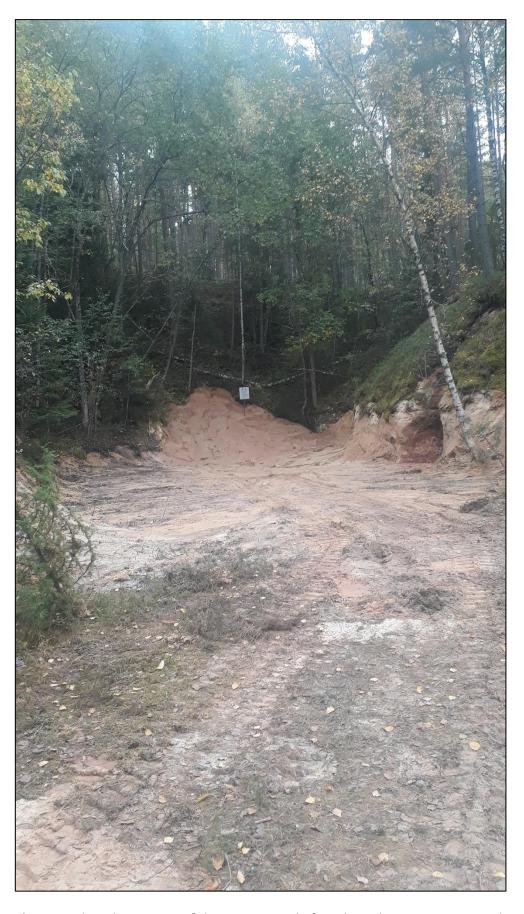
Photo 4. Closed entrance of the cave tunnel after the culvert system was placed.
